# Causes of Rotor Distortions and Applicable Common Straightening Methods for Turbine Rotors and Shafts

Esmaeil Poursaeidi, Mostafa Kamalzadeh Yazdi

**Key words**—Distortion, FEM, Hot Spot Area, Rotor Straightening

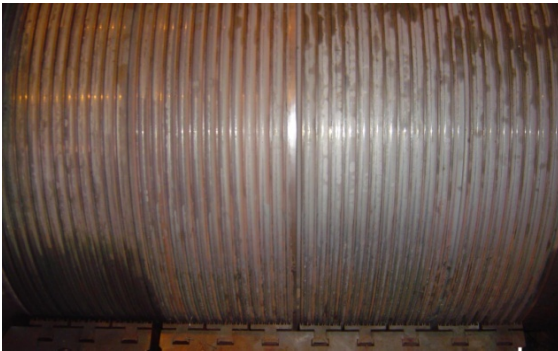
localized thermal expansion and the resultant rotor bend increases the pressure and extent of rubbing in a progressive and unstable manner (Fig. 1). The local thermal expansion is restricted by the cooler bulk of the rotor and an axial compressive stress is thereby set up in the area of the rub. At the same time the local friction lead to reduce the local yield stress by temperature increase, and compressive yielding eventually takes place. Local softening or hardening of rotor body is occurs. The rubbed zone is now permanently displaced leading to a reversed bend when the rotor finally cools to a uniform temperature.

Fig. 1 Effects of rubbing on rotor surface

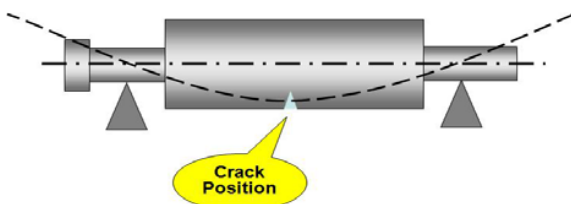
Transverse cracking in rotors can be initiated at surface stress concentrations by corrosion, pitting, thermal fatigue (starts related), or by high cycle fatigue due to self weight rotating bending stresses (Fig. 2). Transverse crack propagation is eventually driven by the bending stresses and this phase can take place over time scales in years. Because they do not directly affect the balance of a rotor, such cracks will not have much effect on normal vibration levels until they occupy a significant portion of the rotor cross section (e.g. 25%). Large cracks can have a sufficient effect in changing the compliance (transverse stiffness) of a rotor that clearances are lost and then rubbing, followed by the bending mechanisms described above takes place.

Fig. 2 Schematic of bending due to cracking

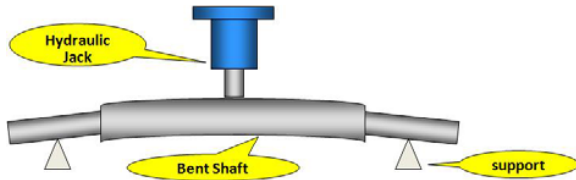
Fig. 3 Schematic of cold mechanical straightening

highest point. A hydraulic jack is to be positioned immediately above that point (Fig. 3) and a dial gauge in contact with the shaft surface immediately below. A load is to be carefully applied by the jack at the shaft surface, and it is to be increased very slowly and smoothly and the deflection is to be measured by suitably located indicators [9].

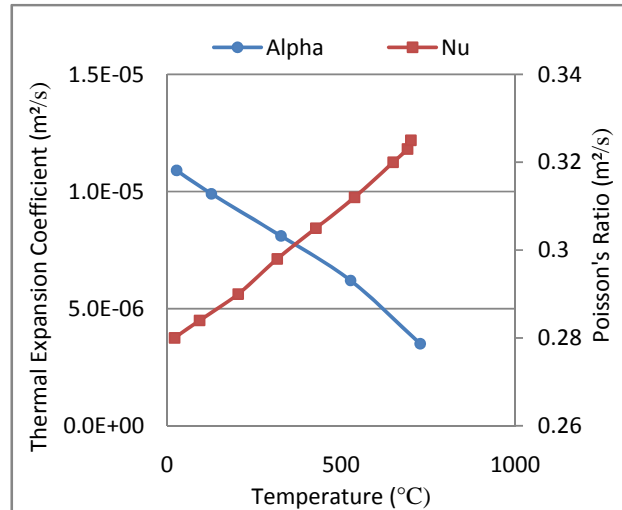
various models. Thermal expansion coefficient and poisson's ratio were modeled as shown in Fig. 5 Also other parameters such as thermal conductivity, specific heat, mass density and elastic modules were defined considering rotor material properties at different temperatures. Initial temperature assumed as a uniform temperature of  $21^{\circ}\text{C}$ .

Fig. 5 Nonlinear material properties of the rotor

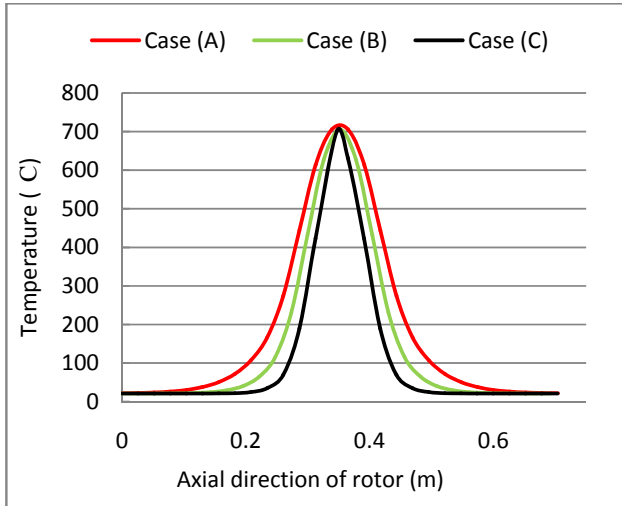
Simulation of hot spotting with three different hot spot areas and heat fluxes was done. The graph of thermal distribution along axial direction of rotor (Fig. 6) shows that the case (C) with the smallest hot spot area has the most thermal gradient between the hot spot area and its surrounding area which is ideal in straightening process but the amount of hot area (cherry red area) is too small to cause required bend. Also it shows that case (A) with the largest hot spot area has the least thermal gradient. The contour of plastic strain magnitude during hot spotting process for three aforementioned cases in Fig. 7 demonstrates that amount of plastic strain in case (A) is not enough to achieve required straightness. In contrast, magnitude of plastic strain in case (C) is the most rather than other cases which may cause some undesirable effects such as thermal shock and phase transformation of the rotor material. Therefore it is resulted that case (B) would cause the most satisfactory straightening effects.

Fig. 6 Thermal distribution along axial direction of rotor

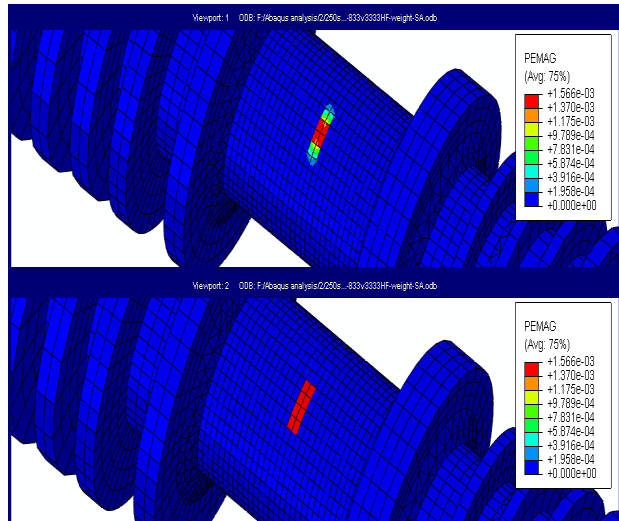
Fig. 8 Contour of plastic strain area at the temperature of (a) 705°C, (b) 750°C

Another simulation was done to investigate the effects of extra heating. Fig. 8 makes a comparison between the size of plastic area at two different temperatures of 705°C and 750°C. It illustrates that extra heating would significantly cause to develop the location of maximum plastic strain along the perimeter of the rotor. Yielding of the material through this large plastic area would contain extra energy to increase distortion of the rotor with no control. On the other hand, according to previous investigations exceeding permutation temperature will cause undesirable sequels on the material structure.

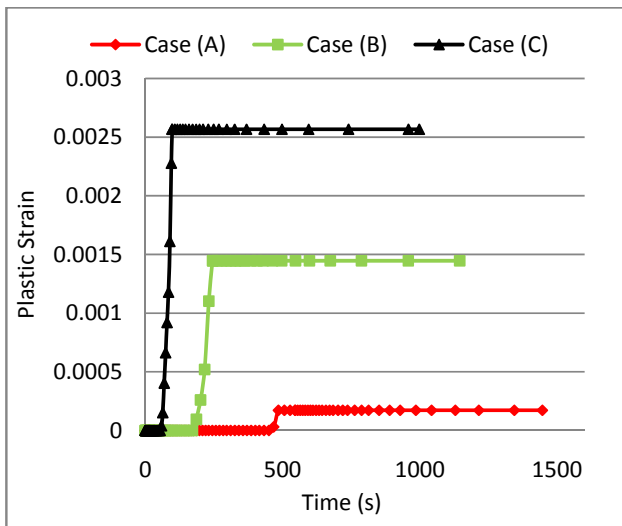
Fig. 7 Magnitude of plastic strain during hot spotting

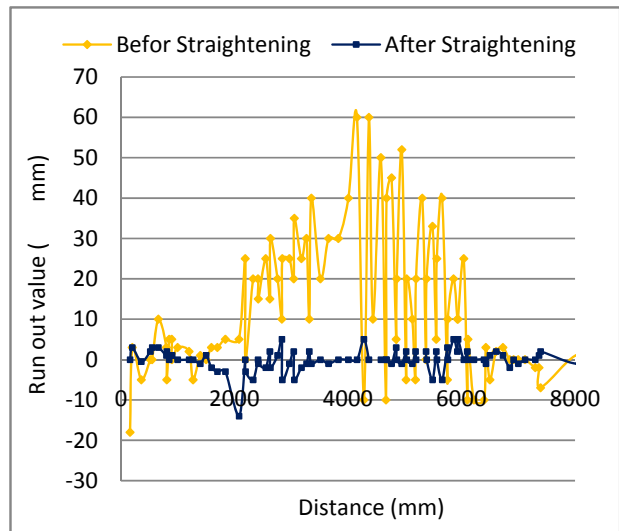
Fig. 9 Results of initial and final run out tests at an angle of 90°

A comparison between received experimental data from initial and final run out tests (Fig. 9) shows that performing the hot spotting execution according to simulated results, has been reduced the rotor eccentricity noticeably. Therefore we recommend using a numerical method before carrying out the selected straightening method.
