# The Significance of the Radiography Technique in the Non-Destructive Evaluation of the Integrity and Reliability of Cast Interconnects

Keshav Pujeri, Pranesh Jain, and Krutibas Panda

#### IV. CASE STUDY OF AN INTERCONNECT FAILURE IN THE FIELD

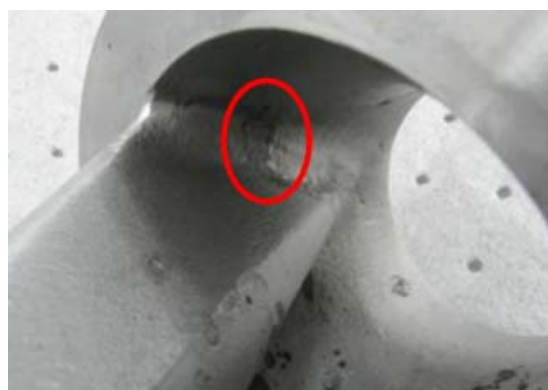
When internal parts of the interconnect assembly were removed; traces of drilling fluid were observed which could have caused the electrical failure (Fig. 3). Further visual inspection of the interconnect revealed a deformity at the inner neck area close to the wire-way. When combined with the evidence of the drilling fluid, we suspected that there was a casting defect in the interconnect body. This defect could have been exposed after the downhole run and drilling fluid would have leaked into wire-way (Fig. 4).

Fig. 4 Suspected casting defect area

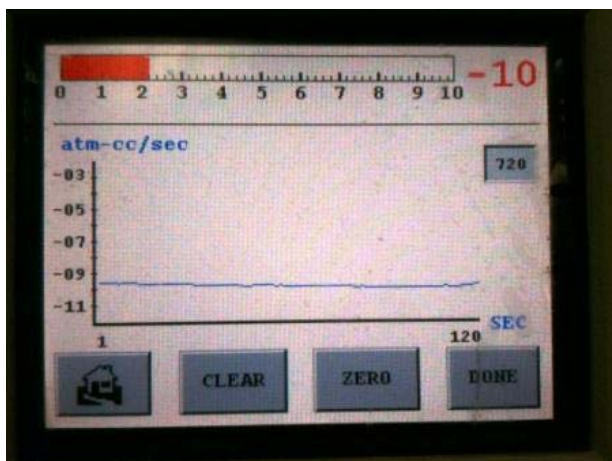
The component was tested for Helium leak with appropriate sealing and fixtures; the leak graph showed no spikes on the sensor/detector monitor (Fig. 5). Hence HLT couldn't detect any defect with the failed interconnect.

Fig. 5 Graph: Rate of Helium leak v/s time

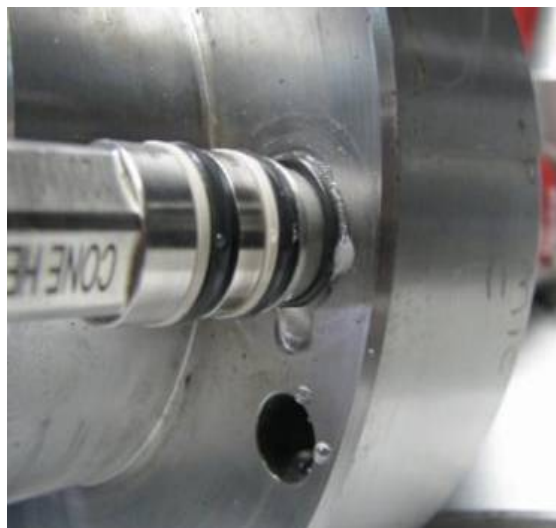
The interconnect was tested three times by applying pressure of 25 ksi twice and 30 ksi once for about 30 minutes each time. We saw that the component had leaked water droplets after the pressure test fixtures were removed but that the fixtures didn't have water drops on them, indicating that the leakage probably did not occur from the fixture side (Figs. 6 and 7).

Fig. 6 Gas escapes while removing fixture

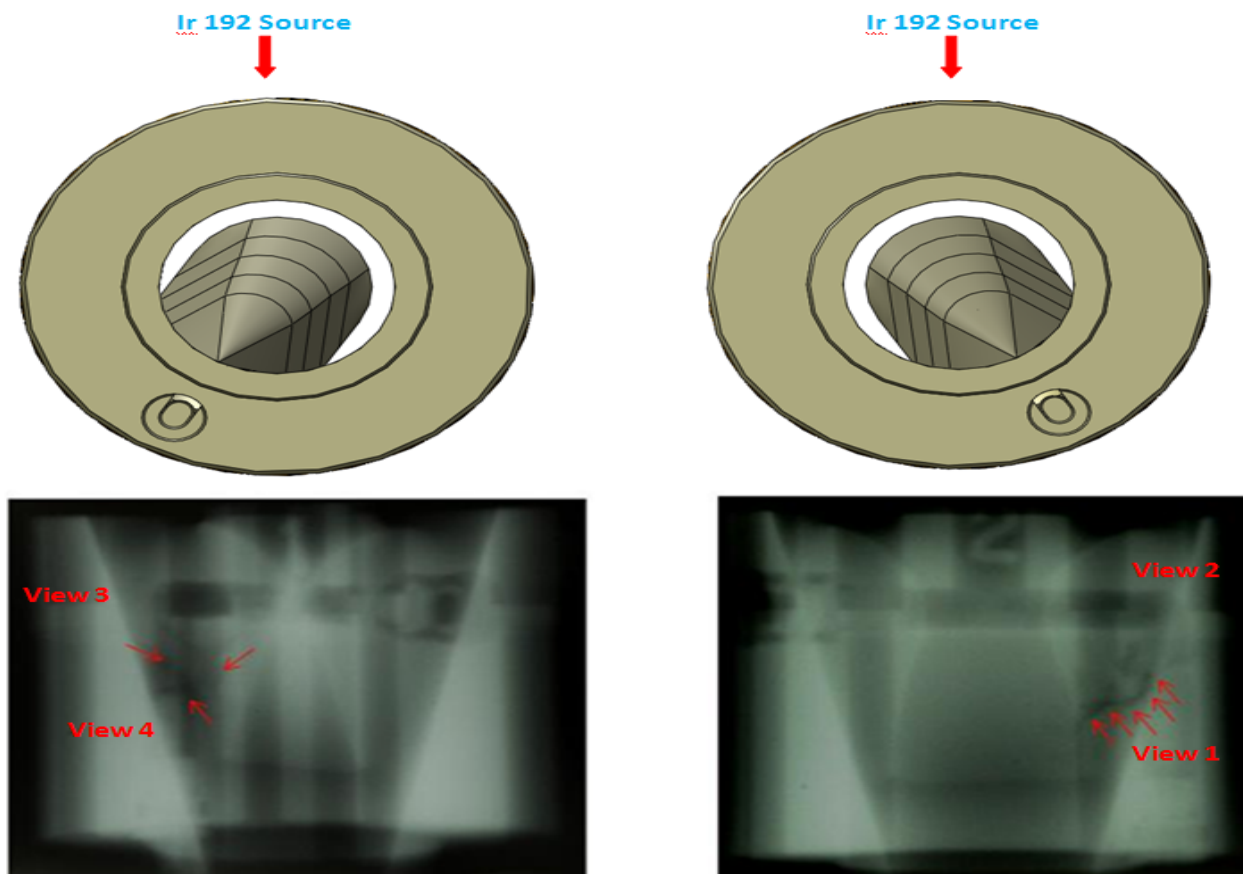
A radiography test was conducted on the component as per ASTM standard E1742/ E1742M [5]. Iridium-192 was used as the source of the gamma rays. The images were captured on radiography films and compared with standard ASTM Radiographs E446-10 [3]. The nature and intensity of the contrasting areas on the radiographs led to the conclusion that the defect was shrinkage porosity type 'CB' and severity level '3' (Fig. 8).

Fig. 8 Radiography test on the defect interconnect

Based on the radiography results, the mold design was improved by introducing a new gating system. Additionally, radiographic inspection was added to test all components in 'as cast' condition irrespective of their class; as testing each component is much less expensive than a down-hole failure.

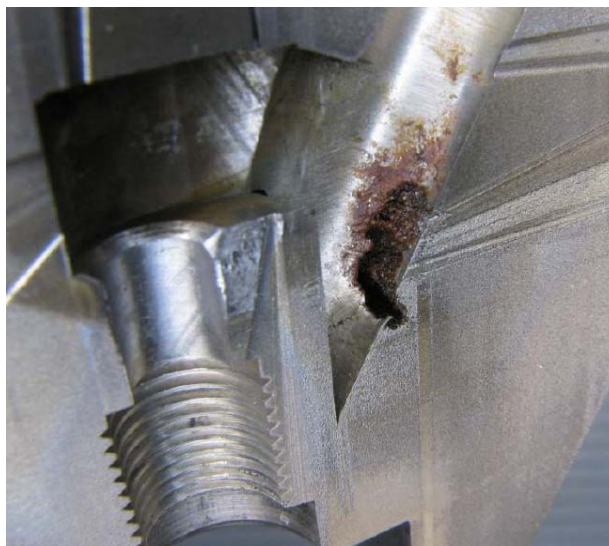
The component was sectioned into two halves by Electric Discharge Machining (EDM) and further metallurgical characterization studies were performed. Cross-sectional analysis near the defect location indicated a hole with brown residue surrounding it as illustrated in Fig. 9. High-resolution electron micrographs at this location indicated solidification of the dendrite structure as shown in Fig. 10. This is indicative of a shrinkage defect. Energy dispersive X-ray spectroscopy performed on the brown residue surrounding this defect indicated a significant presence of carbon, likely grease or oil residue near the defect. The shrinkage porosity was not isolated to a small area but was rather spread across the entire thickness as seen in certain cross-sectional views (Fig. 11).

Fig. 9 Cavity found at defect location

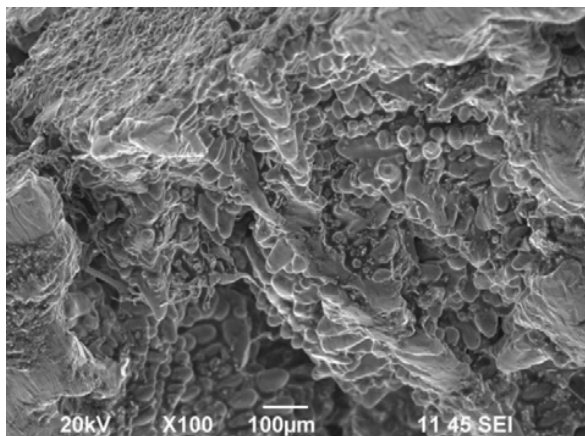
Fig. 10 Microscopic view of the dendrite structure at the shrinkage

In summary, the metallurgical characterization identified the location of the defect and high-resolution microscopy confirmed that the defect was a result of shrinkage porosity. The shrinkage porosity was found to occupy a comparatively larger volume fraction.

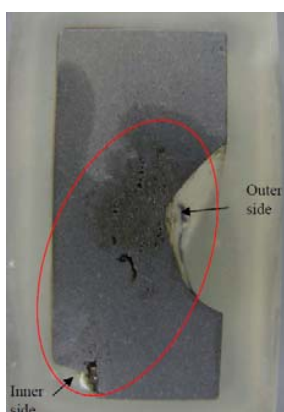
Fig. 11 Cross-sectional view illustrating the shrinkage porosity through the thickness of the interconnect wall
