# Analysis of the Root Causes of Transformer Bushing Failures

E. A. Feilat, I. A. Metwally, S. Al-Matri, and A. S. Al-Abri

**Abstract**—This paper presents the results of a comprehensive investigation of five blackouts that occurred on 28 August to 8 September 2011 due to bushing failures of the 132/33 kV, 125 MVA transformers at JBB Ali Grid station. The investigation aims to explore the root causes of the bushing failures and come up with recommendations that help in rectifying the problem and avoiding the reoccurrence of similar type of incidents. The incident reports about the failed bushings and the SCADA reports at this grid station were examined and analyzed. Moreover, comprehensive power quality field measurements at ten 33/11 kV substations (S/Ss) in JBB Ali area were conducted, and frequency scans were performed to verify any harmonic resonance frequencies due to power factor correction capacitors. Furthermore, the daily operations of the on-load tap changers (OLTCs) of both the 125 MVA and 20 MVA transformers at JBB Ali Grid station have been analyzed. The investigation showed that the five bushing failures were due to a local problem, i.e. internal degradation of the

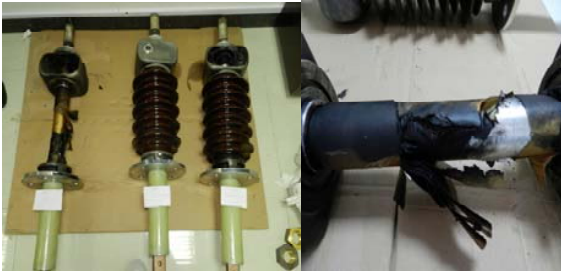
Five incidents of transformer-bushing failures occurred at JBB Ali Grid station on 28 August to 8 September 2011. Some of these incidents resulted in bushing explosion of the porcelain housing and its head. The transformers were in service since 2001 and they were running satisfactorily till the first Bushing failure which occurred after 10 years. A summary of the five incidents are presented in Table I. Mazoon Electricity Company along with consultants undertook detailed study to find root cause of failures.

To identify the root cause of the Grid station transformer bushing repeated failures, physical inspection and detailed simulation studies were conducted. The physical inspection includes viewing and analyzing the layers of the condenser foil and its paper insulation, installation practice, grounding points, maintenance records and tap changer operation. A visual inspection of the failed bushings is shown in Fig. 1, where there are burn-through marks on the bushing condenser paper and two melted spots on the HV central lead. These observations are considered as good indicators of localized internal insulation breakdown.

Fig. 1 Photo of three failed transformer bushings

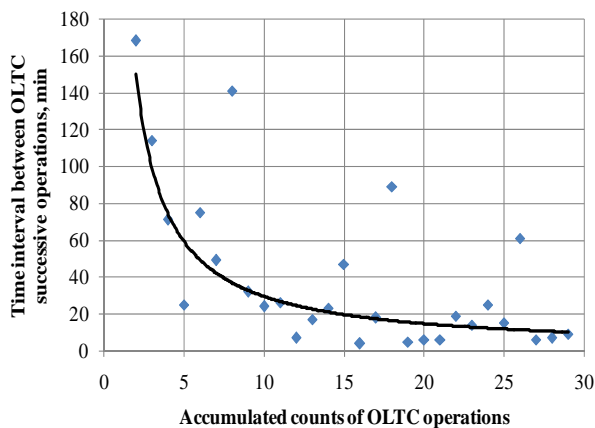
Fig. 3 JBB Grid station, TX1, 8-9-2011

Statistical analysis of the faulty operation of the OLTCs of JBB Ali Grid S/S is depicted in Fig. 3. Fig. 3 shows the time

interval between OLTC successive operations for the faulty JBB Ali Grid transformer. The results indicate that the OLTC time intervals are too small which implies an abnormal operation as a result of frequent variation of the 33 kV voltage level of the 125 MVA transformers. This fast variation could be attributed to successive partial discharges activities in the bushing insulation.

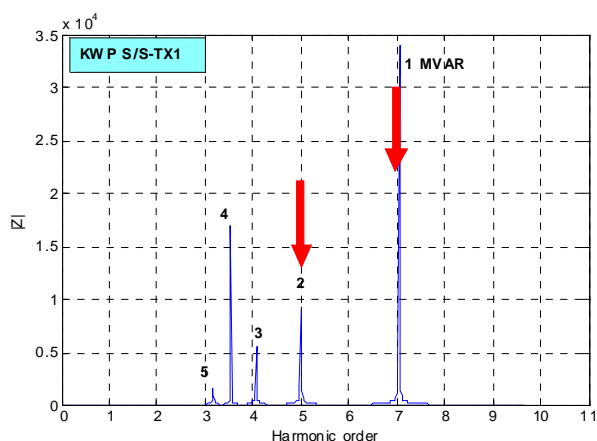
Fig. 4 Impedance scan- Al Kamel water pump S/S (TX1)

11 kV-bus where the capacitor banks are located has been computed for the ten S/Ss. Fig. 4 displays the frequency scan for Al Kamel water pump S/S. The results indicate that there is a possibility of resonance at the 5<sup>th</sup> and 7<sup>th</sup> harmonic frequencies. Therefore, if either the 5<sup>th</sup> or 7<sup>th</sup> harmonic current exists, the corresponding magnified harmonic voltage will be superimposed on the 50-Hz 11-kV bus.

Examining Fig. 4, it can be seen that harmonic parallel resonance at Al Kamel water pump S/S-TX1 is possible at the 5<sup>th</sup> and 7<sup>th</sup> harmonic frequencies corresponding to 3 and 1 MVAR compensation, respectively. The overall impedances of the combination of the capacitor bank and system equivalent short-circuit reactance as seen from the PCC  $Z_{R5} = 90 \text{ k}\Omega$   $Z_{R7} = 34 \text{ k}\Omega$ , respectively. For 5<sup>th</sup> and 7<sup>th</sup> harmonic currents  $I_{h5} = 2.3\%$  and  $I_{h7} = 0.7\%$ , with  $I_{h1} = 24 \text{ A}$ , the corresponding magnitudes of the magnified 5<sup>th</sup> and 7<sup>th</sup> harmonic voltages are  $V_{h5} = 75\%$  and  $V_{h7} = 86\%$ , respectively. However, the damping provided by resistance in the system and the overvoltage surge arresters are often sufficient to prevent catastrophic voltages and currents.

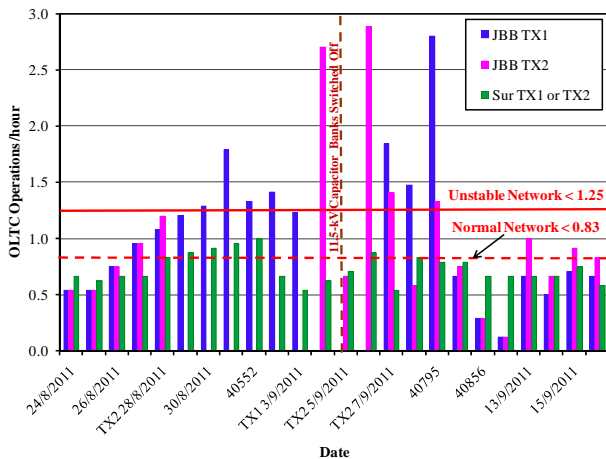
Fig. 5 Hourly-operations 132-kV OLTC at JBBA and Sur Grid S/Ss

The frequency of operations of the OLTCs of TX1 and TX2 of the 132/33 kV 125 MVA transformers at JBB Ali Grid S/S is compared to that of the healthy Sur Grid S/S during the time interval from 24/08/2011 to 16/09/2011 as depicted in Fig. 5. It can be seen that the OLTC of either Sur transformers (TX1 or TX2) hourly operation (i.e. number of tap changers operations per hour) are within the normal network operations i.e. 20 operations per day or <0.83 operations/hour [9]. On the other hand, the OLTC of either TX1 or TX2 at JBB Ali Grid S/S exhibits abnormal hourly operations i.e. above the normal network. This abnormal operation appeared on 27/08/2011 and 28/08/2011, which resulted in failure of TX2 on 28/08/2011 and TX1 on 03/09/2011, respectively.

Likewise, another severe abnormal operation that exceeds the unstable network i.e. 30 operations/day or >1.25 operation/hour was observed on 04/09/2011. As a result, TX2 failed on 05/09/2011. These abnormal operations continued and yielded to two failures of TX2 on 07/09/2011 and TX1 on 08/09/2011, respectively even after switching off the capacitor banks at the 11.5 kV bus of MZEC JBB Ali 33/11.5 kV S/S.

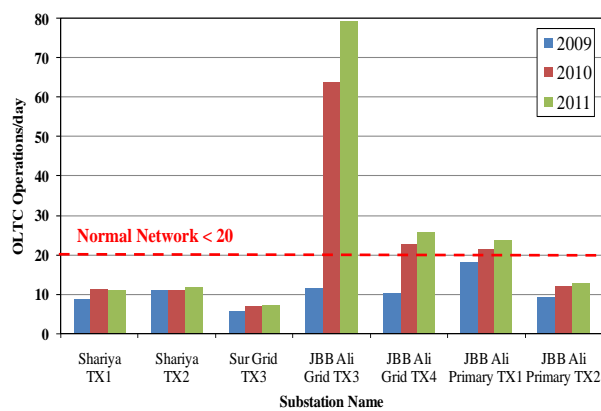
Fig. 6 Average daily operations of 33-kV OLTC in 2009, 2010 and 2011

For the sake of comparison, Fig. 6 shows the frequency of transformer OLTC operations at different 33/11.5 kV MZEC S/Ss including Sur Grid, JBB Ali Grid, JBB Ali primary and Shariya S/S in 2009, 2010 and 2011. It can be seen that TX3 transformer at JBB Ali Grid S/S exhibiting abnormal operation since 2010, where the number of daily operations

exceeds 20 indicating unstable network operations at the JBB Ali Grid S/S.

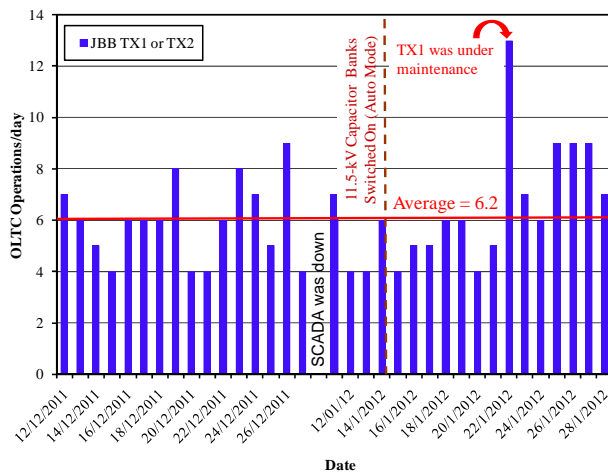
Fig. 7 Hourly 132-kV OLTC at JBB Grid S/S in Dec. 2011 and Jan. 2012 before and after switching-on of the 11.5-kV capacitor banks

Following the five failures of TX1 and TX2, the six 33 kV bushings were replaced. Accordingly, the daily operations of the OLTCs of both TX1 and TX2 during the time interval

from 12/12/2011 to 28/01/2012 fall within the stable network operation as demonstrated in Fig. 7. The average daily operations was 6.2 operations/day or 0.26/hour.

It was also found that monitoring the number of OLTC operations can help in predicting bushing failure when it exceeds a threshold value of 20 operations per day or a monthly average of 10 operations.
