Analysis of Surface Spalling on a First Intermediate Roll in Sendzimir Mills

Abstract—A first intermediate roll of Sendzimir mills was failure by surface spalling during operation. After analyzing by visual, stereo microscope, optical microscope, scanning electron microscope, glow-discharged spectrometer and hardness test, respectively, the results show that some voids and cracks existed on the contact surface as well as subsurface. Further examination verified inadequate hardness and inclusions were responsible for the failure of surface spalling.

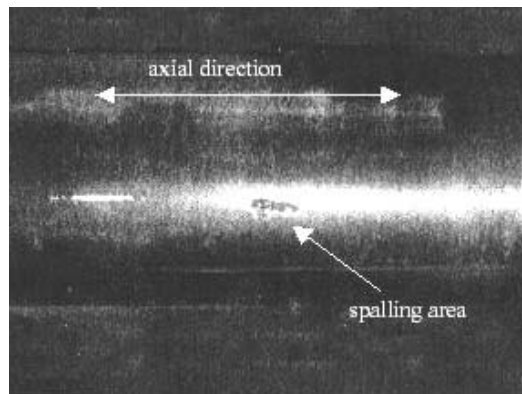
One 1st intermediate roll of the Sendzimir cold-rolling mills was found to be failure due to some spalling were happened on the surface, as shown in Fig. 2. After be examined carefully by visual inspection,

Fig. 2 A macrograph of the surface spalling roll of Sendzimir mills

After visual and stereo-microscope observation, it is found that the spalling areas revealed by elongating along the axial direction of the roll and characterized with an "apex" tips, as indicated in Figs. 2 and 3. Meanwhile, there are some small pits and cracks existing on the surface which are located under the spalling areas, please see Fig. 4.

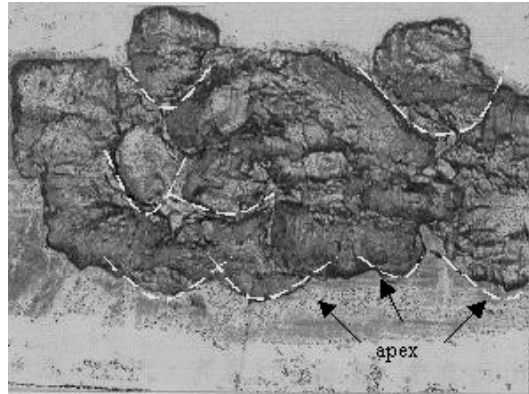
Fig. 3 A stereograph of the spalling area.(8X)

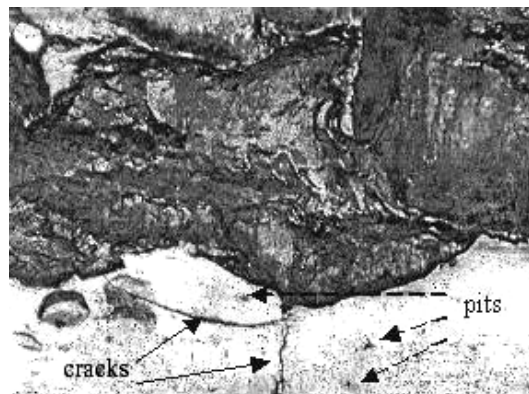
Fig. 4 The lower portion of the spalling area. (32X)

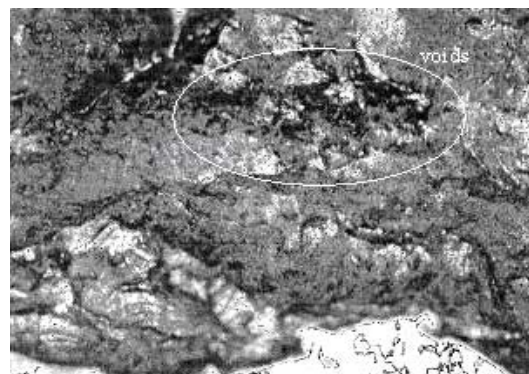
Fig. 5 A higher magnification of the spalling area. (64X)

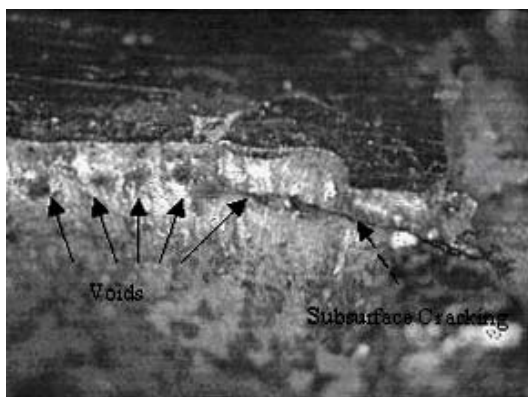
Fig. 6 The side-viewed of the spalling area. (64X)

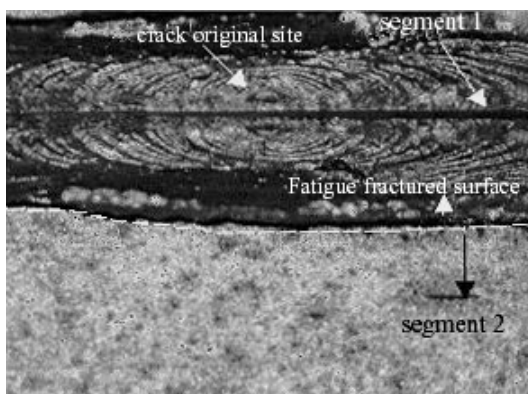
Fig. 7 An example of the fatigue fractured surface. (32X)

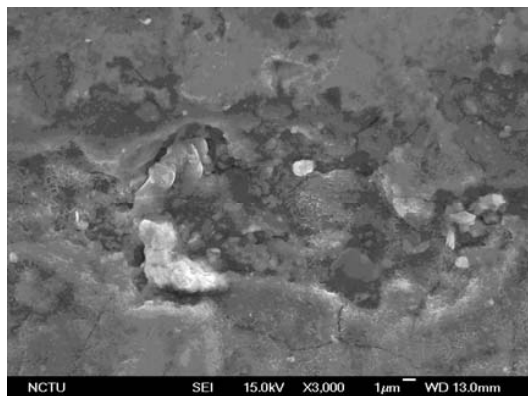
Fig. 8 A SEM micrograph of the origin of fatigue crack

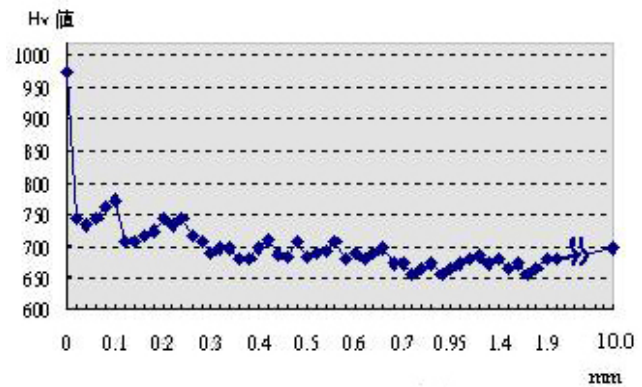
Fig. 9 The micro-hardness distribution of the subsurface

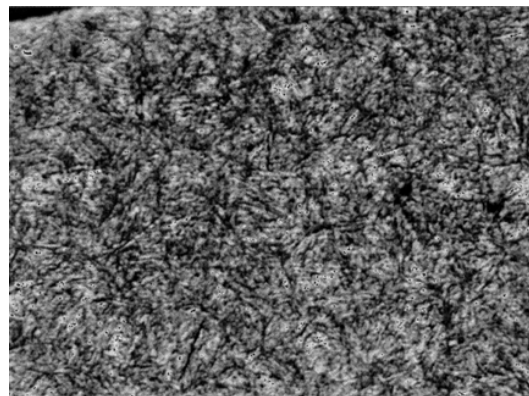
Fig. 10 A optical micrograph of the subsurface microstructure
