Analysis of Surface Spalling on a First Intermediate Roll in Sendzimir Mills

Shiang-Cheng Jeng and Horng-Shing Chiou

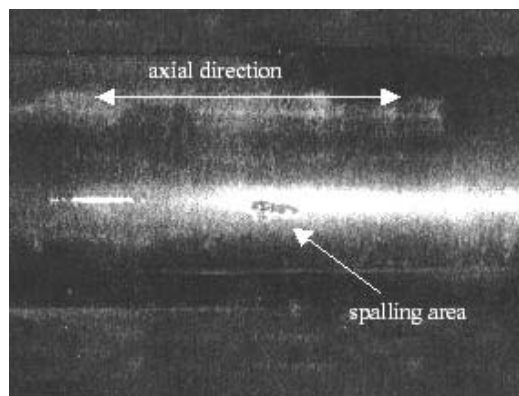
One 1st intermediate roll of the Sendzimir cold-rolling mills was found to be failure due to some spalling were happened on the surface, as shown in Fig. 2. After be examined carefully by visual inspection,

Fig. 2 A macrograph of the surface spalling roll of Sendzimir mills

After visual and stereo-microscope observation, it is found that the spalling areas revealed by elongating along the axial direction of the roll and characterized with an "apex" tips, as indicated in Figs. 2 and 3. Meanwhile, there are some small pits and cracks existing on the surface which are located under the spalling areas, please see Fig. 4.

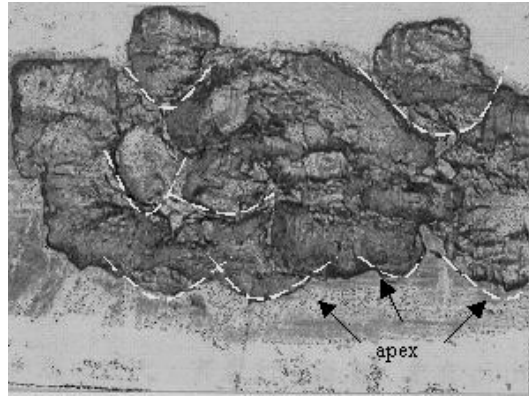
Fig. 3 A stereograph of the spalling area. (8X)

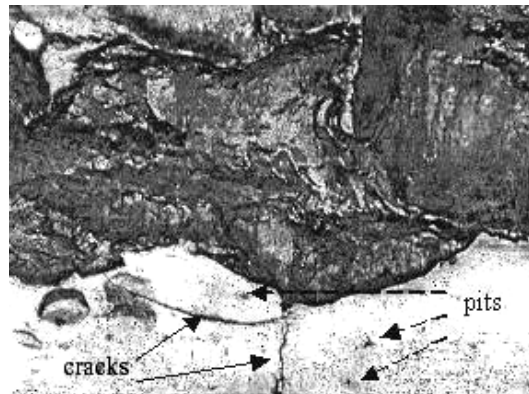
Fig. 4 The lower portion of the spalling area. (32X)

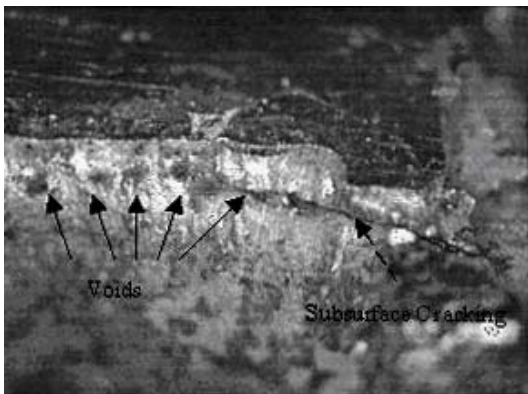
Fig. 6 The side-viewed of the spalling area. (64X)

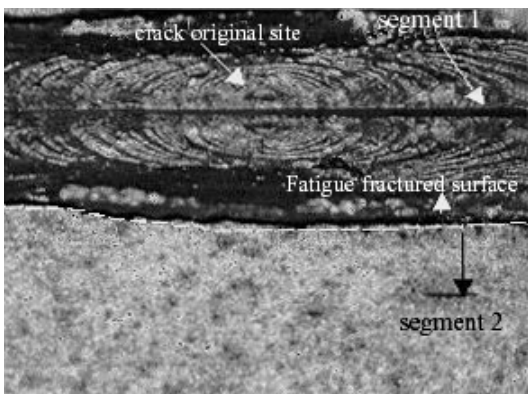
Fig. 7 An example of the fatigue fractured surface. (32X)

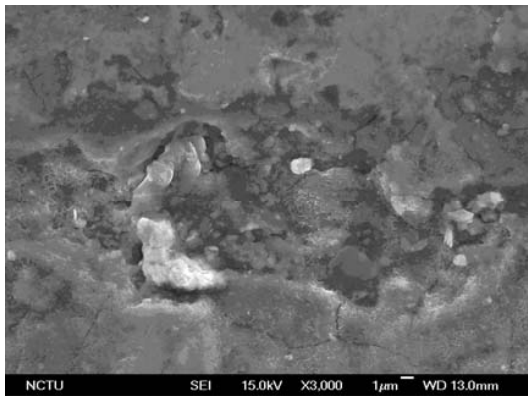
Fig. 8 A SEM micrograph of the origin of fatigue crack

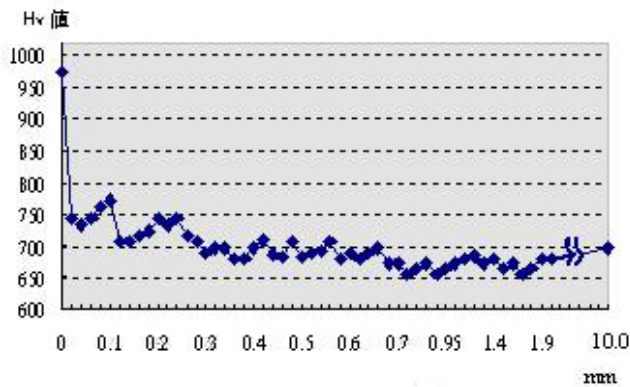
Fig. 9 The micro-hardness distribution of the subsurface

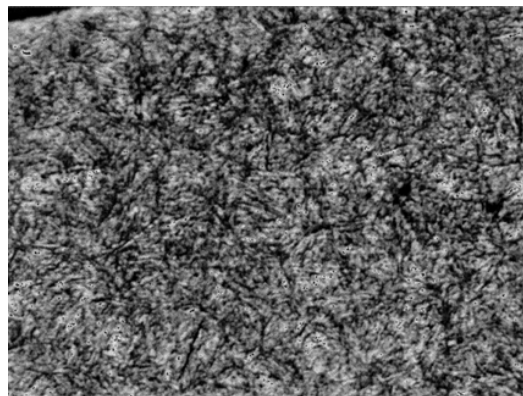
Fig. 10 A optical micrograph of the subsurface microstructure
