Comparison of Double Unit Tunnel Form Building before and after Repair and Retrofit under in-Plane Cyclic Loading

S. A. Anuar, N. H. Hamid, M. H. Hashim, S. M. D. Salleh

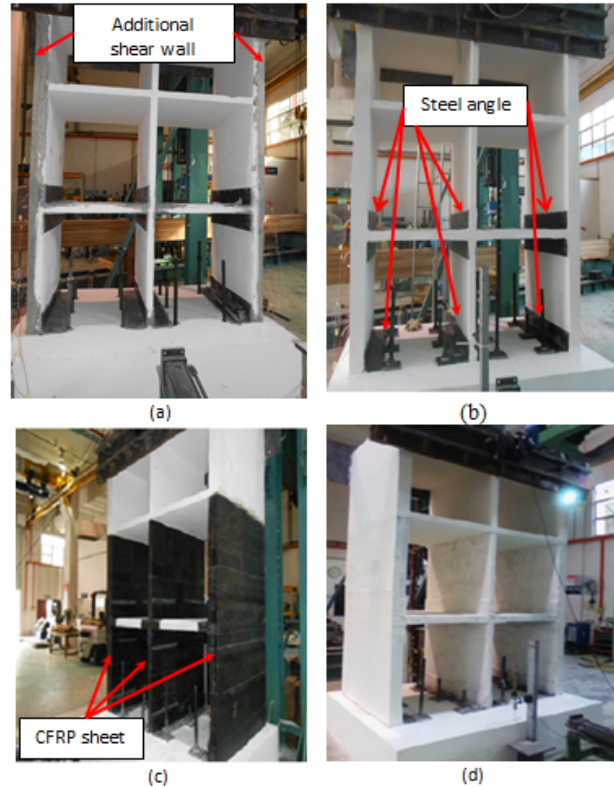
Fig. 1 Repair and retrofit process of double unit TFB (a) the completion of new additional shear wall, (b) the installation of steel angle, (c) the completion of wrapping CFRP sheet on shear wall interfaces and (d) painting the CFRP sheet with white colour

After testing, the similar TFB was repaired and retrofitted using the combination of additional shear wall, steel angle and CFRP sheet attached to the wall. The same size of shear wall were constructed to the existing outer layer of wall for both side left and right as shown in Fig. 1 (a). The overall size of wall including additional wall is 1200mm x 2850mm x 100mm. The wire mesh BRC-8 was placed at middle of wall with 80 mm spacing vertical and horizontally. Twelve (12) steel angles were attached to the wall-slab joint of the first and second floor tunnel form building as demonstrated in Fig. 1 (b). The locations of these steel angles are based on the previous crack obtained from the initial testing. Later, a single layer CFRP sheet was wrapped to the first and second floor wall as shown in Fig. 1 (c). Finally, the whole double unit TFB was painted with white colour to easily captured any rip of CFRP sheet and cracks during testing as shown in Fig. 1 (d).
