Comparison of Double Unit Tunnel Form Building before and after Repair and Retrofit under in-Plane Cyclic Loading

S. A. Anuar, N. H. Hamid, M. H. Hashim, S. M. D. Salleh

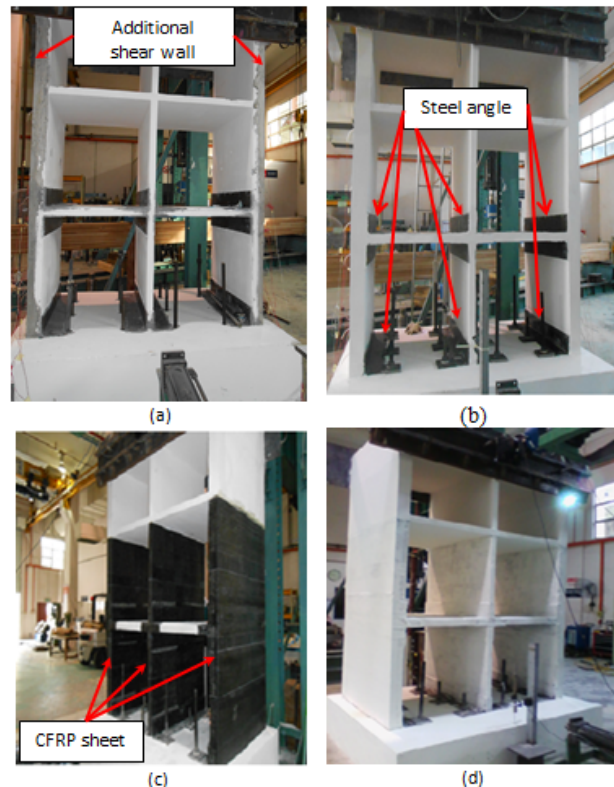
Fig. 1 Repair and retrofit process of double unit TFB (a) the completion of new additional shear wall, (b) the installation of steel angle, (c) the completion of wrapping CFRP sheet on shear wall interfaces and (d) painting the CFRP sheet with white colour

After testing, the similar TFB was repaired and retrofitted using the combination of additional shear wall, steel angle and CFRP sheet attached to the wall. The same size of shear wall were constructed to the existing outer layer of wall for both side left and right as shown in Fig. 1 (a). The overall size of wall including additional wall is 1200mm x 2850mm x 100mm. The wire mesh BRC-8 was placed at middle of wall with 80 mm spacing vertical and horizontally. Twelve (12) steel angles were attached to the wall-slab joint of the first and second floor tunnel form building as demonstrated in Fig. 1 (b). The locations of these steel angles are based on the previous crack obtained from the initial testing. Later, a single layer CFRP sheet was wrapped to the first and second floor wall as shown in Fig. 1 (c). Finally, the whole double unit TFB was painted with white colour to easily captured any rip of CFRP sheet and cracks during testing as shown in Fig. 1 (d).

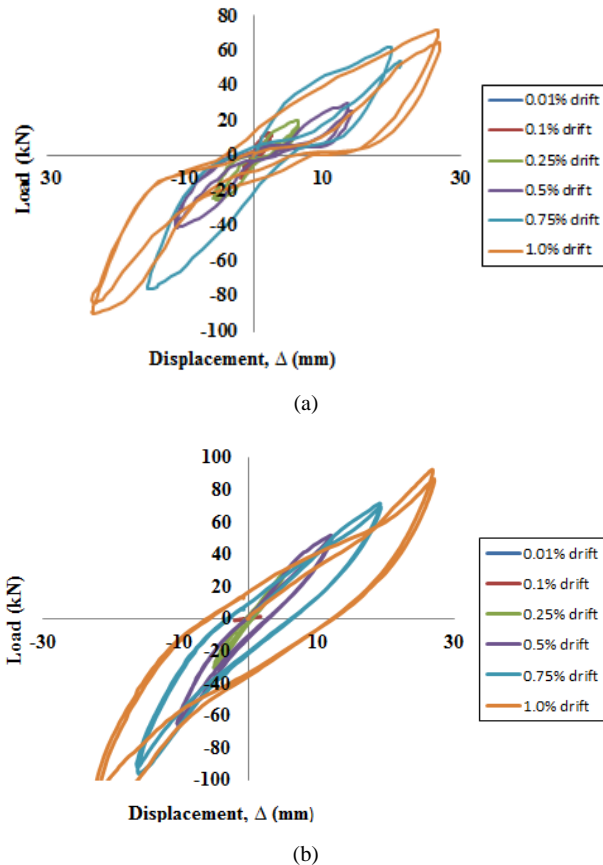
Fig. 2 shows the comparison of hysteresis loop of tunnel form building before and after retrofitting up to $\pm 1.0\%$ drift. The enclosed hysteresis loops after retrofitting is bigger than the hysteresis loop before retrofitting. The usage of additional shear wall, angle steel and CFRP sheet give a higher value of lateral strength as compared before retrofitting. The greater

increment of lateral load obtained from the first cycle in pushing direction after retrofitting is 90kN as compared before retrofitting of 70kN. A similar pattern in pulling direction (first cycle) where the lateral load after retrofitting is higher (98kN) than before retrofitting (72kN). It indicates that this retrofit method could increase the lateral strength capacity of TFB in pushing and pulling direction for the first and second cycle.

Fig. 2 Hysteresis loop (a) before retrofitting and (b) after retrofitting

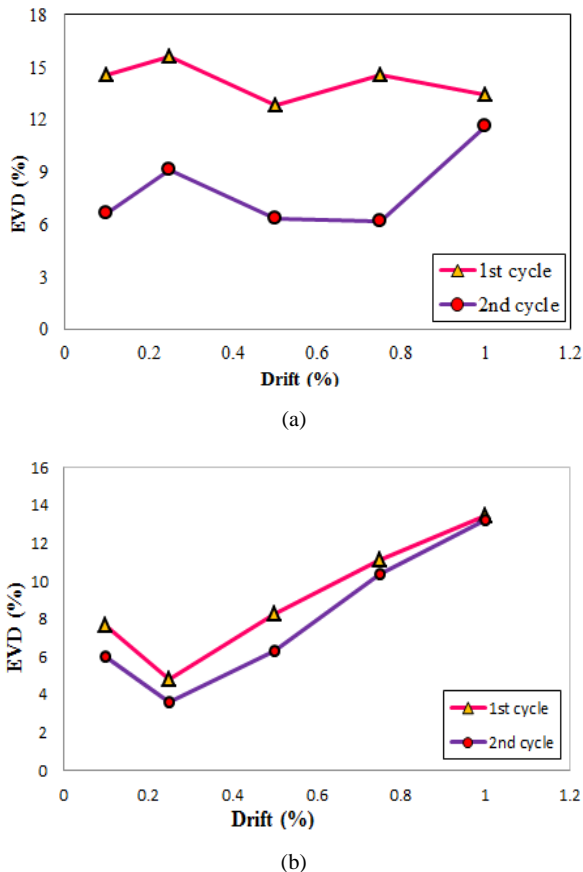
Fig. 3 shows the comparison of equivalent viscous damping (EVD) before and after retrofitting for both cycles. The EVD for the first cycle before retrofitting seems to be decreased as the drift increase. EVD first cycle after retrofitting seems to be increased as the drift increased. The percentage increment between before and after repair for the first cycle is not much differing. However, the EVD for the second cycle, before and after repair seems to have similar pattern. It is increased as the drift increase, but EVD after repair increased 12.34% from before repair. In fact, even though EVD after repair started at lower value as compared with before repair, but it manages to increase much more higher than before repair.

Fig. 3 Equivalent viscous damping (a) before retrofitting and (b) after retrofitting
