Failure Analysis of Pipe System at a Hydroelectric Power Plant

Ali Gökseml, Barlas Eryürek

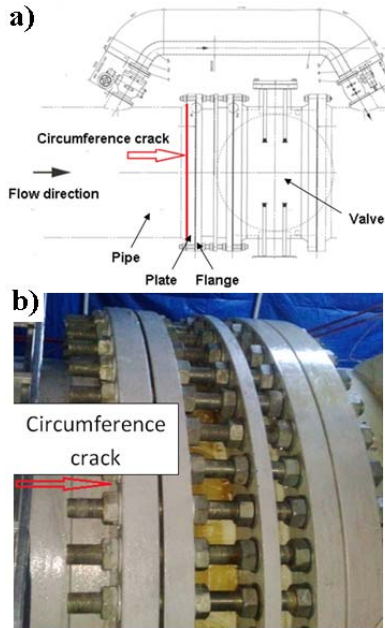
As can be seen in Fig. 2, circumference crack had been constituted at the flange-pipe welding zone.

Fig. 2 General view of the flange-plate-pipe system and circumference crack

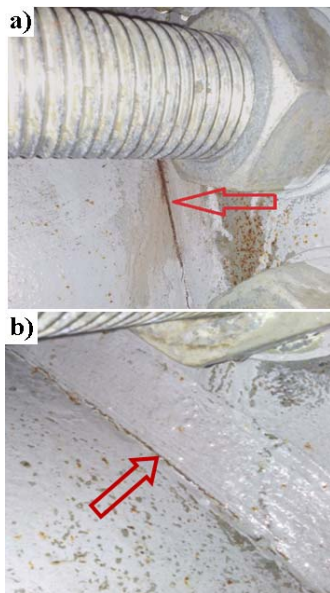
Fig. 3 Crack formation in pipe-plate welding zones

After detailed investigation it is concluded that crack had been propagated in pipe-plate welding zones (Fig. 3) and in pipe-flange plate welding zones (Fig. 4).

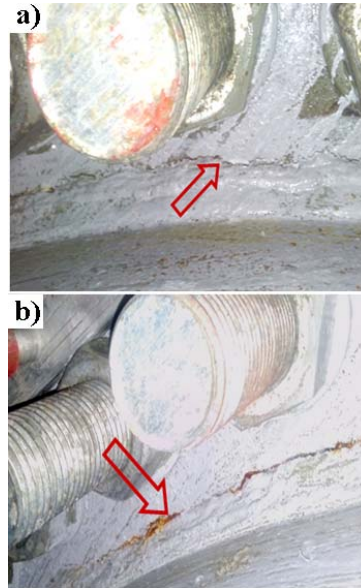
Fig. 4 Crack formation in pipe-flange welding zones

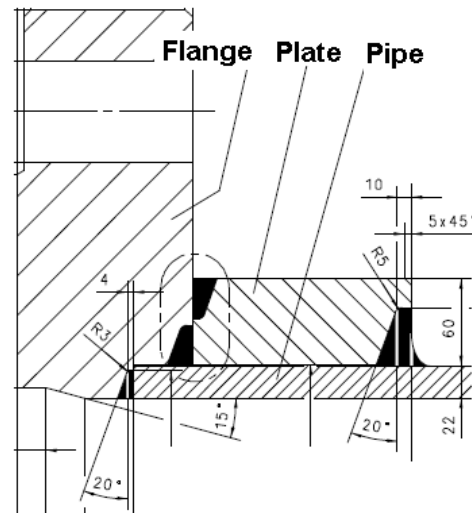
Fig. 5 Technical drawing of the pipe-plate-flange system

The design of the flange-pipe region can be seen in Fig. 5. To strengthen the pipe, a plate is welded at four regions to the pipe and flange. Flange material is steel St 52-3.

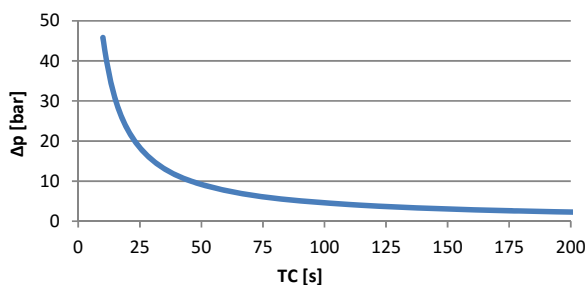
Fig. 6 Relation between pressure rise due to water hammer (Δp) and time to close the main valve (T_C)

As can be seen in Fig. 6, even a valve closing time of one minute will cause a pressure increase of 7.6 bar. The valve closing time at the accident day is not clear, but it is certain that the shut down time of the valve was not considered by the operator, which had resulted in a water-hammer effect.

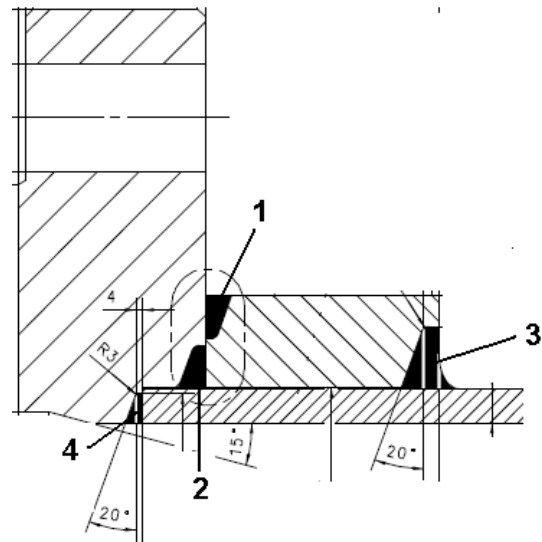
Fig. 7 Assembly drawing of the plate-flange-pipe system

Weld seams 1 and 2 are applied between plate and flange, weld 3 between plate and pipe and weld 4 between pipe and flange as can be seen in Fig. 7. For further detailed weld analysis it is investigated if these mentioned four weld seams are applied correct as can be seen in Fig. 7. During observation an additional weld seam, which was not mentioned in assembly drawing in Fig. 7 was detected, as can be seen in Fig. 8.

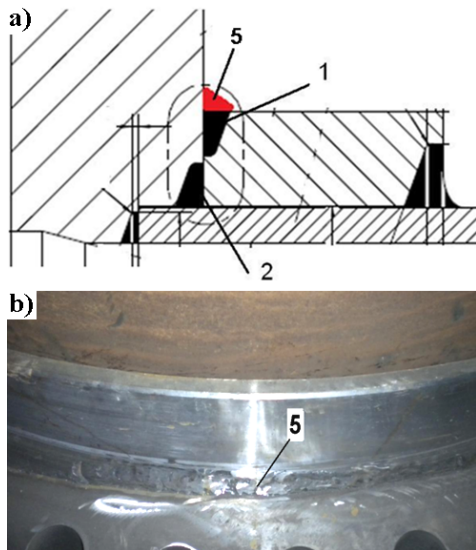
Fig. 8 Weld seam no.5 (b), which was not mentioned in assembly drawing as can be seen in Fig. 7

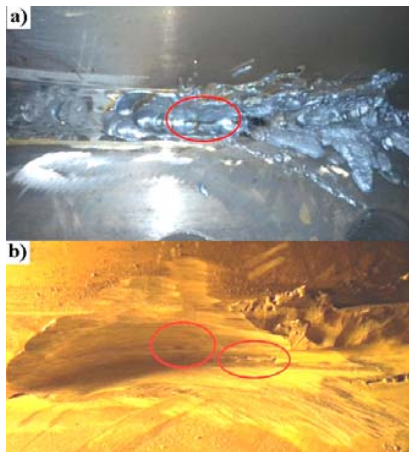
To analyze weld seam 1 and 2, weld seam 5 was grinded. After grinding it is detected that weld groove for weld 1 and 2 was constituted, but no welding process for weld 1 and 2 was applied, as can be seen Fig. 9. Therefore, a gap under weld 5 existed.

After weld seam analysis it is concluded that assembly of the plate-flange-pipe system was not applied correctly. Weld seams 1 and 2 were not applied; only weld grooves of weld 1 and 2 were constituted. The unfilled grooves 1 and 2 acted as inside cracks resulting in a strong notch effect. Stresses raised at this region caused crack propagation to the weld seam 5. By further investigation it is detected that weld groove for weld 3 was prepared incorrect. Groove angle was 70° instead of 20°. This had resulted in an increase of weld thickness from 25 mm to 110 mm, as can be seen in Fig. 10. This has resulted in a decrease of safety of the pipe-plate system, due to the low strength and high brittleness of weld seam according to base material.

Fig. 9 Weld groove of weld seam 1 and no welding process

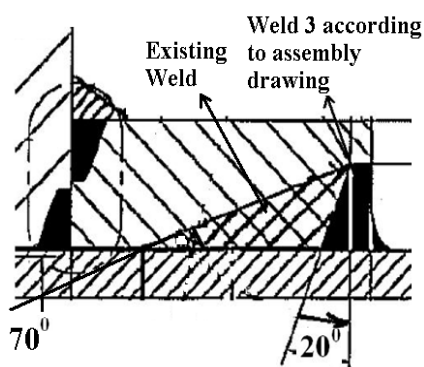
Fig. 10 Incorrect weld groove of weld seam 3
