Failure Analysis of Pipe System at a Hydroelectric Power Plant

Ali Göksenli, Barlas Eryürek

Keywords— Failure analysis, hydroelectric plant, water-hammer, crack, welding seam.

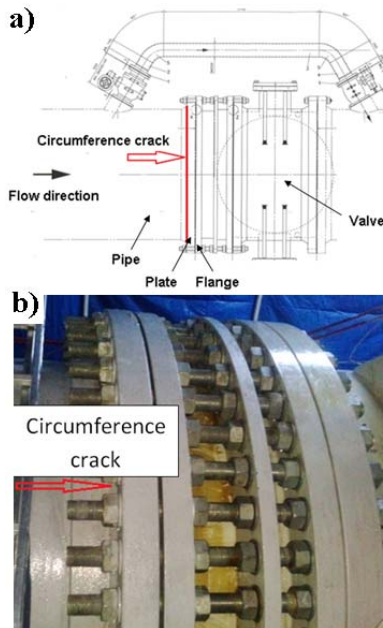
damaging forces [11]. In our case, for maintenance the butterfly valve was shut down resulting in a hammer like noise increase which had lasted for 10 minutes. After the waterfall incident, a circumference crack was detected at the flange-pipe welding zone. Investigations were carried out to determine the procedure after the crack formation.

As can be seen in Fig. 2, circumference crack had been constituted at the flange-pipe welding zone.

Fig. 2 General view of the flange-plate-pipe system and circumference crack

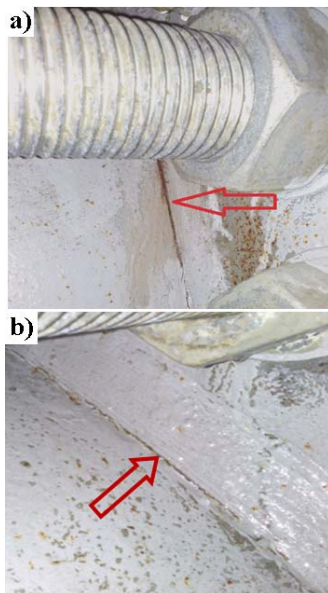
Fig. 3 Crack formation in pipe-plate welding zones

After detailed investigation it is concluded that crack had been propagated in pipe-plate welding zones (Fig. 3) and in pipe- flange plate welding zones (Fig. 4).

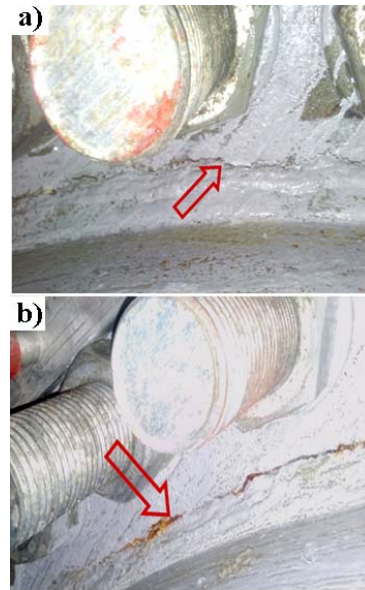
Fig. 4 Crack formation in pipe-flange welding zones

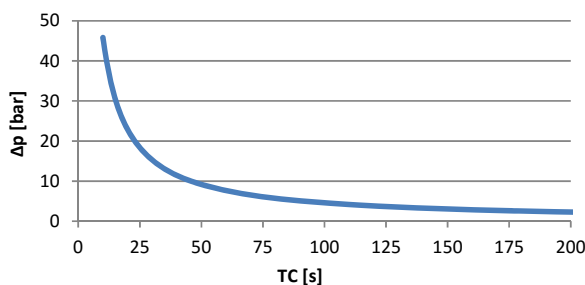
As can be seen in Fig. 6, even a valve closing time of one minute will cause a pressure increase of 7.6 bar. The valve closing time at the accident day is not clear, but it is certain that the shut down time of the valve was not considered by the operator, which had resulted in a water-hammer effect.

Fig. 6 Relation between pressure rise due to water hammer (Δp) and time to close the main valve (T_C)

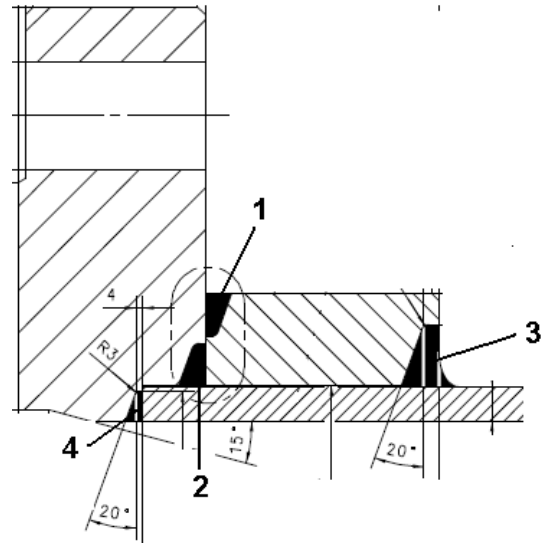
Fig. 7 Assembly drawing of the plate-pipe system

Weld seams 1 and 2 are applied between plate and flange, weld 3 between plate and pipe and weld 4 between pipe and flange as can be seen in Fig. 7. For further detailed weld analysis it is investigated if these mentioned four weld seams are applied correct as can be seen in Fig. 7. During observation an additional weld seam, which was not mentioned in assembly drawing in Fig. 7 was detected, as can be seen in Fig. 8.

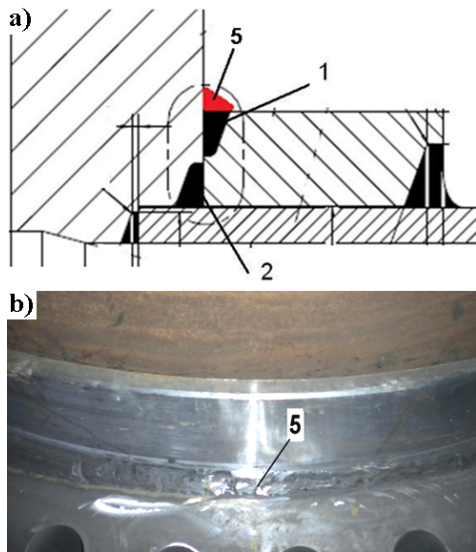
Fig. 8 Weld seam no.5 (b), which was not mentioned in assembly drawing as can be seen in Fig. 7
