Condition Monitoring for Controlling the Stability of the Rotating Machinery

A. Chellil, I. Gahlouz, S. Lecheb, A. Nour, S. Chellil, H. Mechakra, H. Kebir

A. Measuring Points «Separator Z2-S01»

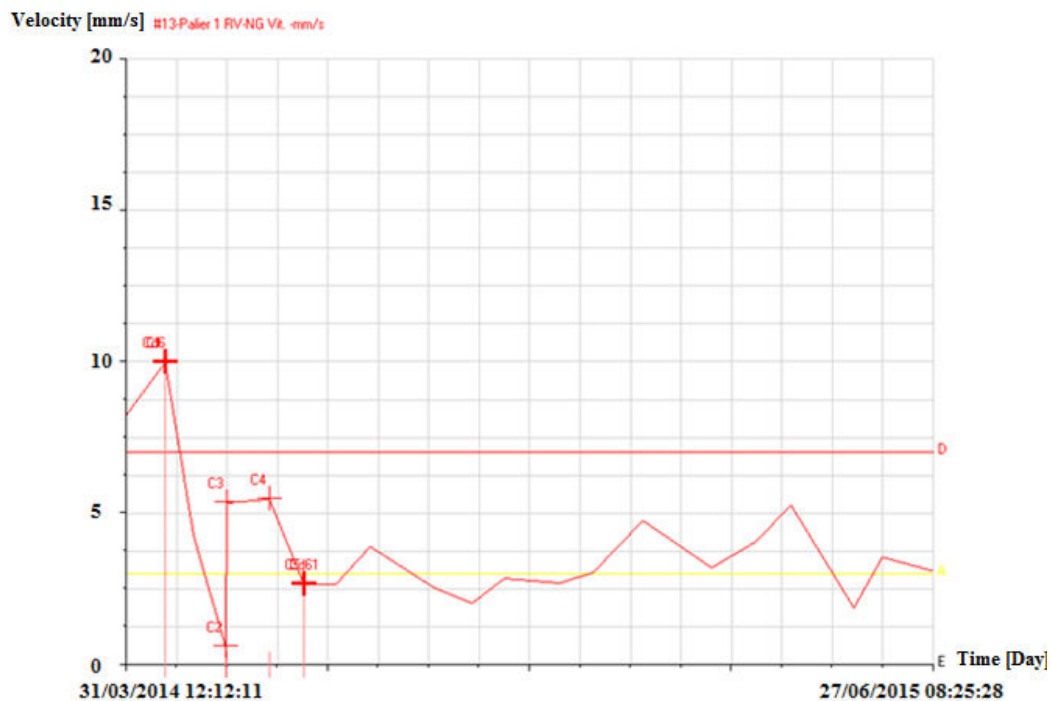
Fig. 4 Trend curve of bearing (01) RV-NG

The trend curve for the bearing N°01 (mm / s) is presented. There was an increase vibratory velocity level which exceeds the alarm threshold in point C4 (5.49 mm / s) which shows the presence of an anomaly, but we do not know their origin, after repair a speed decrease is observed with a reduction in (2.84 mm / s), for diagnosing the origin of the excess passes to spectral analysis.

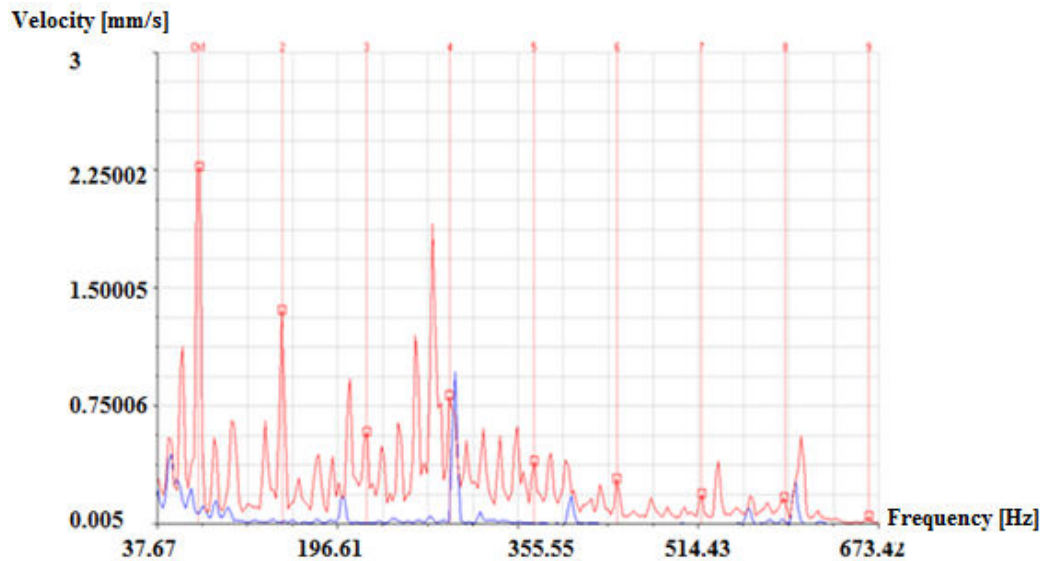
Fig. 5 Linear spectral image superimposed on bearing N°01 RV

■ : spectrum before repair → net level rise in speed
■ : spectrum after repair → net improvement in speed level

The spectral signature represents a net increase of vibrational amplitude level of speed (red spectrum) in the medium frequency domain, corresponds to the frequency value equal to 73.05 Hz, this value corresponds at the same time to the frequency internal bearing ring, which shows a fault bearing inner ring. The recommendation is to change the bearing N°01.

After the repair performed (change bearing) we notice (blue spectrum) a net decrease in the speed level (the fault disappears), which confirms the accuracy of diagnosis.

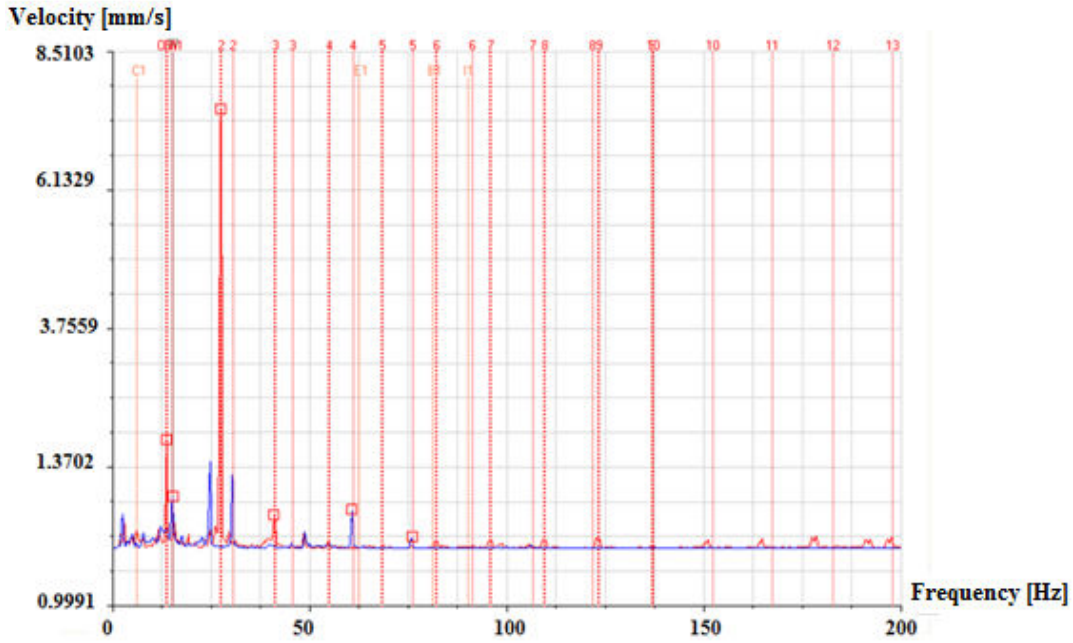
Fig. 6 Spectral Image superimposed on bearing N°02 RH

Concerning the Bearing N°02, through the Trend curve we noticed a speed level of increase that exceeds the danger threshold Cd1 points (9.25 mm / s), indicating the presence of an anomaly but does not know their origin, this anomaly is more danger. According repair a speed decrease is observed with a reduction in (6.27 mm / s), for diagnosing the cause of the excess passes to spectral analysis. The spectrum N°02 (mm/s) is given in Fig. 6.

The spectral signature (red spectrum) represents a net increase in amplitude equal (7.51mm / s) in the low frequency

range corresponding to a frequency value equal to 27.41 Hz, this value corresponds to the 2nd harmonic of the rotation frequency of the motor shaft, which is a misalignment between the motor and reducer. The recommendation is the lineage of the line engine transmission – gearbox and the coupling change.

After the repair carried out (the coupling change) we notice (blue spectrum) a net decrease in the speed level (the fault disappears), which confirms the accuracy of diagnosis. The spectrum N°03 (mm/s) is given in Fig. 7.

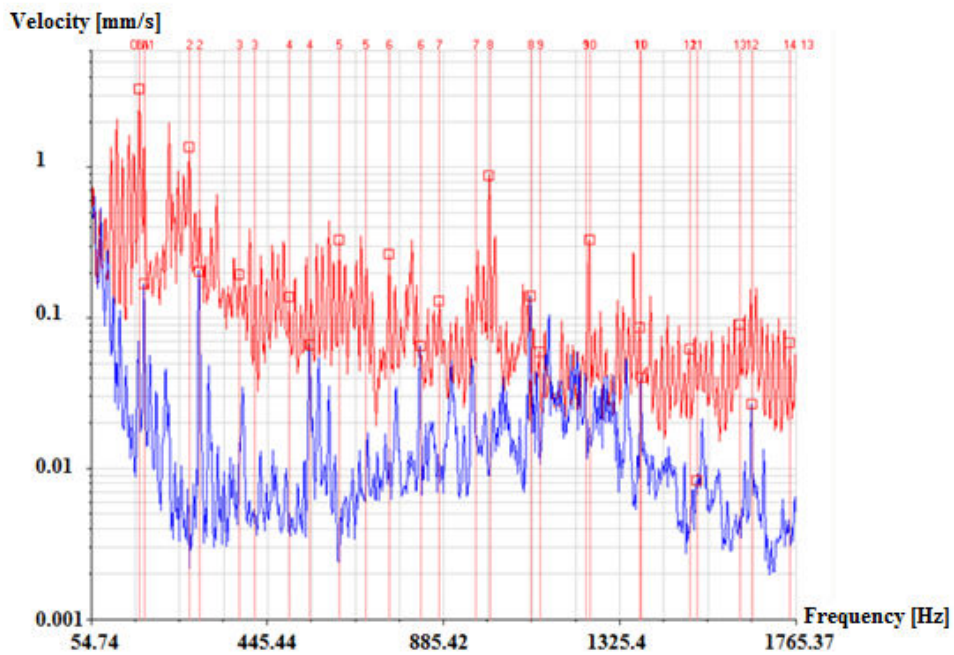
Fig. 7 Spectral Image superimposed on the logarithmic scale on bearing N°03 RO

The spectral signature (red spectrum) represents a net increase of amplitude in the medium frequency domain corresponds to a second frequency value that equals 250 Hz, this value corresponds to one of the first train of the gear meshing defect (pinion). The recommendation is changing the gearbox.

After the repair carried out (the gear change) we notice (blue spectrum) a net decrease in the speed level (the fault disappears), which confirms the accuracy of diagnosis.

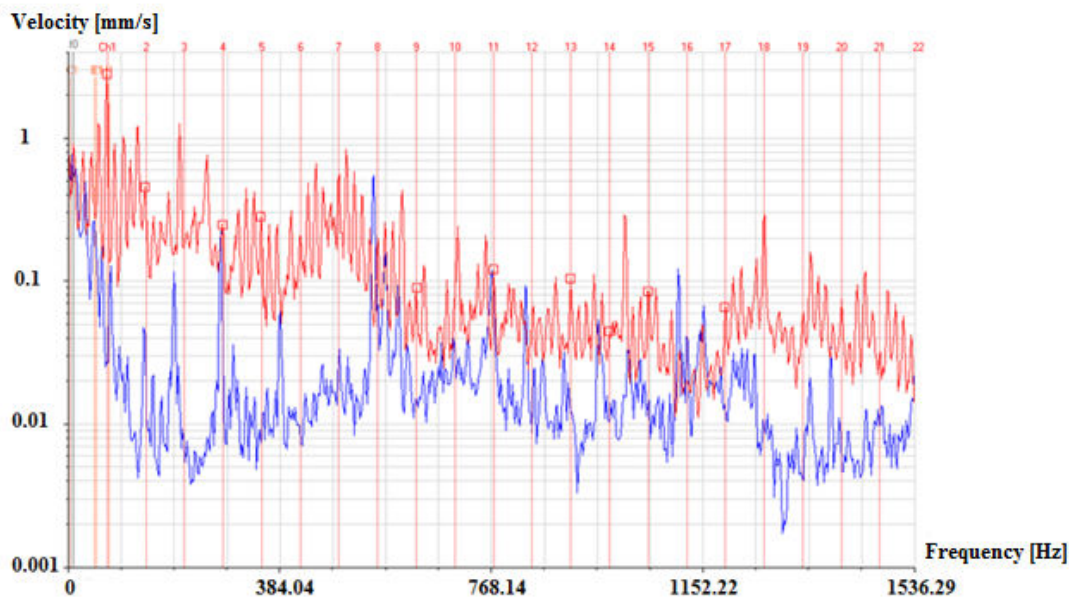
Fig. 8 Spectral Image logarithmic scale superimposed on bearing N°04 RO.

For the bearing N°04, According to the trend line oblique radial extent in remarks at point C2 (4.80 mm / s) an alarm threshold is exceeded, after repairing a decrease until Cd11 (1.86 mm/s), to diagnose original passes to frequency analysis.

The spectrum N°04 (mm/s) is given in Fig. 8. The spectral signature (red spectrum) represents a net increase of amplitude in the medium frequency domain corresponds to a frequency value equal to Ch1 = 70.15 Hz, this value corresponds to a discharge failure of the internal bearing ring.

The recommendations are changing the rolling bearing No 04. After the repair carried out (the gear change) we notice (blue spectrum) a net decrease in the speed level (the fault disappears), which confirms the accuracy of diagnosis.

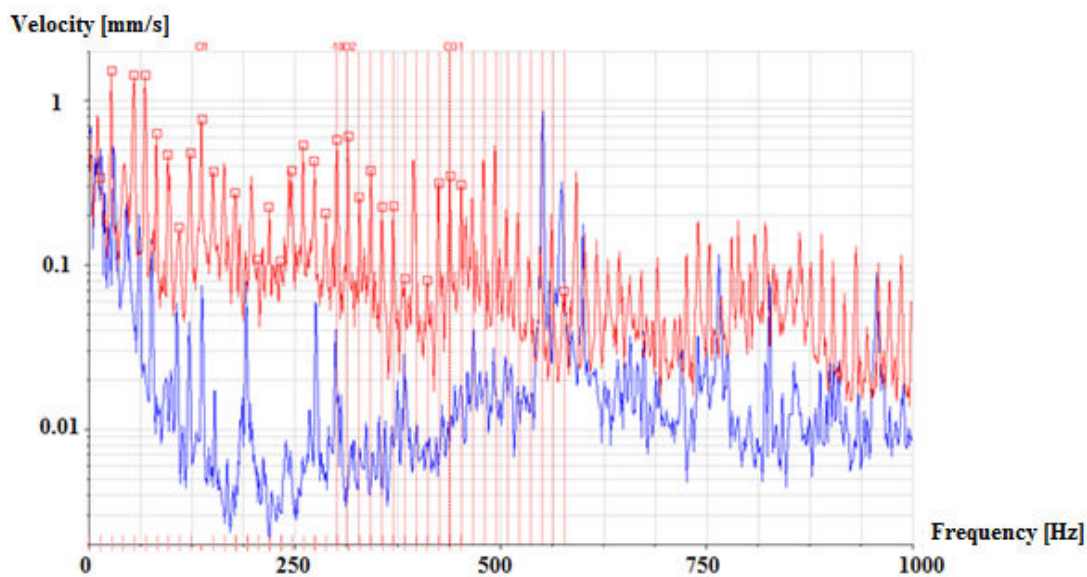
Fig. 9 Spectral Image superimposed on a logarithmic scale on bearing N°05 RO.

For the bearing N°05, According to the oblique radial extent of the bearing 05, we note that the point C2 (4.08 mm / s) an alarm threshold is exceeded, after repair decreased to C3 (1.86 mm / s) is observed. The spectrum of bearing N°05 (mm/s) is given in Fig. 9.

The spectral signature (red spectrum) represents a net increase of the average amplitude in frequency domain corresponding to a shock to the frequency of rotation of the motor on the bearing supporting the shaft of the separator.

The recommendation is changing the rolling bearing No 05. After the repair performed (the change bearing and gearbox) we notice (blue spectrum) a net decrease in the speed level (the fault disappears), which confirms the accuracy of diagnosis.
