Restoring Trees Damaged by Cyclone Hudhud at Visakhapatnam, India

Mohan Kotamrazu

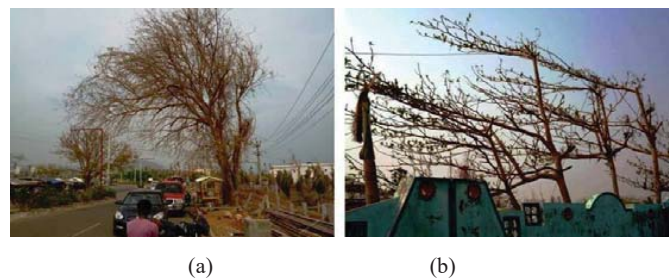
recover fast from damage due to defoliation. Defoliated *Ficus religiosa* trees at Rushikonda and defoliated *Terminalia catappa* trees at a park in Bheemli are shown in Figs. 1 (a) and (b) respectively. Fresh sprouts on a *Terminalia catappa* tree at Tenneti Park soon after the storm are shown in Fig. 2 (a) and the same tree regained most of its foliage two months after the storm as shown in Fig. 2 (b).

Fig. 1 (a) Defoliated *Ficus religiosa* tree at Rushikonda, Visakhapatnam (b) Defoliated *Terminalia catappa* tree in a park at Bheemunipatnam

Defoliated trees should be saved as usually they will re-foliate. If the tap root of a fallen tree is intact, then the chances of its survival are good. Leaning trees and trees with roots severed roots which are a source of hazard for buildings or for the movement of pedestrians should be removed.

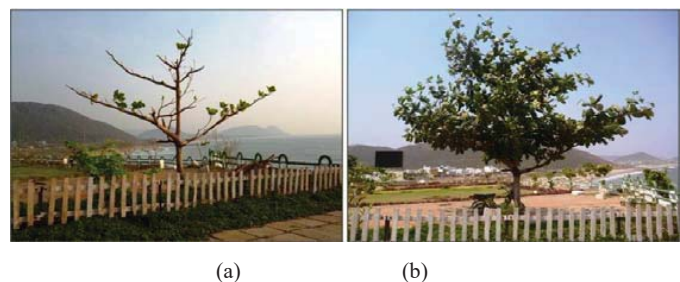
Fig. 2 (a) Fresh sprouts on a *Terminalia catappa* tree at Tenneti park (b) Defoliated *Terminalia* tree with foliage regained two months later

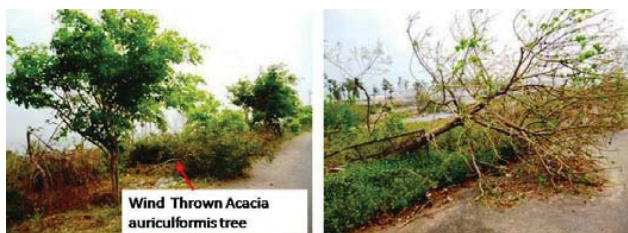
Tall trees that are top heavy and possess shallow roots such as *Sweitenia mahagoni*, *Spathodea campanulata*, *Greviella robusta* are more prone to wind throw and uprooting than smaller trees with deep roots [4]. Tall trees with deep roots, widely spaced branches and a symmetrical, tapering crown such as *Araucaria heterophylla* are less vulnerable to damage from wind throw [5]. Trees whose roots get cut during the laying of roads or pavements are also susceptible to damage from wind throw. Wind thrown *Acacia auriculiformis* and *Thespesia populnea* trees along the Visakha-Bheemli Beach Road are shown in Fig. 9. An uprooted *Ficus religiosa* tree along a road at Andhra University Campus in Visakhapatnam is shown in Fig. 10 (a). Wind thrown *Sweitenia mahagoni*

Fig. 9 (a) Wind thrown *Acacia auriculiformis* tree along the Beach Road at Visakhapatnam (b) Wind thrown *Thespesia populnea* tree along the Beach Road at Visakhapatnam.

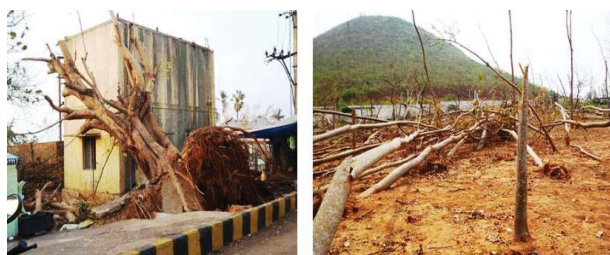
trees in the Gitam University Campus at Visakhapatnam are shown in Fig. 10 (b).

Fig. 10 (a) Uprooted *Ficus religiosa* tree at Andhra University Campus (b) Wind thrown *Sweitenia mahagoni* trees at Gitam University Campus

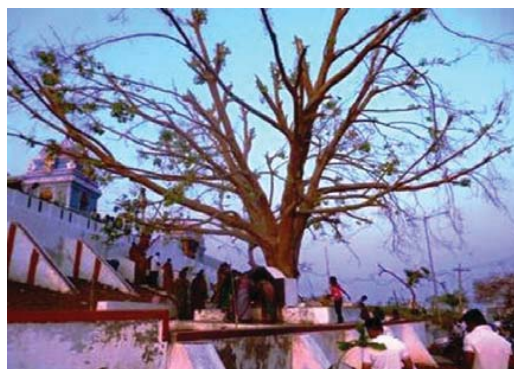
Soon after a cyclonic storm an assessment of the damage to trees, shrubs and landscape elements should be carried out and various actions have to be taken to rescue damaged trees. As pointed out by [1], at least four factors should be evaluated prior to making a decision to save a damaged tree: sentimental value, growth rate, condition of the tree and transplantability. Fig. 11 shows a partially damaged *Ficus religiosa* (Peepal) tree at Visalakshmi Nagar at Visakhapatnam. This tree, located at the entrance of a temple has sentimental value and is worshipped by people who visit the temple.

Fig. 11 A partially damaged *Ficus religiosa* (Peepal) at the entrance of a temple at Visalakshinagar

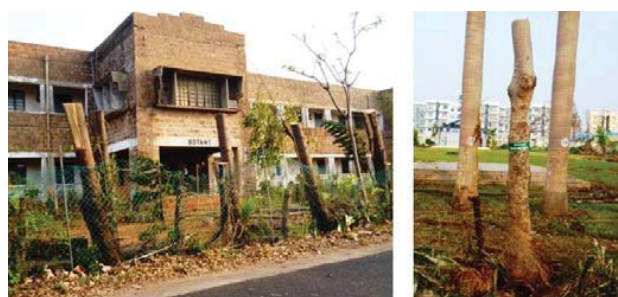
Pre-disaster pruning of the foliage can save trees, especially top-heavy trees, from blowing over and make them more wind resistant. Trees with damaged co-dominant stems should be pruned rather than topped. Topping (Fig. 12) is a harmful practice where the entire canopy of a tree is severely reduced with heading cuts and leads to tree decay [8].

Fig. 12 (a) Topped *Polyalthia longifolia* trees in the Botany department at the Andhra University campus (b) Topped *Delonix regia* tree in the Vuda Park at Visakhapatnam

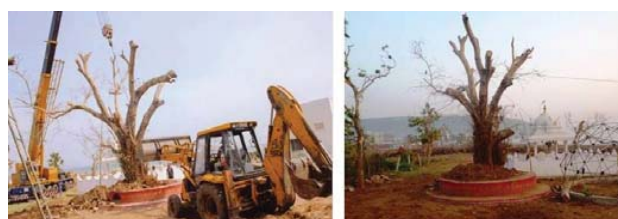
Fig. 13 A restored *Ficus religiosa* tree at Shanti Ashram at Visakhapatnam. Photo Credit: C. V. Subhramanyam

A fifty year old *Ficus religiosa* tree at the Shanti Ashram was completely uprooted and given up for dead has been

given a new life through careful restoration efforts. The tree had sentimental value for the inmates of the Ashram as it was planted by its founder Swami Omkar. Fig. 13. shows the restoration efforts for the *Ficus religiosa* tree. Earth was dug six feet deep with the help of an earthmover. By crane and some strong ropes were used to provide support and the huge trunk was covered with heaps of soil for replanting the fallen tree. Fig. 14 shows the restored tree with regained foliage one year after the cyclonic storm.

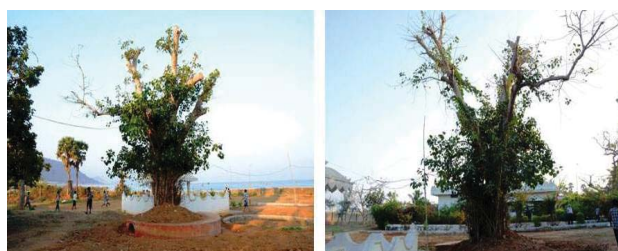
Fig. 14 Restored *Ficus religiosa* tree with regained foliage one year after the cyclone Hudhud

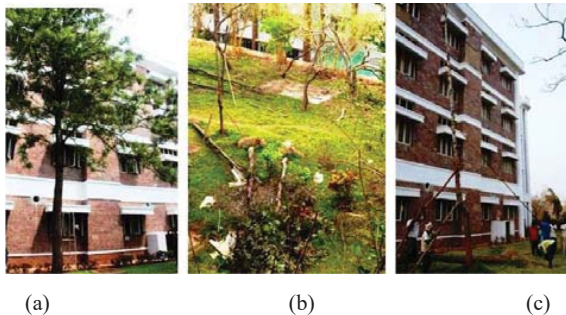
Fig. 16 (a) A *Greviella robusta* tree before the cyclone Hud-Hud (b) Uprooted *Greviella robusta* trees (c) A restored *Greviella robusta* tree

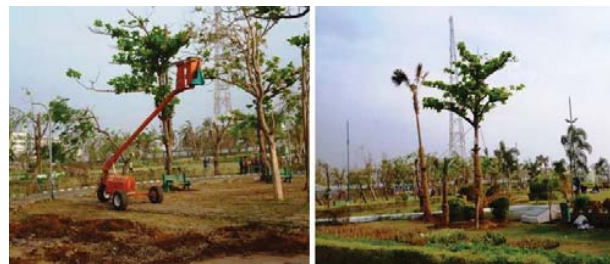
Fig. 20 Structural pruning and restoration of *Terminalia catappa* trees at Vuda Park
