Structural Analysis and Strengthening of the National Youth Foundation Building in Igoumenitsa, Greece

Chrysanthos Maraveas, Argiris Plesias, Garyfalia G. Triantafyllou, Konstantinos Petronikolos

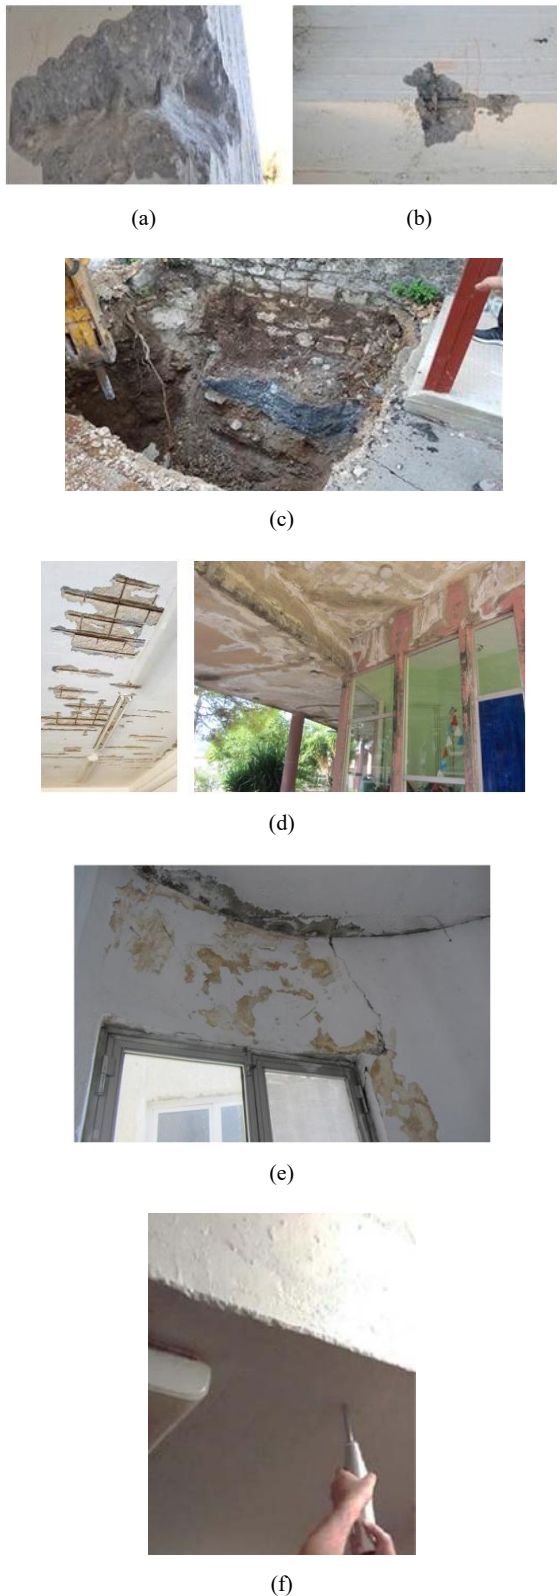
The main objectives of this study were to evaluate the structural adequacy and plan a retrofit of Buildings II and IV, as well as to perform a seismic assessment according to KAN.EPE [1]. In-situ, non-destructive and destructive tests were conducted to further assess the structural condition and details. The cover was removed in order to assess the reinforcement at selected column and beam locations. Locations from the initial construction phase and from the concrete jacketing intervention were accessed in order to verify reinforcement details, as shown in Figs. 3 (a) and (b). A sample excavation was performed to reveal the foundations in a column of Building IV, as presented in Fig. 3 (c). Areas with localized damage were also inspected, as shown in Figs. 3 (d) and (e).

Fig. 3 Disclosure of steel reinforcement materials (a,b), disclosure of the foundation in a column (c), localized damage (d,e), and a non-destructive test (f)

The configuration of the reinforcement materials was captured via local disclosure of steel rebar. Ribbed steel rebar of quality StIII with an average tensile strength $f_{ym} = 460$ MPa was identified in the main steel reinforcement. Smooth steel rebar of quality St I with an average tensile strength $f_{ym} = 260$ MPa was identified for the stirrups. Typically, the steel rebar in the supports for the Building IV slab (edge of beam) presented surface corrosion. In addition, significant moisture was noted on the surface of the concrete in the same positions. Corrosion activity was tested by measuring the half-cell potential of the steel reinforcement. The experimental results indicated that the probability of corrosion was over 90% for 54% of the surface of the soffit floor of Building I. The probabilities of corrosion were lower in the soffit slabs of Buildings II and III. Higher concrete carbonation depths were observed in the unprotected parts of the slab near the supports. The long period of abandonment and low-intensity use of the building complex had significant effects on its durability in the face of environmental factors. Despite the successful crack repairs, the ensuing lack of maintenance led to development of moisture, gradual corrosion of some elements, and detachment of the concrete cover. The corrosion half-cell potential measurements indicated further evolution of corrosion, leading to progressive degradation of the load-bearing capacity of the structure.

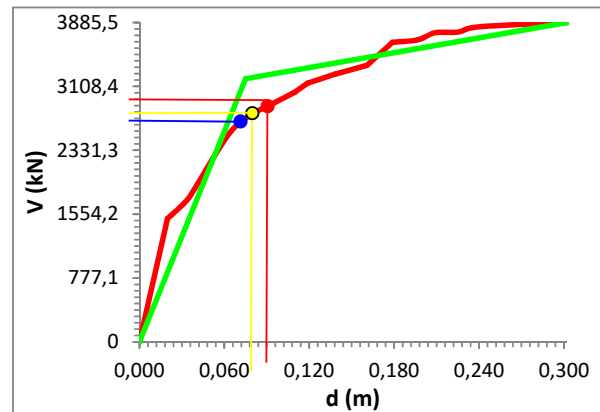
confirmed the significant number of plastic hinge positions and hence the retrofit requirement identified by the preliminary analysis. The results indicate that the direction of the earthquake does not affect the retrofits that are required. In conclusion, Building IV exhibited damage to several structural elements. Retrofitting and strengthening are thus required. The locations where strengthening is required include existing strengthened elements, including beams. This introduces additional difficulties. The force-displacement curve of Building IV for a triangular load distribution of the seismic combination $F_x+0.3F_z$ is illustrated in Fig. 7.

Fig. 7 Force-displacement curve of Building IV for a triangular load distribution of the seismic combination $F_x+0.3F_z$

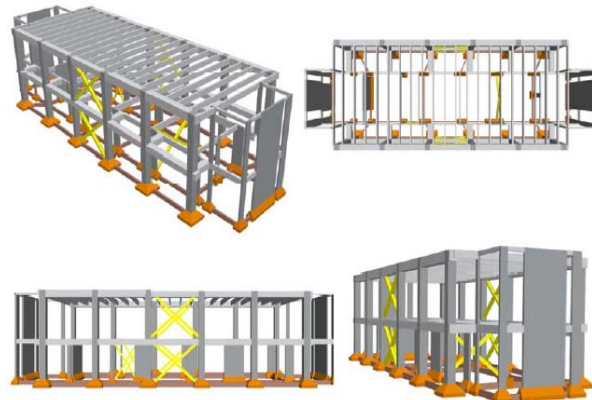
Fig. 9 Building IV strengthening proposal with type X steel braces for modeling purposes

The analytical results indicate that solution c) is the most efficient, as it provides better building performance. The number of point interventions is reduced and most importantly, retrofitting of members that were previously strengthened via concrete jacketing is avoided. A presentation

The retrofit plan for Building IV includes strengthening the slabs with shotcrete concrete, demolishing concrete surfaces, and repairing corroded concrete surfaces by applying anti-corrosion measures. Two scenarios are proposed for strengthening of the beams and concrete walls. The first includes construction of concrete jacketing for both beams and concrete walls, while the second includes concrete jacketing for beams and construction of new metal frames and concrete elements. The total cost of restoring and strengthening Building IV following the first scenario is estimated to be approximately 200.000€, whereas the cost of the second scenario is estimated to be approximately 210.000€.
