# Metallurgical Analysis of Surface Defect in Telescopic Front Fork

Souvik Das, Janak Lal, Arthita Dey, Goutam Mukhopadhyay, Sandip Bhattacharya

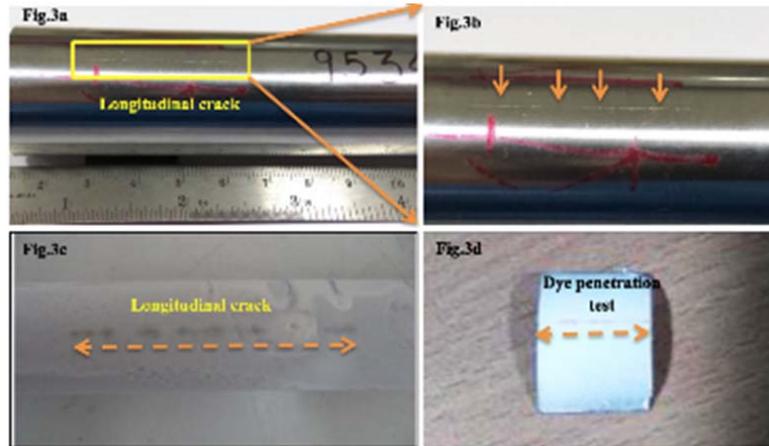
**Sample #1:** Visual observation of the failed fork showed small longitudinal crack along the length of the tube at the circumference close to the weld (Figs. 3 (a) and (b)). The crack was about 4 cm in length and very thin and difficult to detect easily. Crack was very shallow in depth and difficult to detect, so it was detected by dye penetration test (Figs. 3 (c) and (d)).

Fig. 3 (a) and (b) Longitudinal crack along the length of the tube, longitudinal crack was detected through dye penetration test

**Sample #1:** Visual observation of the failed fork tube showed presence of small cracks along the length of the tube at the circumference adjacent the weld flow lines. The crack was about 5 cm in length. The unetched microstructure of crack showed 'J' type hook crack [1], [2]. MnS inclusions were observed in the vicinity of the crack. The overall MnS inclusion was high as shown in Table III. Microstructural analysis further revealed that the hook of the crack was turning toward upward surface. The originator of hook crack is non-metallic inclusion primarily MnS stringers. These flattened non-metallic inclusions are formed during hot rolling of plate. They reduce the ductile toughness of the steel even in their normal position but do not affect the yield or tensile strength of the steel [3]. So, the mechanical properties of the tube under investigation were also satisfactory. Near bondline, these weak layers reorient themselves in such a way that they become subjected to tensile hoop stress when the pipe is pressurized [4] and a small crack originates. The slight upset of the metal at the weld acted to turn the ends of this usually very small subsurface crack in the direction of the upset. Because the metal flow during the upset is toward the both surfaces. The hook of the hook crack may turn toward either the outside or inside surface, depending on which the

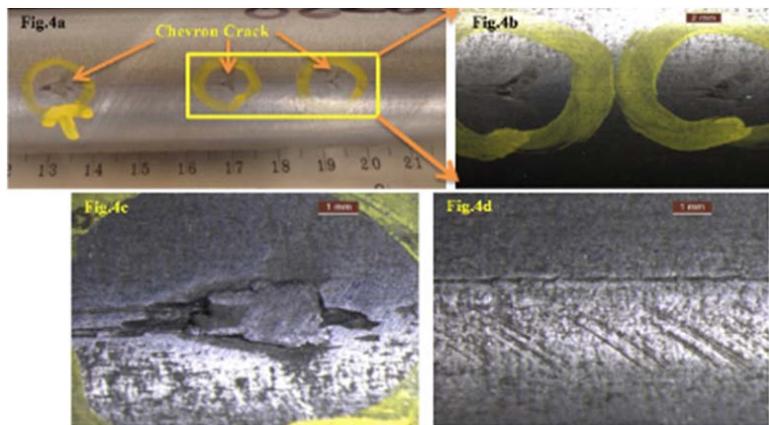
**Sample #2:** General view of the tube sample with defect is shown in Fig. 4 (a). Multiple chevron marks were observed on the surface of the tube. These chevron marks were found to form a single line (Figs. 4 (a) and (b)). Similar marks with less severity and a line mark running through centre of these defects were observed at 180-degree location (Fig. 4 (a)).

Fig. 4 (a)-(c) Chevron cracks on the surface of the tube, (d) Less severity defects were observed at 180-degree location of the chevron crack

**Sample #2:** Repeating chevron marks were observed to form a single line at certain interval on the tube surface. Similar marks with less severity and a line mark running through centre of these defects were observed at 180-degree location. Closer observation of the chevron marks in stereo microscope shows accumulation of material at centre of the chevron. Optical microscopy shows grain deformation at the defect contour indicating cold stage deformation. Based on the repetitive nature of the defect, it appears to be originating from the drawing stage itself and that too at exactly diametrically opposite locations of the tube. Decarburised grains along with internal oxidation associated with dark brown entrapment were observed along the cracks. Presence of mould powder entrapment inside the material indicates origin of the defect from slab stage. The morphology and location on the tube suggests that the steel defect got aggravated during drawing forming the chevron mark. Mold powder entrapment mainly occurs in the so-called “transient casting” periods, e.g. the time of casting start, casting end, ladle exchange, mold width change, SEN change, etc. During the unsteady casting periods, usually, the casting speed is largely varied, which disturbs the flow of the liquid steel in the mold and results in severe level fluctuation. Hence, mold powders are easy to be carried into the liquid steel, and some are entrapped by the solidified shell

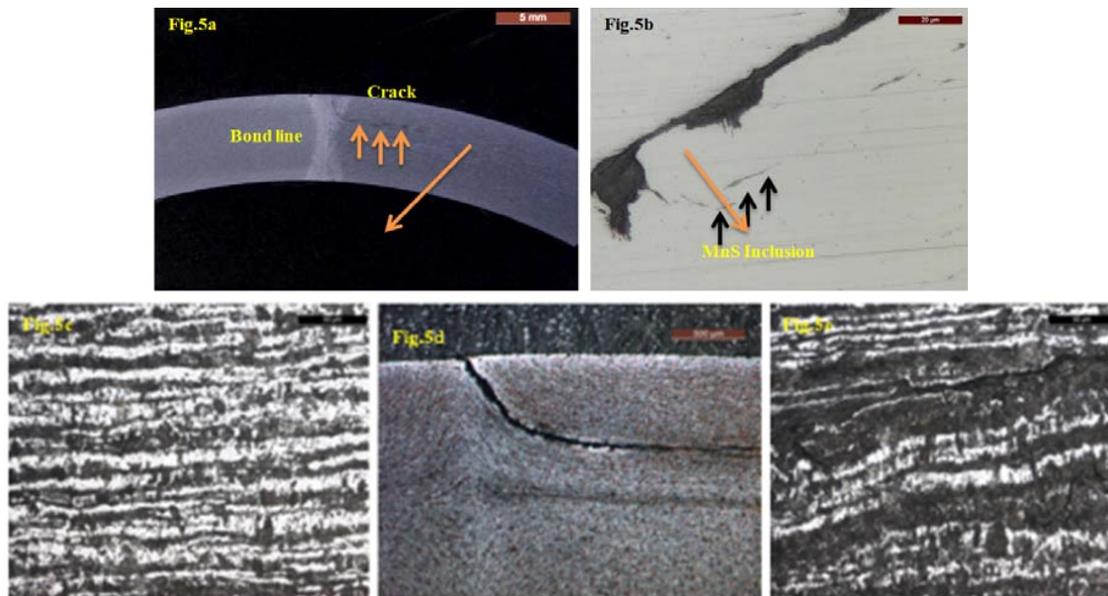
Fig. 5 (a) Chevron cracks on the surface of the tube, (b) Un-etched micro image of the defect location, (c)-(e): Etched micro image of the defect location at different magnifications

**Sample #1:** The un-etched microstructure showed a crack, 'J' type in shape and of 0.5 mm in depth (Fig. 5 (a)), typical to hook cracking [1]. Further the crack was found to be associated with some non-metallic manganese sulfide (MnS) inclusions (Fig. 5 (b)) which were further confirmed through EDS analysis. The macro dual zoom photograph of the micro sample revealed white bond line associated with the crack (Fig. 5 (c)). The 3% nital etched microstructure showed that the crack was slightly offset from the bond line of the Cold drawn Electric resistance Welding (CEW) seam (Fig. 5 (a)), but following the weld flow lines and opened up at the circumference. The hook of the crack turned toward upward, as shown in Fig. 5 (d). The weld flowline of the tubes was compatible to the cold drawn structure (Fig. 5 (d)), and the matrix revealed banded ferrite pearlite structure (Figs. 5 (c) and (e)) common to such high manganese structural steel

manganese and sulfur ratio and in this case favored the formation of MnS inclusion resulted in higher inclusion rating. These MnS inclusions caused imperfection at the edge of the strip which turned toward the outside diameter pipe surface resulting in hook crack formation during upsetting at the time of welding. Thus, the hook crack was originated during tube manufacturing which surfaced out when the tube was put in field service.

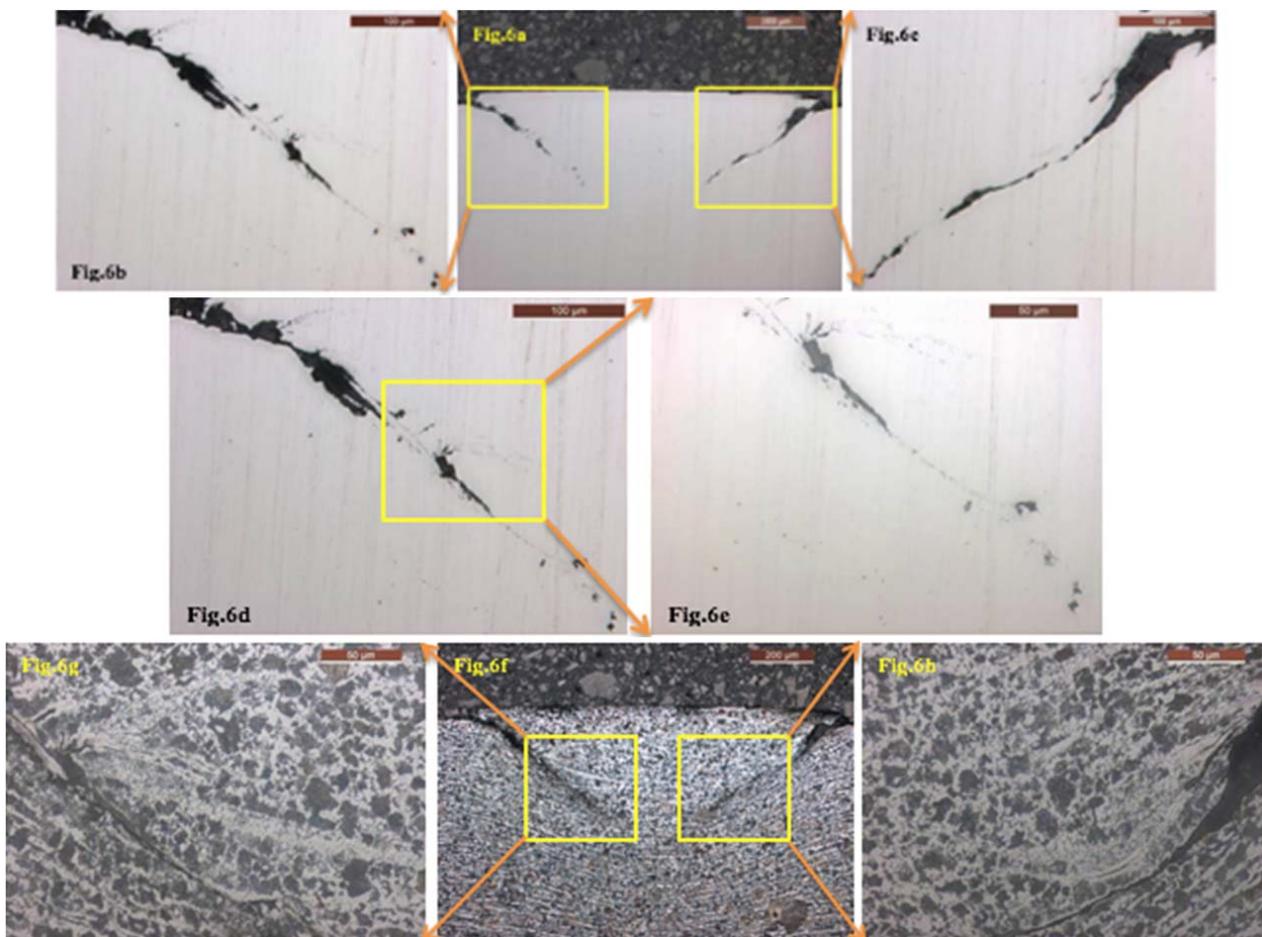
**Sample #2:** Un-etched micro image of the samples from defect area revealed bowl shaped defect. This was formed by chipped-off material as shown in Fig. 6 (a). Figs. 6 (b) and (c) show closer view of the cracks on both edges of the defect. It can be observed that the cracks contain some non-metallic entrappings in it. At higher magnification, as shown in Fig. 6 (e), suspected internal oxidation can be observed in chipped-off material.

The etched microstructure at the defect location is shown in Fig. 7 (a). Banded ferrite - pearlite structure was observed which followed the contours of the defect/chipped-off material. At higher magnification, decarburised grains were observed along the suspected internal oxidation. The chipped-off material does not show any banding or deformation. However, due to accumulation of this material, grains in the matrix below, it got deformed which is cold condition effect.

Fig. 6 (a)-(d) Un-etched micro image of the defect location at different magnifications, (e) Presence of dark brown entrainment along with internal oxidation (f)-(h) Etched micro image of the defect location at different magnifications

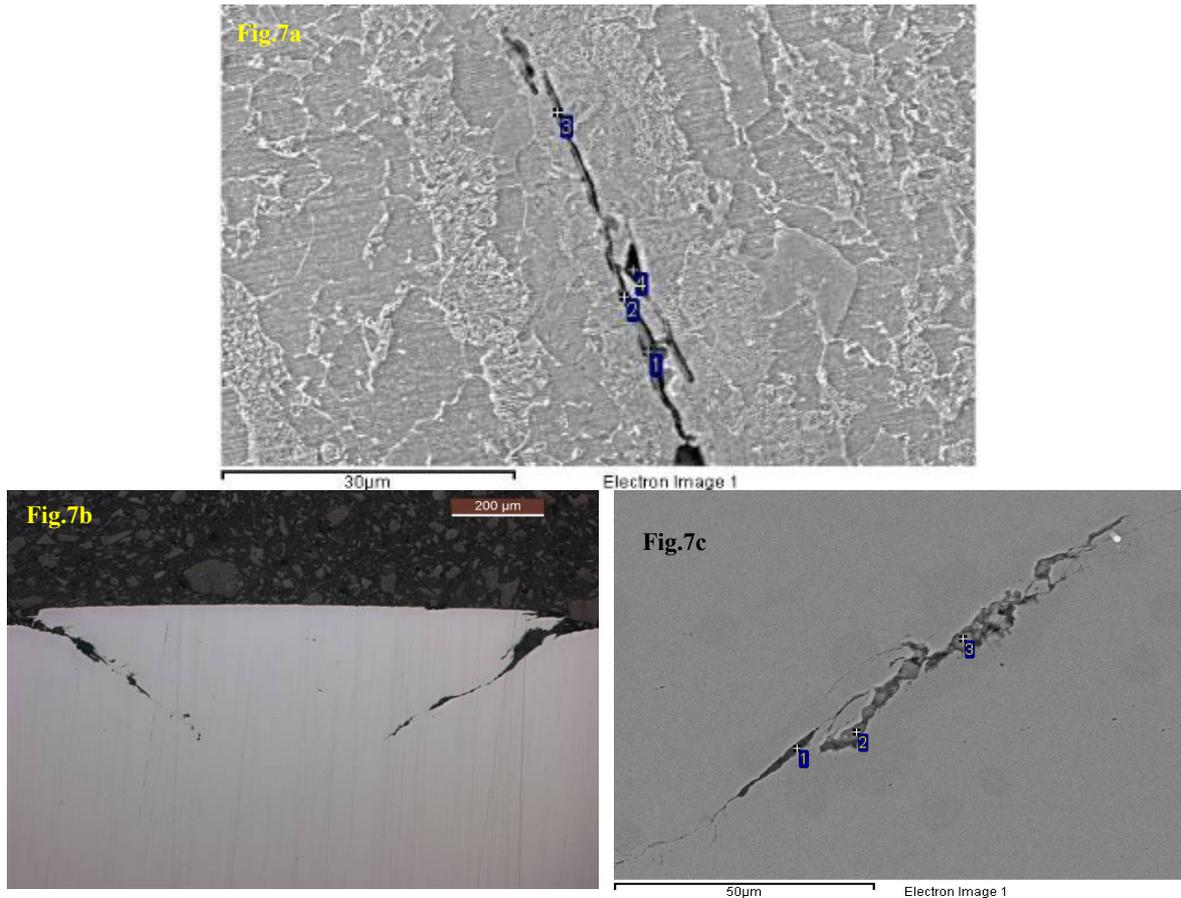
**Sample #1:** EDS analysis was carried out on non-metallic inclusion by Scanning Electron Microscope at an accelerating voltage of 15 kV. EDS analysis confirmed the inclusions as

MnS (Fig. 7 (a), Table II). Then, inclusion rating was also carried out by ASTM E 45 method to check overall cleanliness of the steel. The inclusion rating, shown in Table III, revealed higher MnS inclusions in steel.

Fig. 7 (a) EDS analysis of sample#1 at cracked location, (b) and (c) EDS analysis of sample#2 at defect location

**Sample #2:** EDS analysis of the dark brown entrapment revealed prominent peaks of Ca, Si, Al, Na, F and O which proves that crack has generated due to mould powder entrapment.

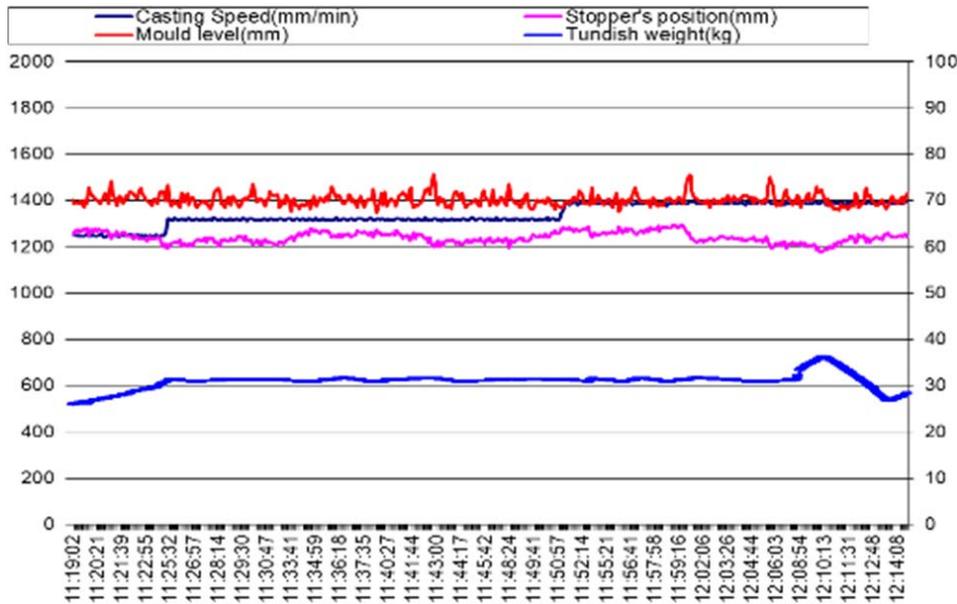
Fig. 8 Casting parameters for sample #2

and exist as non-metallic inclusions in slabs. If the interfacial velocity of steel melt which exceeds tear off velocity results in associated shear stress to become greater than the cohesion forces of the slag. Slag gets torn off and carried over in the form of droplets in the liquid metal. While a part of these droplets immediately floats back towards the meniscus, another part is transported by the metal flow and scattered in the liquid pool [7]. In case of sample #2, it has been observed that higher severity index in this coil is explained due to unstable stopper position shown in the caster (Fig. 8). As seen from the chart given for this slab, there are large fluctuations in casting speed along with large mold level fluctuations. Hence, changing stopper position causes unstable molten steel flow and so entrapment of mold powder.

**In case of Sample #2:** The slag entrapments of the mold fluxes in sub-surface of the strands are the main origin of the surface defect in telescopic fork tube. The morphology and
