Diagnosis of Intermittent High Vibration Peaks in Industrial Gas Turbine Using Advanced Vibrations Analysis

Abubakar Rashid, Muhammad Saad, Faheem Ahmed

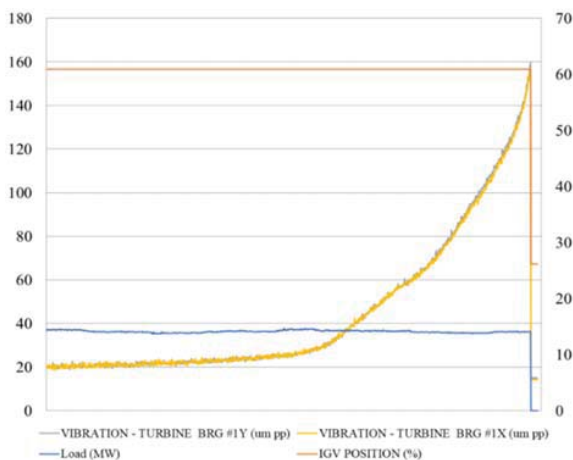
ambient conditions etc. were trended to find any irregularity or deviation from the normal baseline data (as shown in Fig 2). The only observation was the gradual increase in Bearing#02 vibrations to $76\mu\text{m pp}$ at the time when Bearing#01 cross the trip limit of $155\mu\text{m pp}$. No other anomaly was found in any of the other parameter during the analysis. After necessary checks by machinery, instruments & electrical teams, GT was successfully started again on 30th October, 2018 at 1350 Hrs.

Fig. 2 (a) Bearing#01 vibrations trend against Load & IGV

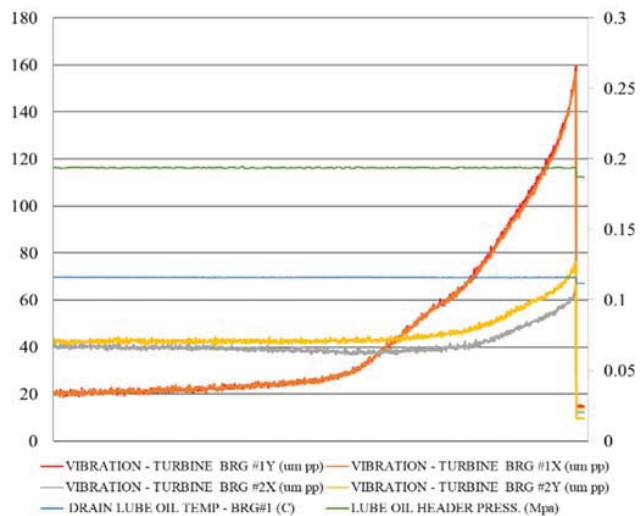
Fig. 2 (b) Turbine Bearings vibration trend against Lube oil drain temperature & header pressure

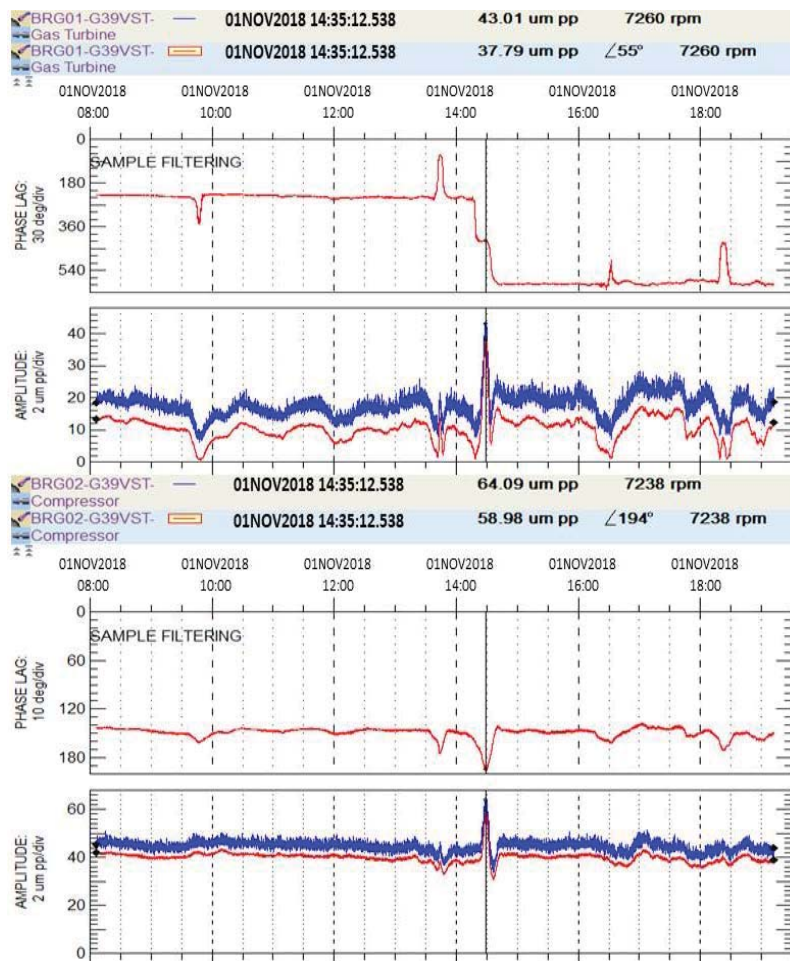
Vibration peaks was observed during steady state data recorded on 1st November 2018. Vibration peak was recorded at 1435hrs up to 40.09 & $35.54\mu\text{m pp}$ at Turbine Bearing#01 against normal vibrations of 22 & $24\mu\text{m pp}$ & at Turbine Bearing#02 up to 64.09 & $58.98\mu\text{m pp}$ against its normal trend of 43 & $45\mu\text{m pp}$. As per vibration trend data, vibration peaks were observed to appear at different times & the peak lasted for duration of approximately 15 minutes (as shown in Fig. 3).

Fig. 4 (a) Time base trend of Bearing#01 & 02 with Phase angle

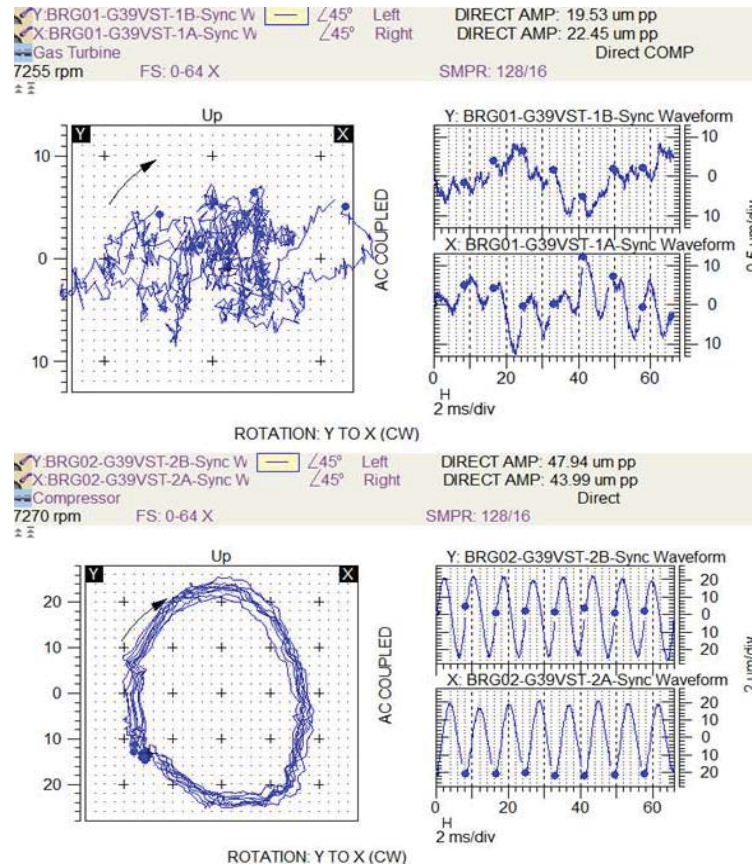
Basic rotor dynamic theory [3] states that when rotating at constant speed, rotor synchronous response remains constant, both in amplitude & phase. The occurrence of phase changes at constant speed could be caused by several different things, including rubs between stationary & rotating parts, angular shift of shrink fit components, a crack propagating through the rotor. In this case almost all vibration change was observed at frequency of 1X Turbine rpm while significant change in 1X phase (up to full 360° rotation) was also observed at Bearing#01 which most probably corresponds to symptoms of rubbing [4] (as shown in Fig. 4). Also, as per shaft centerline plot, movement of rotor in horizontal plane was evident at Bearing#01 (as shown in Fig. 5)

Fig. 4 (b) Orbit Plot of Turbine bearings showing rubbing symptoms at Bearing#01

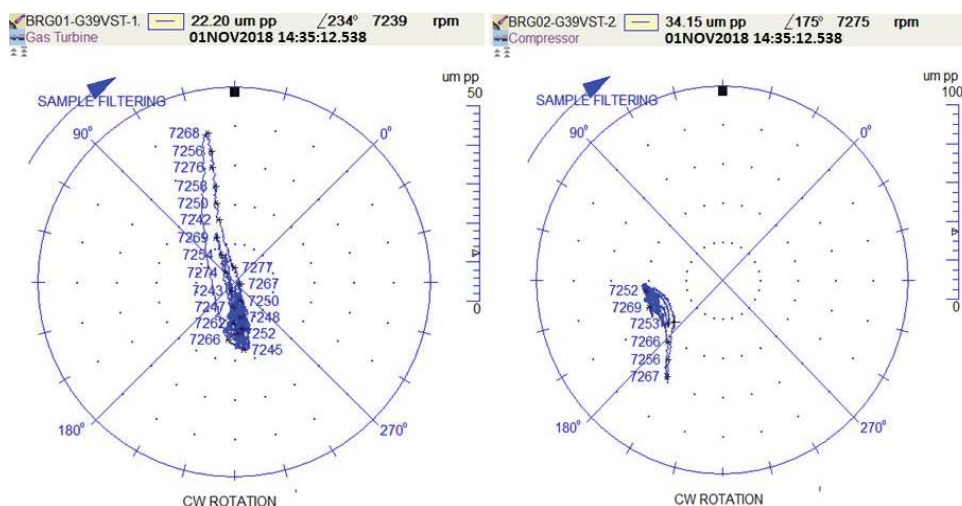
Fig. 4 (c) Polar Plot of Turbine bearings showing phase change of almost 360° at Bearing#01

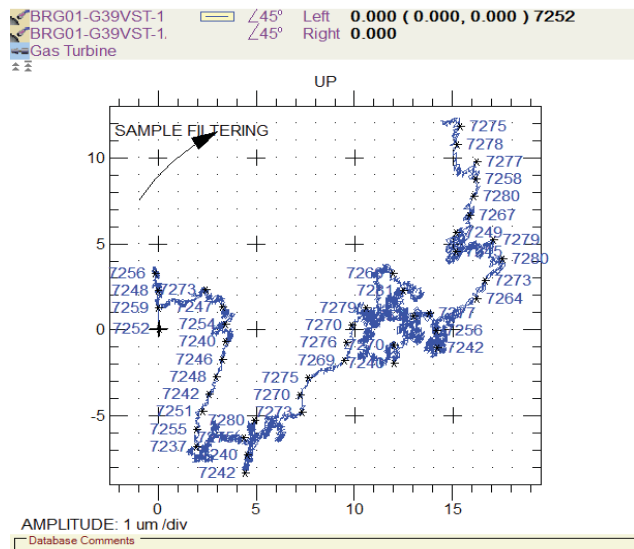
Fig. 5 Time base trend of Bearing#01 & 02 with Phase angle

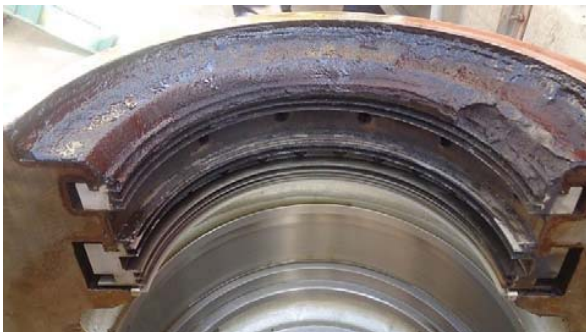
build-up of deposits resulting in localized reduction in seal clearance. Carbon deposits may be formed if lubricating oil comes in contact with high temperature causing oil to overheat. This may cause intermittent contact of rotor with deposits resulting in high vibration which tends to become normal upon clearance of deposits; however, vibration cycle may be repeated upon formation of new deposits.

At Bearing#01, two labyrinth seal sets installed in the bearing housing each on forward & after side. In the forward side labyrinth seals clear rubbing marks were present, covering around 25 degrees in the inner radius of bearing housing. The bearing pedestal end & labyrinth seal close to turbine side had excessive coke deposition. A layer of coke varying in thickness from 5 mm on outer radius to 2 mm on inner radius was formed on the forward side bearing pedestal face. The cavities of the first set of labyrinths were completely choked because of heavy coke deposition. This coke was brownish black & was hard but not tough. There was a small area from that layer where coke was removed showing signs of an impact load (as shown in Fig. 7). Coke deposition was also observed on the after-side labyrinth seals, but the severity of deposition was comparatively less. However, the mechanical integrity & geometric profile of labyrinth seals were intact & they were installed back after thorough cleaning followed by inspection.

Fig. 7 Heavy coke deposition, rubbing marks on Bearing#01 housing

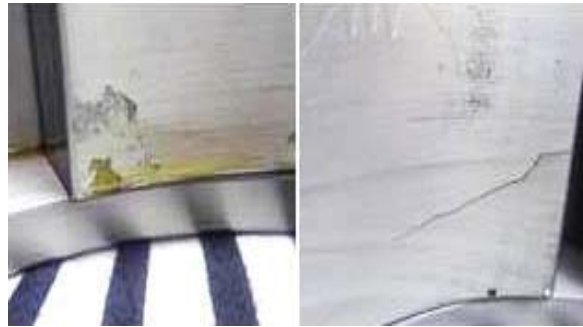
Two out of three shoes in the upper half of the bearing had symptoms of damage on the Babbitt layer. One shoe had a crack on the Babbitt while the other had pitting across its ends (as

shown in Fig. 8). The two shoes in lower half of the bearing had signs of rubbing, oil patches & Babbitt discoloration. The observations on the Bearing#01 pads were quite usual for a bearing with equivalent operating hours of more than eighty-

Fig. 8 Pitting and cracks on Babbitt layer of Bearing#01

After thorough cleaning & following the all quality hold points, new bearing was installed at location. Quality check measurements like semi height, bearing crush & radial clearance were also taken. The radial clearance of bearing was maintained at 0.45mm (shaft journal OD: 184mm). Bearing#02 was also inspected & did not have excessive coke formation like Bearing#01. The radial Bearing#02 at the driving end had minor signs of rubbing & oil marks. Its condition was comparatively better but replaced with new one with the top clearance of 0.40 mm. The thrust bearing was healthy & installed back after quality checks & inspection. Before final box-up, cooling & sealing air lines were thoroughly blown with instrument air to remove any suspected choking & installed back.

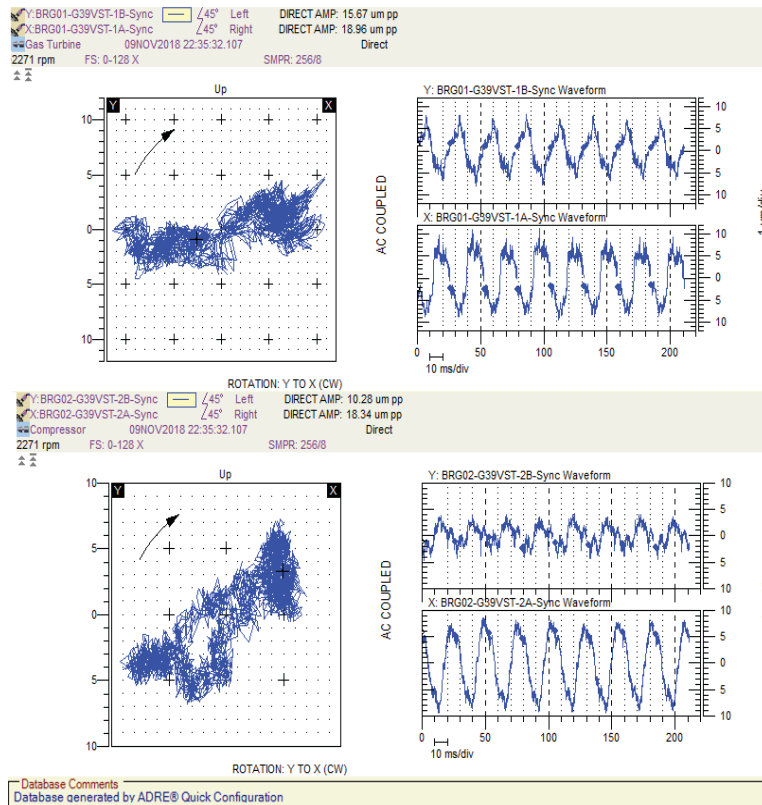
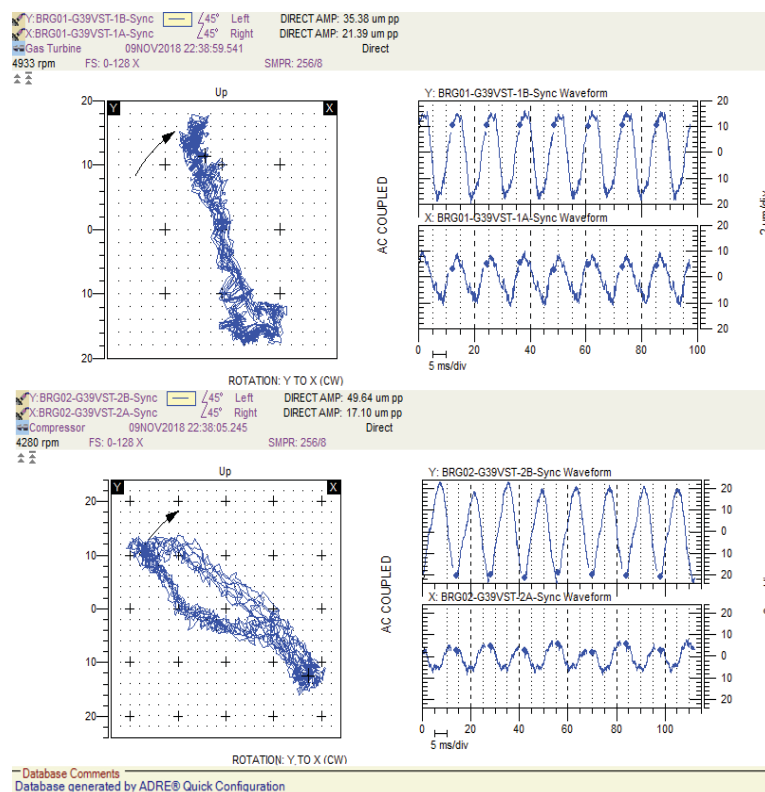
directly related to increasing machine speed, therefore unbalance was not suspected as the cause of vibration & the 1X vibration most probably was related to shaft bow condition during the machine start up. Orbit plots were found indicating 1X orbits & remained highly flat/elliptical throughout speed range from 2000 rpm to 5000 rpm (as shown in Fig. 9) suggesting possible rub during coast up. At operating speed i.e.

Fig. 9 (a) Orbit plot of turbine bearings at 2271 rpm

Fig. 9 (b) Orbit plot of turbine bearings at 4933 rpm

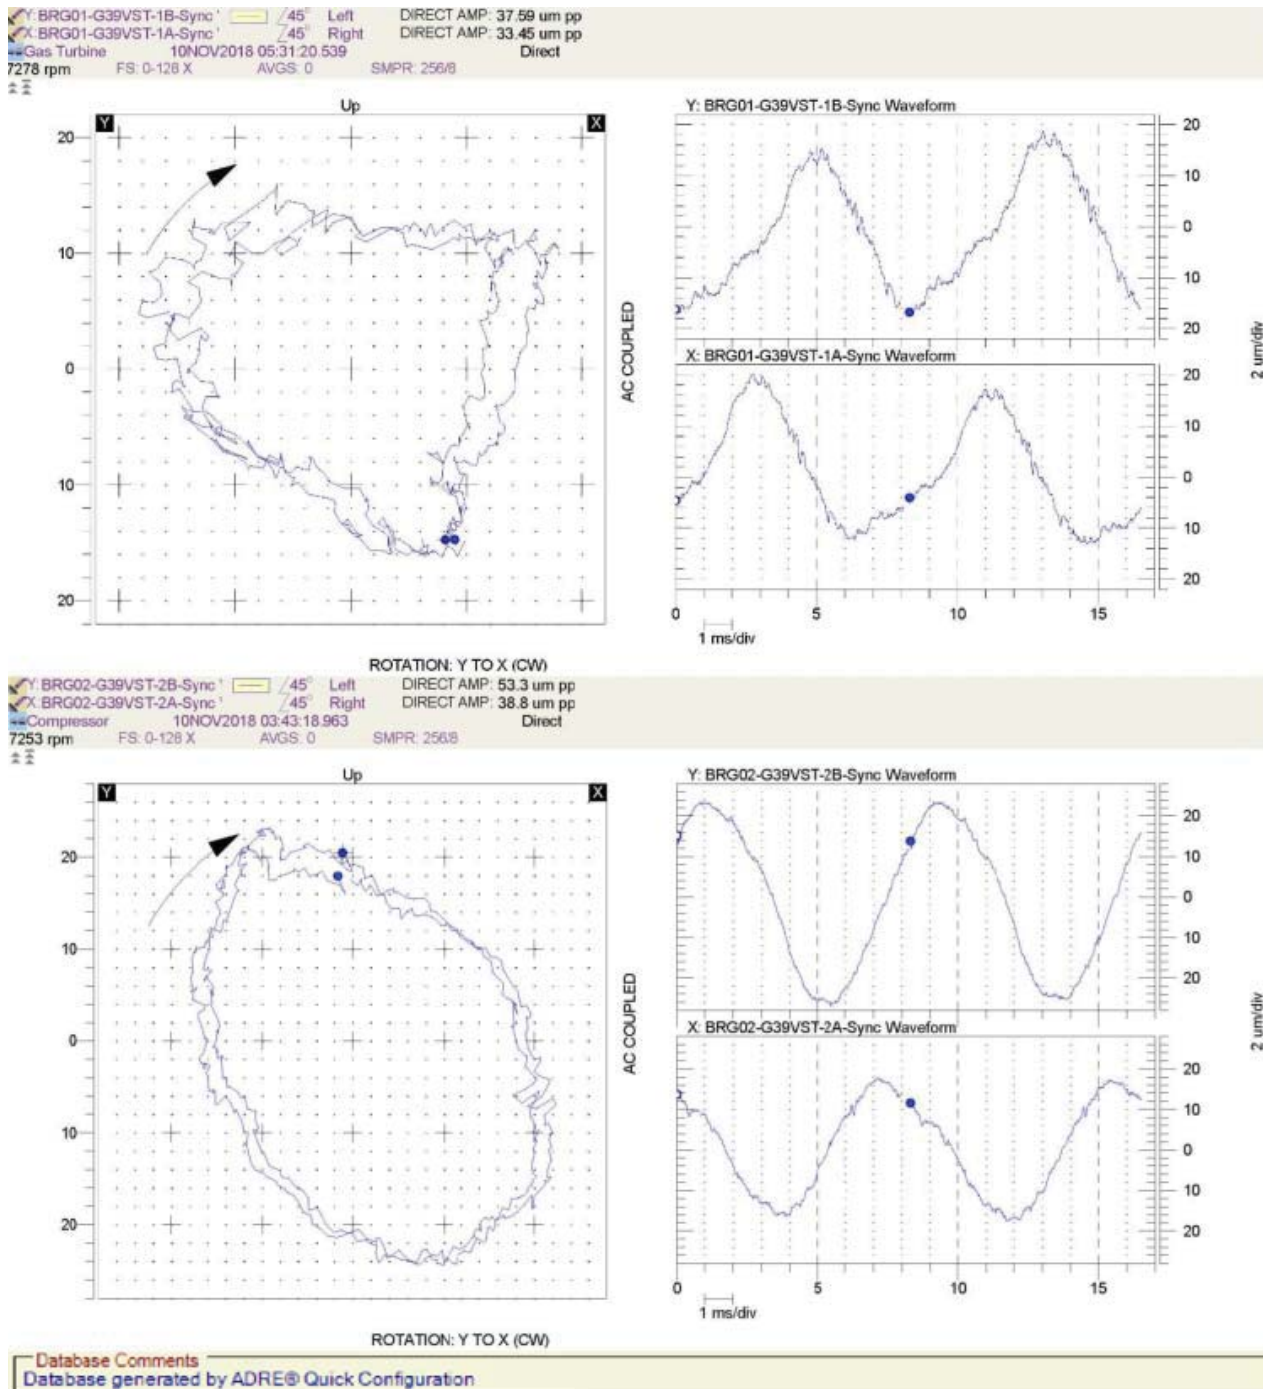
7272 rpm no such observation was found in 1x orbit plots (as shown in Fig. 10). As per Shaft center line plots, maximum shaft vertical upward movement of 134 microns was observed at Turbine NE Bearing#01 when machine was loaded from FSNL to 21 MW, which was within bearing clearance boundaries (as shown in Fig 11).

Fig. 10 Orbit plot of turbine bearings at 7278 rpm

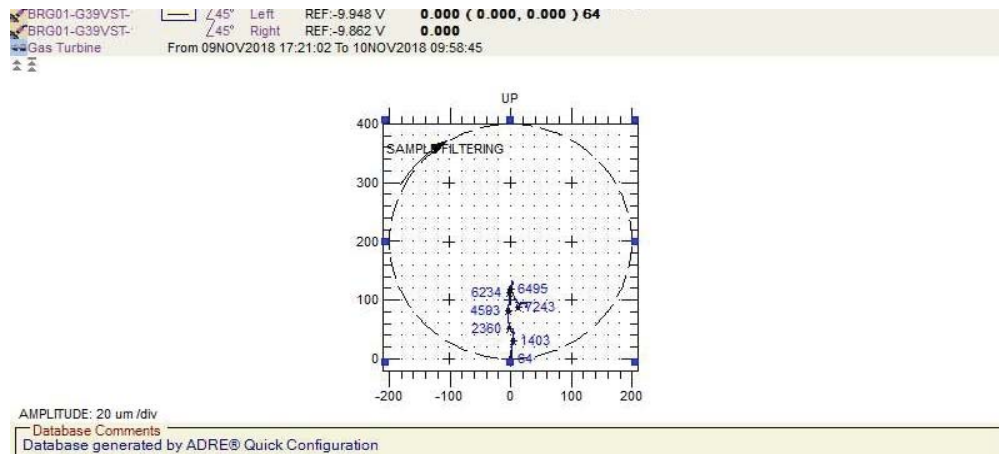
Fig. 11 Shaft Centre line of Bearing#01 after bearing replacement

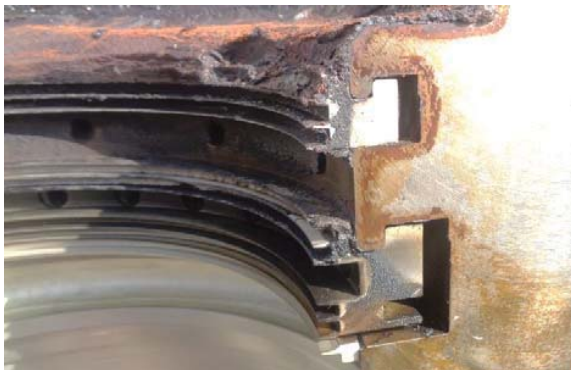
In the subject case puddle formation was observed in the labyrinth of the bearing housing (as shown in Fig. 12). Puddles form from high surface to volume ratio of lube oil layers & by long residence time of oil in a cavity. Physically it's in form of thick chunks of varying size & hardness depending on the age of coking. Its surface texture varies from shiny to matte like finish.

Coking phenomena occurs because of continuous exposure to elevated temperatures and long oil residue time of oil. Operational factors such as hot shutdowns can influence coke formation. Similarly, obstructions to flow or directional changes in lube oil path cause reduction in flow rate & increase the oil residence time.

Fig. 12 Physical texture of Coke puddles

Although coke formation is more of an aging phenomenon and be addressed by timely planning the maintenance of components exposed to lube oil circuit, there are some design phase measures to prevent this from happening. One technique is to introduce scavenge or vent lines in the gas path, this can significantly reduce deposits. Secondly, some coking tests have demonstrated powerful predictive capability and are essential during oil formulation and development phases of lubrication

oils. The cooling and sealing air lines towards bearing housing also to be checked and blown away to remove any suspected choking.

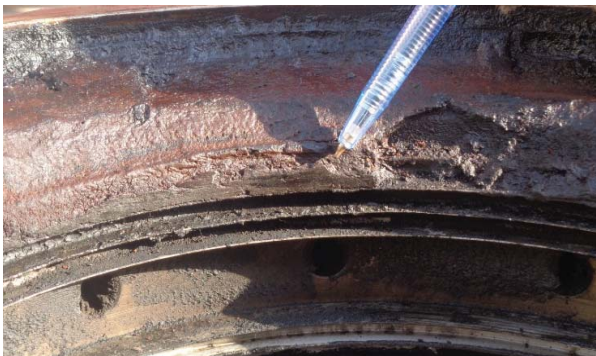
Fig. 13 Shedding of coke deposits after getting rubbed
