Diagnosis of Intermittent High Vibration Peaks in Industrial Gas Turbine Using Advanced Vibrations Analysis

Abubakar Rashid, Muhammad Saad, Faheem Ahmed

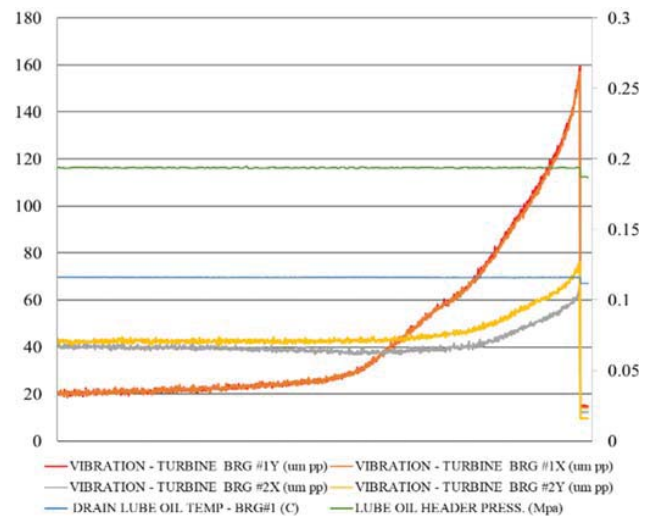
Fig. 2 (b) Turbine Bearings vibration trend against Lube oil drain temperature & header pressure

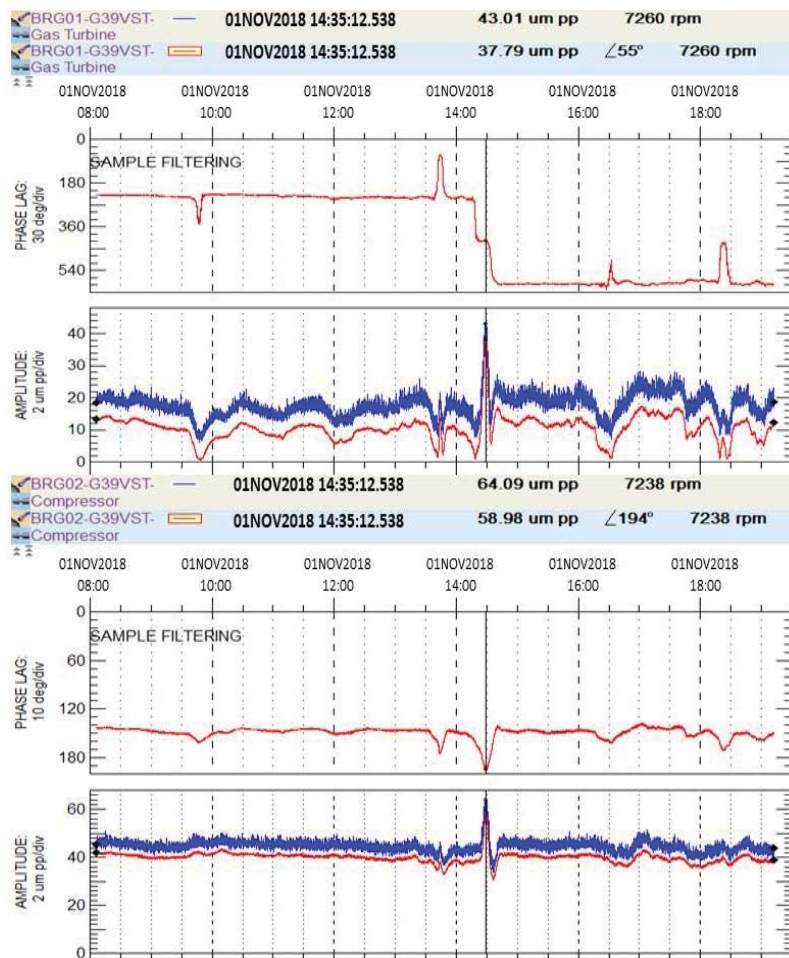
Vibration peaks was observed during steady state data recorded on 1st November 2018. Vibration peak was recorded at 1435hrs up to 40.09 & $35.54\mu\text{m pp}$ at Turbine Bearing#01 against normal vibrations of 22 & $24\mu\text{m pp}$ & at Turbine Bearing#02 up to 64.09 & $58.98\mu\text{m pp}$ against its normal trend of 43 & $45\mu\text{m pp}$. As per vibration trend data, vibration peaks were observed to appear at different times & the peak lasted for duration of approximately 15 minutes (as shown in Fig. 3).

Fig. 4 (a) Time base trend of Bearing#01 & 02 with Phase angle

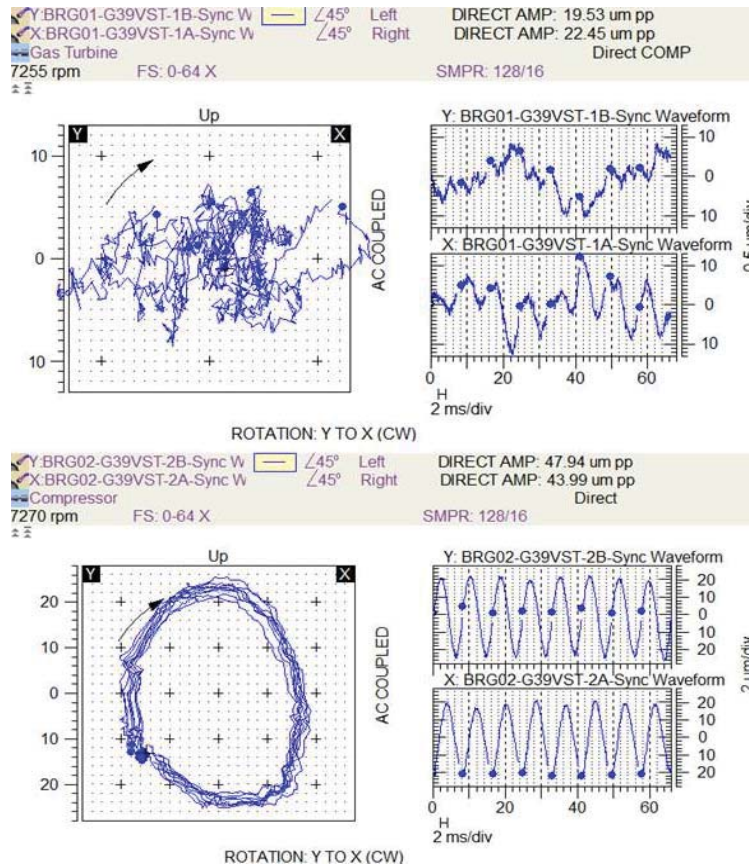
Basic rotor dynamic theory [3] states that when rotating at constant speed, rotor synchronous response remains constant, both in amplitude & phase. The occurrence of phase changes at constant speed could be caused by several different things, including rubs between stationary & rotating parts, angular shift of shrink fit components, a crack propagating through the rotor. In this case almost all vibration change was observed at frequency of 1X Turbine rpm while significant change in 1X phase (up to full 360° rotation) was also observed at Bearing#01 which most probably corresponds to symptoms of rubbing [4] (as shown in Fig. 4). Also, as per shaft centerline plot, movement of rotor in horizontal plane was evident at Bearing#01 (as shown in Fig. 5)

Fig. 4 (b) Orbit Plot of Turbine bearings showing rubbing symptoms at Bearing#01

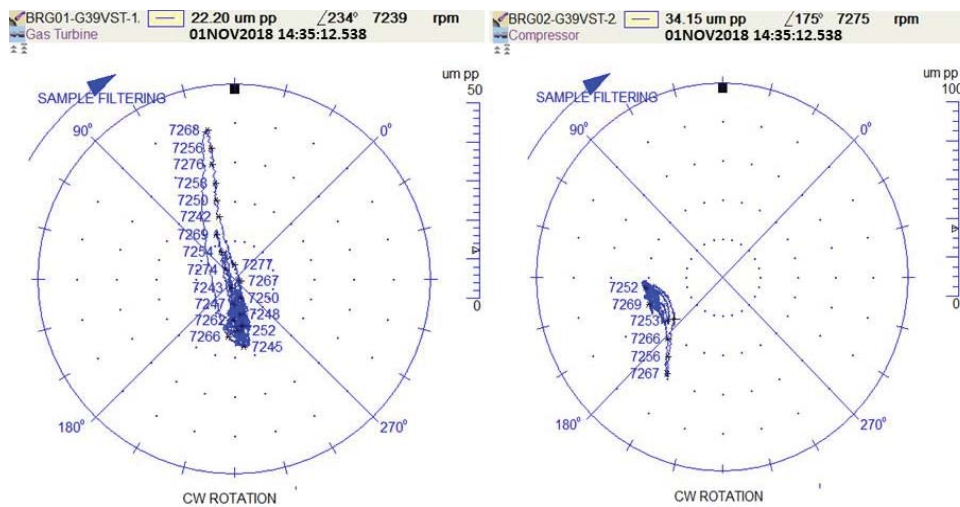
Fig. 4 (c) Polar Plot of Turbine bearings showing phase change of almost 360° at Bearing#01

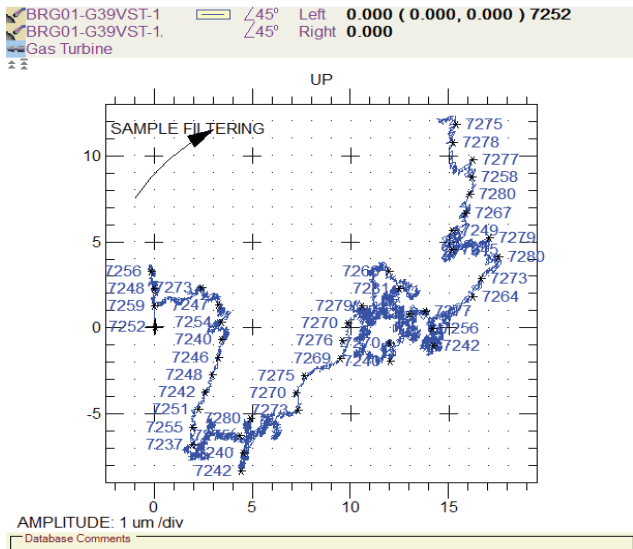
Fig. 5 Time base trend of Bearing#01 & 02 with Phase angle

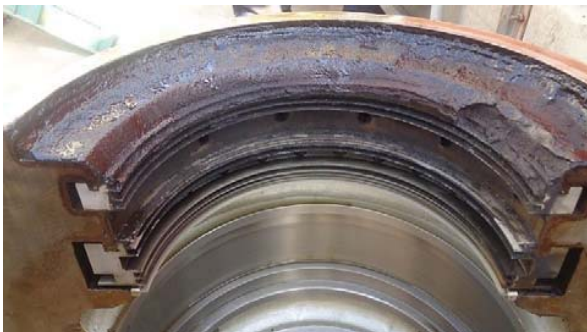
build-up of deposits resulting in localized reduction in seal clearance. Carbon deposits may be formed if lubricating oil comes in contact with high temperature causing oil to overheat. This may cause intermittent contact of rotor with deposits resulting in high vibration which tends to become normal upon clearance of deposits; however, vibration cycle may be repeated upon formation of new deposits.

At Bearing#01, two labyrinth seal sets installed in the bearing housing each on forward & after side. In the forward side labyrinth seals clear rubbing marks were present, covering around 25 degrees in the inner radius of bearing housing. The bearing pedestal end & labyrinth seal close to turbine side had excessive coke deposition. A layer of coke varying in thickness from 5 mm on outer radius to 2 mm on inner radius was formed on the forward side bearing pedestal face. The cavities of the first set of labyrinths were completely choked because of heavy coke deposition. This coke was brownish black & was hard but not tough. There was a small area from that layer where coke was removed showing signs of an impact load (as shown in Fig. 7). Coke deposition was also observed on the after-side labyrinth seals, but the severity of deposition was comparatively less. However, the mechanical integrity & geometric profile of labyrinth seals were intact & they were installed back after thorough cleaning followed by inspection.

Fig. 7 Heavy coke deposition, rubbing marks on Bearing#01 housing

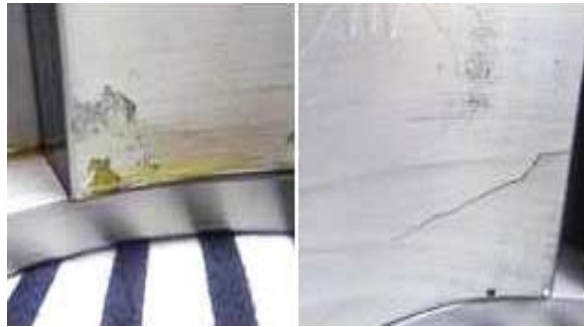
Two out of three shoes in the upper half of the bearing had symptoms of damage on the Babbitt layer. One shoe had a crack on the Babbitt while the other had pitting across its ends (as

shown in Fig. 8). The two shoes in lower half of the bearing had signs of rubbing, oil patches & Babbitt discoloration. The observations on the Bearing#01 pads were quite usual for a bearing with equivalent operating hours of more than eighty-

Fig. 8 Pitting and cracks on Babbitt layer of Bearing#01

After thorough cleaning & following the all quality hold points, new bearing was installed at location. Quality check measurements like semi height, bearing crush & radial clearance were also taken. The radial clearance of bearing was maintained at 0.45mm (shaft journal OD: 184mm). Bearing#02 was also inspected & did not have excessive coke formation like Bearing#01. The radial Bearing#02 at the driving end had minor signs of rubbing & oil marks. Its condition was comparatively better but replaced with new one with the top clearance of 0.40 mm. The thrust bearing was healthy & installed back after quality checks & inspection. Before final box-up, cooling & sealing air lines were thoroughly blown with instrument air to remove any suspected choking & installed back.

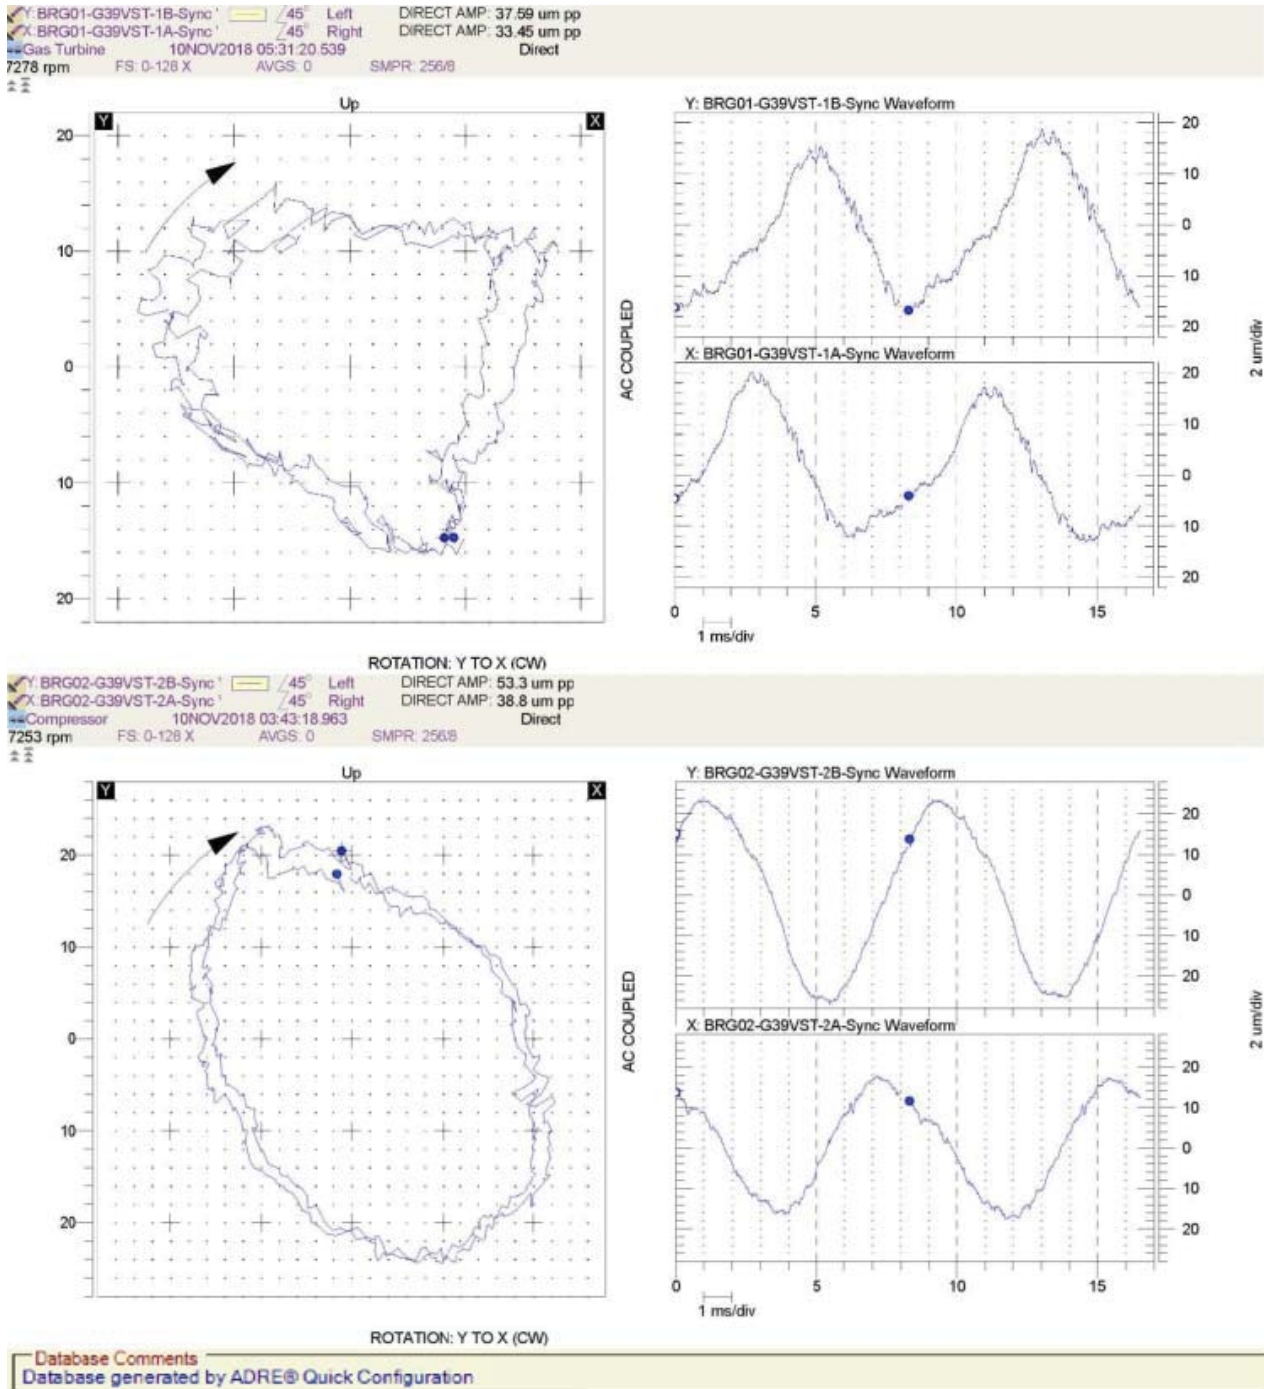
7272 rpm no such observation was found in 1x orbit plots (as shown in Fig. 10). As per Shaft center line plots, maximum shaft vertical upward movement of 134 microns was observed at Turbine NE Bearing#01 when machine was loaded from FSNL to 21 MW, which was within bearing clearance boundaries (as shown in Fig 11).

Fig. 10 Orbit plot of turbine bearings at 7278 rpms

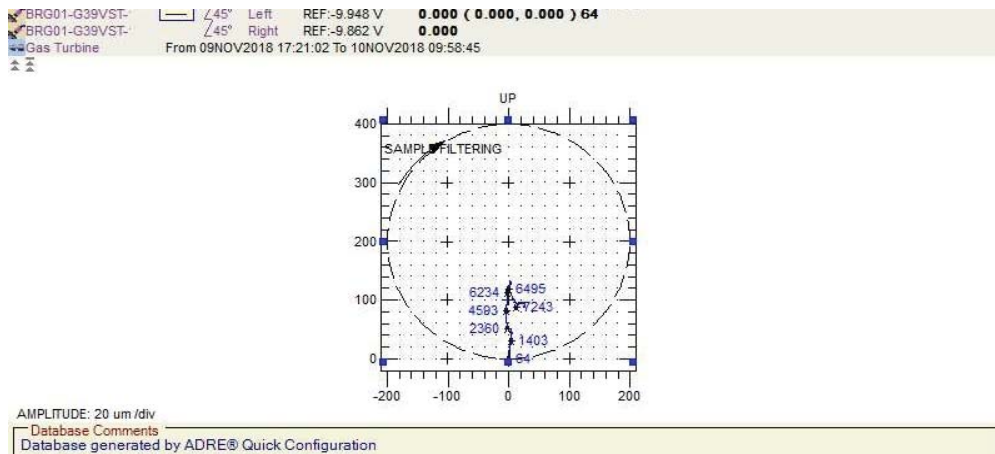
Start-up data of machine, as explained above, suggests some rubbing may have taken place, possibly due to shaft bow condition [10] in turbine-compressor during coasting up of the machine speed. But Steady state shaft vibration levels of Gas Turbine were found within acceptable limits & found to be in zone A/B as per ISO 7919-3 / 10816-7, thus the machine was declared healthy for continuous operation.

Fig. 11 Shaft Centre line of Bearing#01 after bearing replacement

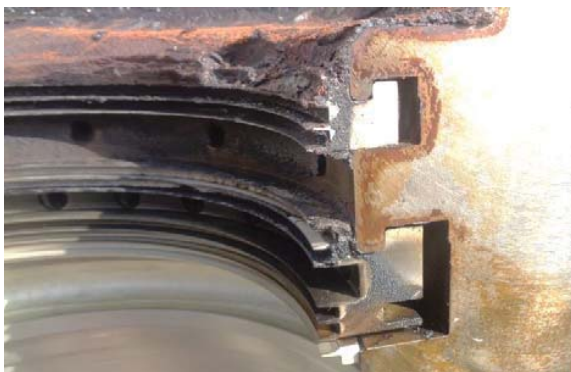
In the subject case puddle formation was observed in the labyrinth of the bearing housing (as shown in Fig. 12). Puddles form from high surface to volume ratio of lube oil layers & by long residence time of oil in a cavity. Physically it's in form of thick chunks of varying size & hardness depending on the age of coking. Its surface texture varies from shiny to matte like finish.

Coking phenomena occurs because of continuous exposure to elevated temperatures and long oil residue time of oil. Operational factors such as hot shutdowns can influence coke formation. Similarly, obstructions to flow or directional changes in lube oil path cause reduction in flow rate & increase the oil residence time.

Fig. 12 Physical texture of Coke puddles

Although coke formation is more of an aging phenomenon and be addressed by timely planning the maintenance of components exposed to lube oil circuit, there are some design phase measures to prevent this from happening. One technique is to introduce scavenge or vent lines in the gas path, this can significantly reduce deposits. Secondly, some coking tests have demonstrated powerful predictive capability and are essential during oil formulation and development phases of lubrication

oils. The cooling and sealing air lines towards bearing housing also to be checked and blown away to remove any suspected choking.

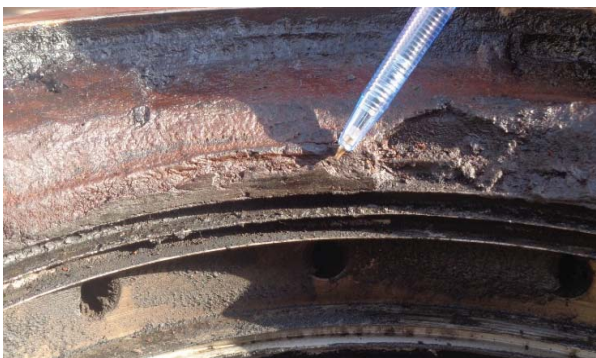
Fig. 13 Shedding of coke deposits after getting rubbed
