# Failure Analysis of a Medium Duty Vehicle Leaf Spring

Gül Çevik

**Keywords**—Leaf spring, failure analysis, fatigue, fractography.

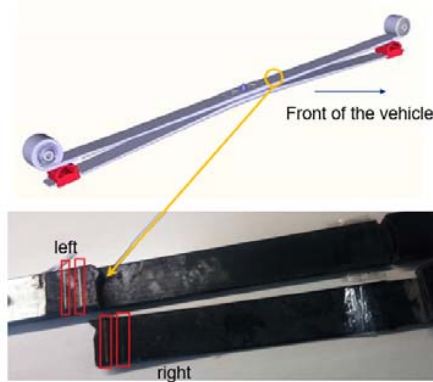
Location of failure is shown on Fig. 1. A complete separation of the upper leaf spring has occurred on vehicle due to fracture. Failure has occurred near to the center to the front side of the leaf. Red rectangles on the picture show the material verification test sample locations.

Fig. 1 Failure location

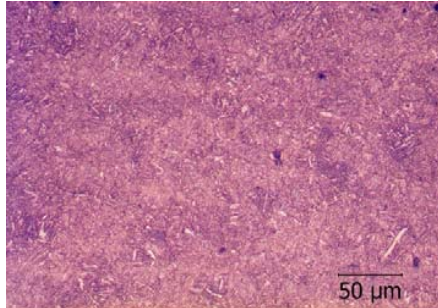
A microscopical analysis was carried out by optical microscope on samples from 5 mm and 50 mm to the failed section. Observed microstructure is tempered martensite as specified. No remarkable bainite or retained austenite phases were observed within the structure which may reduce mechanical strength and durability of the part under cyclic loading conditions.

Measured grain size is ASTM grade 8 as per ASTM E112 Method or finer which is as required. Fig. 3 shows a representative micrograph from the examined samples.

Fig. 3 Microstructure

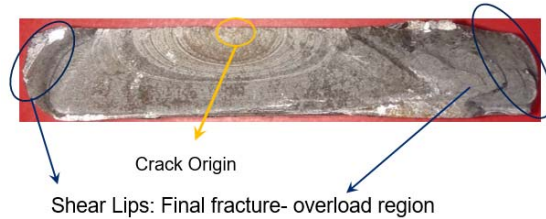
For microscopic examinations, the surfaces were cleaned by ultrasonic cleaning method with the usage of a special cleaning agent. Left-side fracture surface after cleaning is shown on Fig. 5. The thumbnail type of fatigue crack and shear lips at the final fracture region can be differentiated on this figure.

Macro examinations showed that a fatigue crack is present on the failed section. The shear lips and rough surface to the edges describe the final fracture region. Macroscopically observable size of the fatigue crack was found to be

approximately one-fourth of the total cross-sectional area. As the thumbnail shape of the crack is a possible indication of stress-corrosion cracking; further investigations were conducted on the micro-examinations and will be discussed in the micro-fractography section.

Fig. 5 Fracture surface (left-side) after ultrasonic cleaning

The orientation of the failed section and crack propagation plane describes a fatigue type of failure due to unidirectional cyclic bending loading condition.

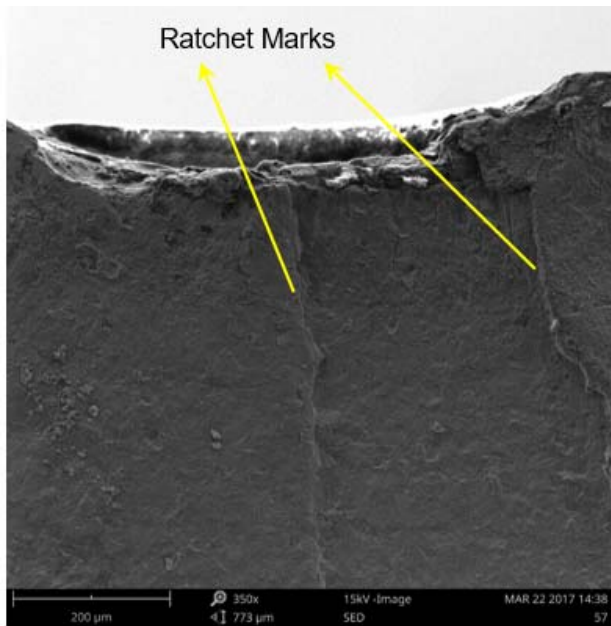
Fig. 7 shows the fatigue crack origin (point a) at X350 magnification. Ratchet marks which are indications of fatigue crack initiation mechanism were observed at the crack origin. Crack has emanated from a surface collapse of  $\sim 500 \mu\text{m}$  which is possibly formed by plastic deformation of the surface during shot peening process. On the other hand, this is accepted as a natural phenomenon as these regions can act as local stress-raisers.

Examinations on crack origin showed that the crack initiation has occurred at single region. Singular crack initiation requires very low stress concentration. Examinations at crack origin region showed that this region is free of pre-existing cracks and metallurgical defects. These findings of low stress concentration and defect-free surface and singular type of crack propagation indicate that the reason of fatigue crack initiation and propagation is high magnitude of cyclic

stresses on the part.

Fig. 7 Crack origin

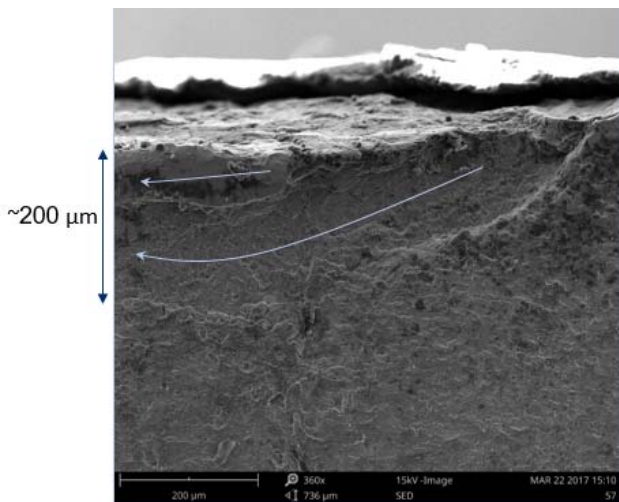
Fig. 8 shows the extension of crack initiations further beyond to the left (point b). However these cracks did not propagate and fatigue cracking continued with initial crack starting from point a.

Fig. 8 Extension of multiple crack initiation

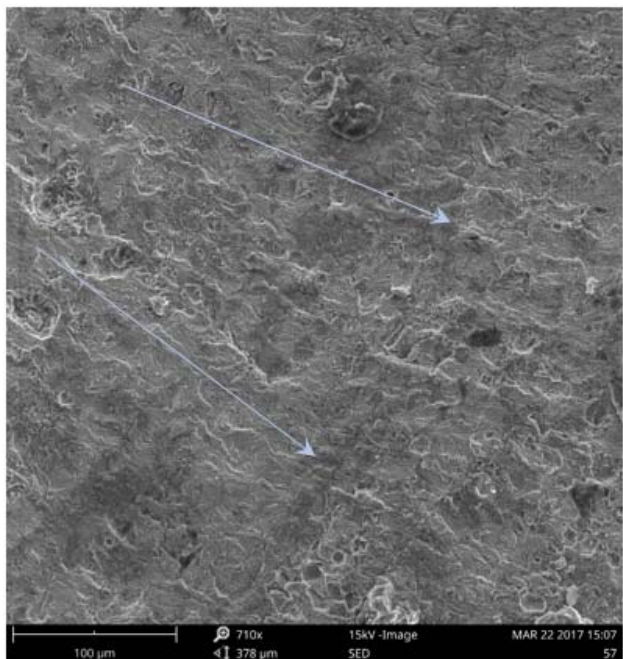
Figs. 9 and 10 show the crack propagation directions. Fatigue striations can also be observed on Fig. 9 which are indications of stable crack propagation.

Fig. 10 Fatigue crack propagation directions (point c)

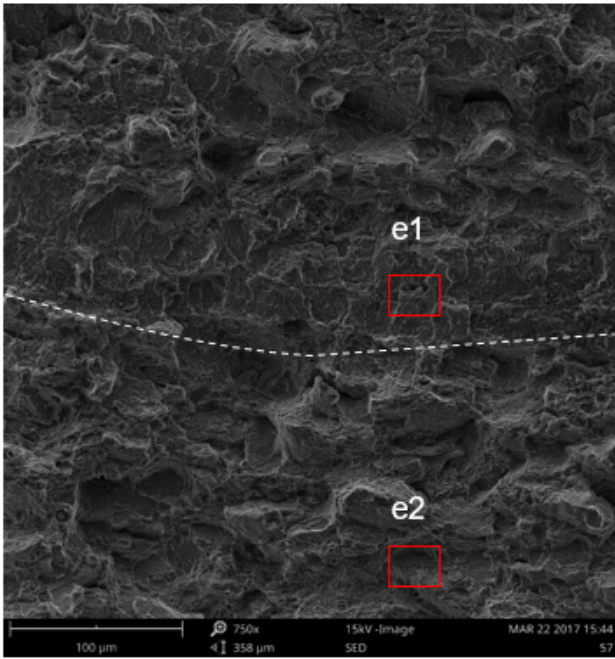
Micro examinations validated that the macroscopic transition from beach marks to rough and dull surface is the transition from fatigue to final overload fracture region. Figs. 11-13 describe the replication of fracture mechanism change from fatigue to ductile failure.

Fig. 11 Fatigue to overloading transition region (point e)

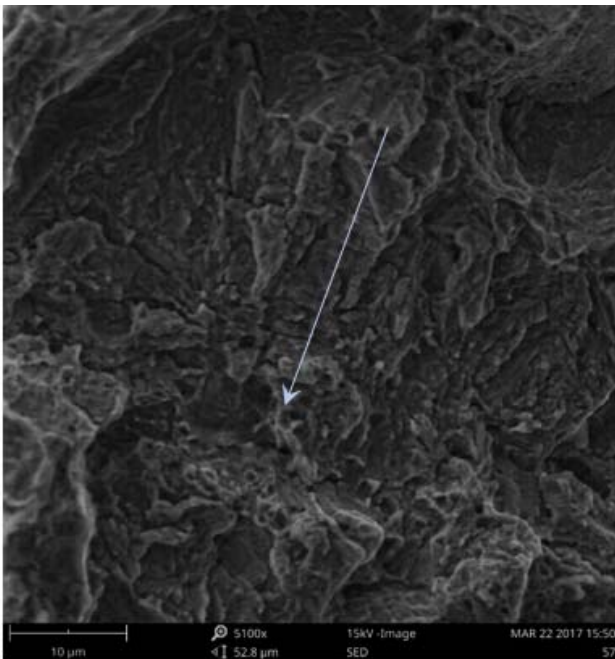
Striations and tear ridges were observed in fatigue region whereas dimples were observed on the overloading region.

Fig. 12 Fatigue striations and tear ridges (e1)

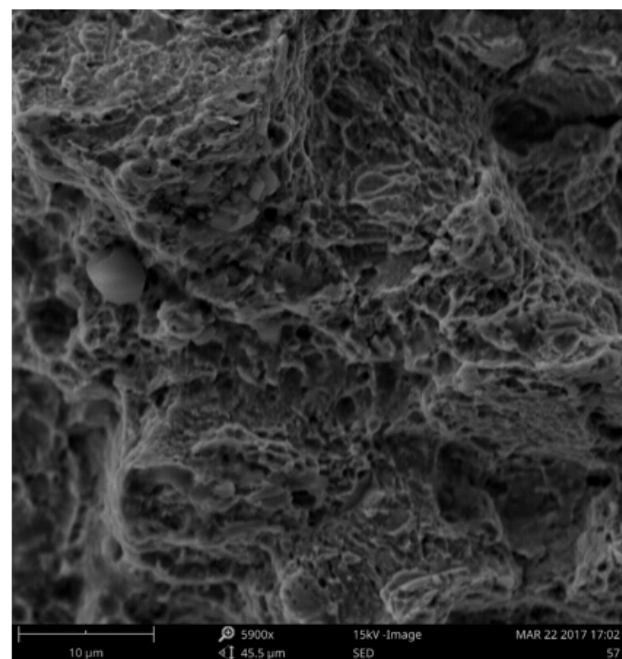
Fig. 14 Ductile dimples at final fracture (point f)

Figs. 14 and 15 show fractographs from the final failure regions. A complete ductile failure was observed near to the crack tip whereas both ductile and brittle features were observed near to the edge of the part. This may have occurred by more than one step of final overloading and increased strain rates at final stage resulting in cleavage plane formation due to brittle failure.
