# Railway Crane Accident: A Comparative Metallographic Test on Pins Fractured during Operation

Thiago Viana

**Keywords**—Crane, fracture, pin, railway.

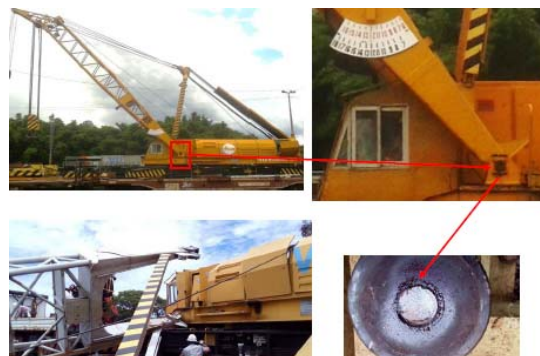
In order to assist the movement of locomotives and wagons that derailed off the track, a railway crane is used. The objective of this study is to analyze the cause of the fall of the crane hoist caused by the fracture of the two. The consequence of the fracture of these two pins that support the hoist was the fall of the same (accident), see Fig. 1. This crane is used to attended trains accident, being used to move wagons or locomotives that have derailed and are outside the railway

Fig. 1 The accident occurred with the railway crane due to the fall of the hoist by the fracture of the two support pins

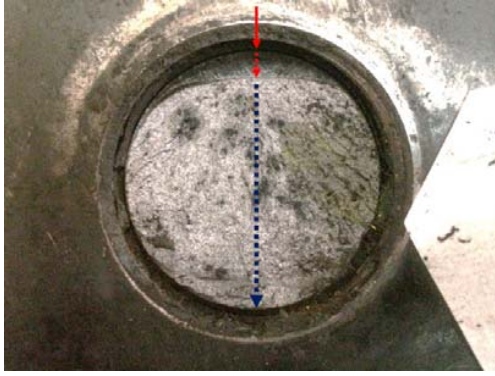
The fractured pin 1 (right side of crane), see Fig. 7, was fractured by fatigue through repeated efforts of unidirectional bending (presence of beach marks). The region of instantaneous and final fracture (about 90% of the cross section) was of the brittle fracture (radial marks).

Fig. 7 The visual inspection of the fracture shows: region of beginning of the fatigue crack (red arrow); beach marks: beginning and propagation of fatigue crack by unidirectional flexion (red dotted arrow); and radial marks: region of instantaneous fracture and final of brittle fracture (blue dotted arrow)

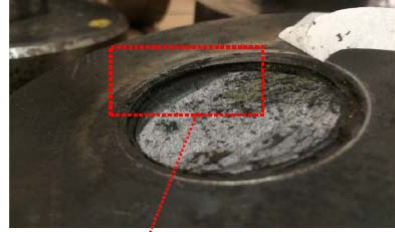
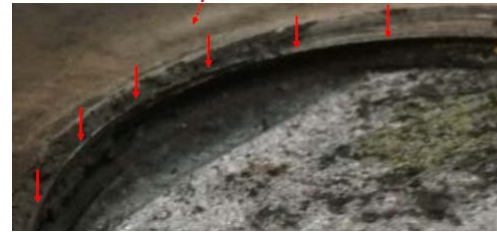
Further, Fig. 8 shows the detection that the screw peaks of the pin seat have no curvature, that is, they have sharp edges (sharp corners). This figure shows the presence of a sharp

corner in the first thread of the screw seat, and the same anomalies in the other threads are also shown.

Fig. 8 Presence of sharp edge (sharp corners) in the peaks of the threads of the seat of the fracture pin 1

- Perform visual tests with magnifying glass and/or non-destructive tests (dye penetrant, ultrasonic, etc.) on all the pins applied on the crane in order to detect notches and/or crack initiation.
- Calculate efforts to determine whether SAE 1045 steel (with or without heat treatment) and/or the entire crane is sufficient for the mechanical stresses imposed by the operation. Same for the seat.
- Elaborate technical drawing of the pin and seat, as well as elaborate technical specification containing various details including the design, material and type of heat treatment.
- Adapt the mechanical forming process of the seat and/or pin threads in order to eliminate sharp edges on the thread peaks.

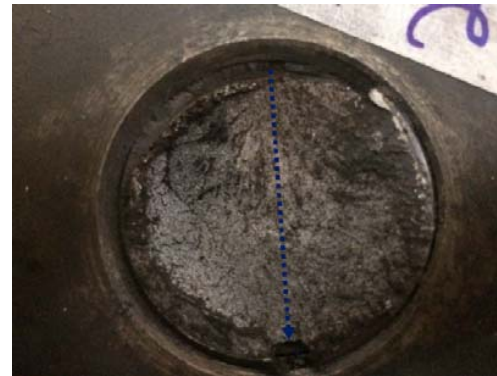
The fracture of pin 2 was of the brittle bending type through a single overload stress (fracture occurred almost instantaneously). Fig. 9 shows the radial marks proving to be a brittle fracture. The results of the chemical composition showed that the steels of the three pins are similar to those specified for the steel SAE 1045.

Fig. 9 Fracture of pin 2 due to bending overload stress generating brittle fracture (radial marks). The blue dotted arrow indicates the direction of instantaneous propagation

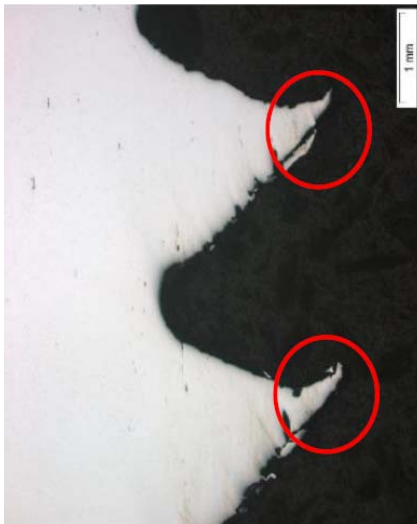
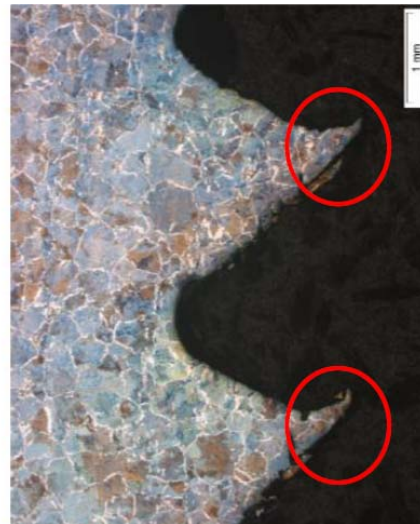
The metallographic examination of all three pins and of the three sites showed is formed by a perlite, as was already expected to be SAE 1045 steel. No irregularities were found in the microstructure. However, the anomaly in the peak of the threads of the seat of the fractured pin 1 was corroborated due to the presence of a cutting edge (Fig. 10). In addition, in the valleys of pin 1 threads several fatigue cracks were found in the beginning of propagation phase (Fig. 11).

Fig. 10 The presence of a sharp edge in the peaks of the threads of the seat of the fracture pin 1

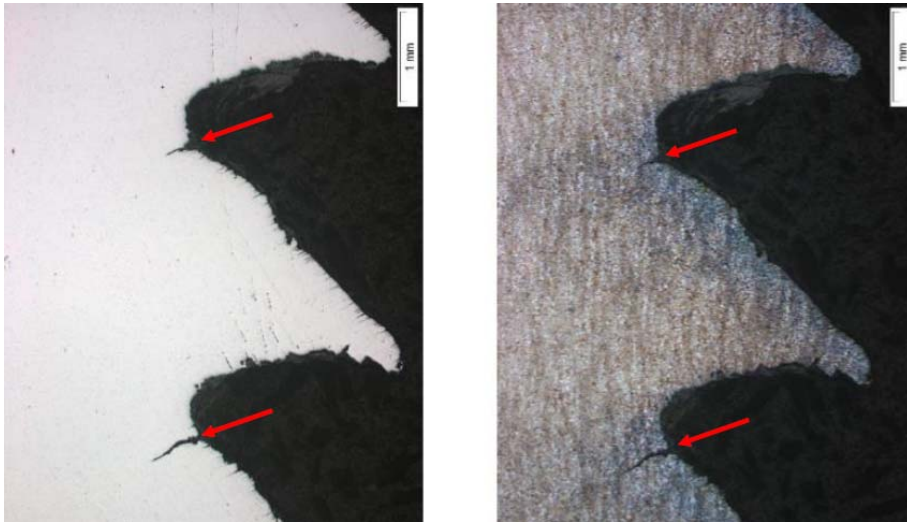
Fig. 11 Recording of several cracks found in some of the valleys of the threads of the fractured pin 1. The threads of pin 1, as well as that of its seat, were probably deformed plastically after the fracture occurred

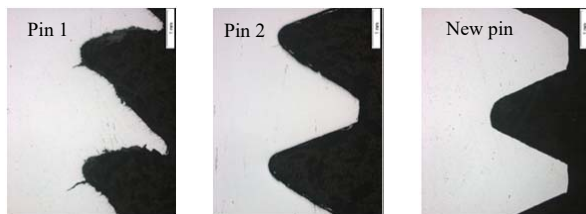
Fig. 12 Pin threads

The threads of the pin/seat 2 and the pin/new seat were shown with thread geometry to the satisfaction (without cutting edge) and without the presence of cracks and/or plastic deformations. An exception is that only a small crack was found in a valley of the pin 2 thread, most likely as a

consequence of the overload imposed after the fracture of pin 1. The comparative table in Fig. 12 shows the comparison

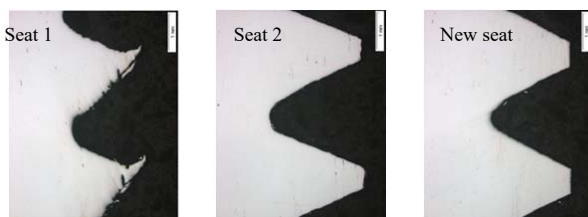
Fig. 13 Seat threads of pins

between the pin threads and Fig. 13 shows the comparison between the seat threads.

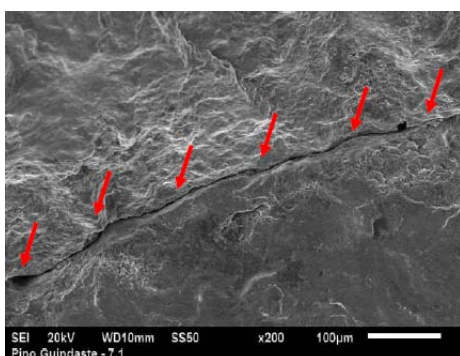
Aiming to verify the presence of notches, the fracture of pin 1 was analyzed in SEM (Scanning Electron Microscope). Fig. 14 shows the existence of notch in the valley of the thread of pin 1. This test was also performed for pin 2, with no notch in the thread.

Fig. 14 SEM analysis evidencing the presence of notch (risk) in the valley of the thread of the fractured pin 1

The main cause of the failure was the notch caused in valley of pin 1 (right side of crane hoist) by the action/contact with the cutting edge contain in the peaks of the seat threads. From these grooves, the fatigue crack was started in pin 1.
