# Modelling for Roof Failure Analysis in an Underground Cave

M. Belén Prendes-Gero, Celestino González-Nicieza, M. Inmaculada Alvarez-Fernández

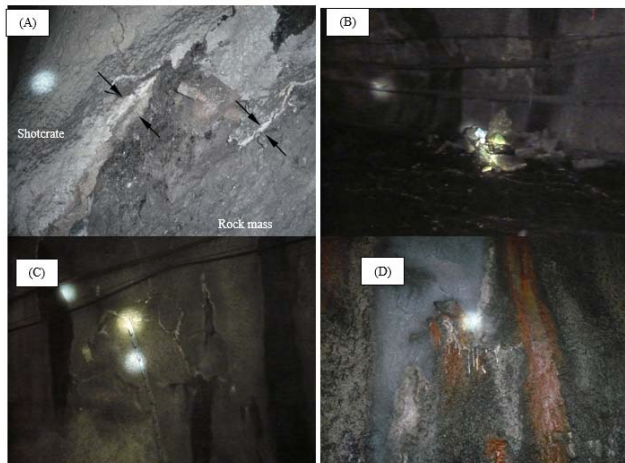
Along the ramp, when coal layers are crossed, the shotcrete support suffers a lot, because when this type of ground is deformed, it cracks and detaches the shotcrete. At some points it was found that the thickness of shotcrete was small and, in others, the shotcrete was not resting on the floor, if not "hung". These situations indicate that the shotcrete was not working properly as support. On the other hand, the infiltrating water produced oxidation problems in the bolts, as well as in the reinforcing fibbers of the shotcrete in the sections they were metallic. These problems are shown in Fig. 1. In some places, the support was reinforced by increasing the bolt density or installing new wood-clad metal frames (Fig. 2).

Fig. 1 Found problems in the shotcrete: (A) poor thickness, (B) detached blocks, (C) cracking, (D) leaks and oxidation

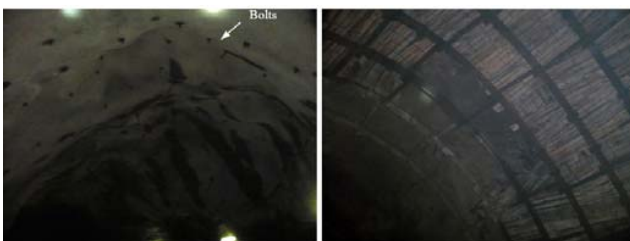
Fig. 2 Places with reinforced support in the ramp

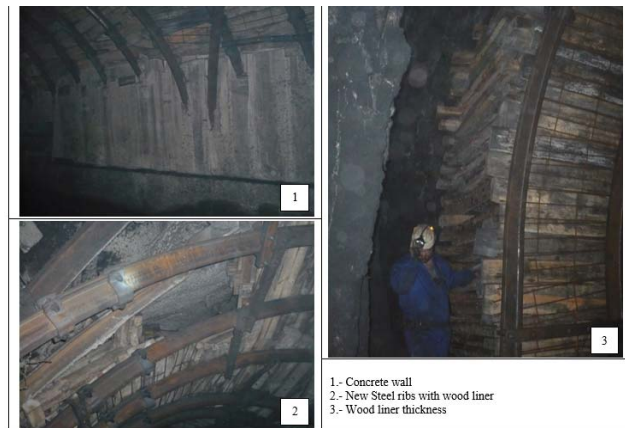
Fig. 3 Reinforced support after the accident

The area of the collapse was entirely reinforced after the incident, with new metallic frames (type Th29) and a coating of wood that in some areas exceeded one meter of thickness (see Fig. 3). The coating wood produces a reduction of the size of the section. On the right wall, where the detachment of

material happened, the metal frames were braced by embedding them in a concrete wall.

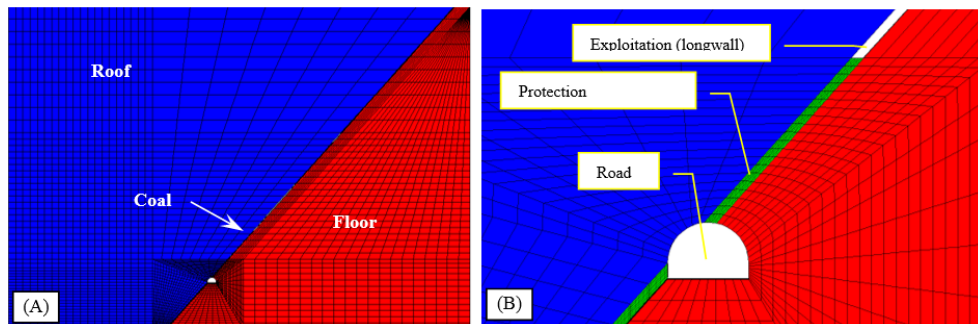
Fig. 4 Model description

The model shown in Fig. 4 has 350 m width and 270 m height. The rest of the ground, until reaching the 700 m depth, was replaced by an equivalent overload. In the figure, it is possible to see the different simulated materials: the layer of coal (in green), the roof of the layer (sandstones, in blue), the wall of the layer (shales, in red), and the simulated works of the exploitation: the tailgate and the workshop of the

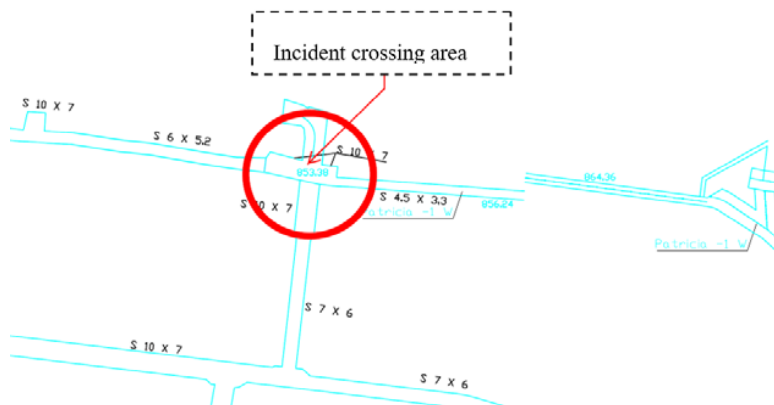
Fig. 5 Dimensions of the galleries in the collapsed area

- 1) Case 1: The tailgate has the most common dimensions in this type of infrastructure, that is to say, 6 m of width and 5.2 m of height.
- 2) Case 2: The tailgate has a bigger cross section, 10 m of width and 7 m of height. These dimensions are the dimensions of the collapsed place (Fig. 5).

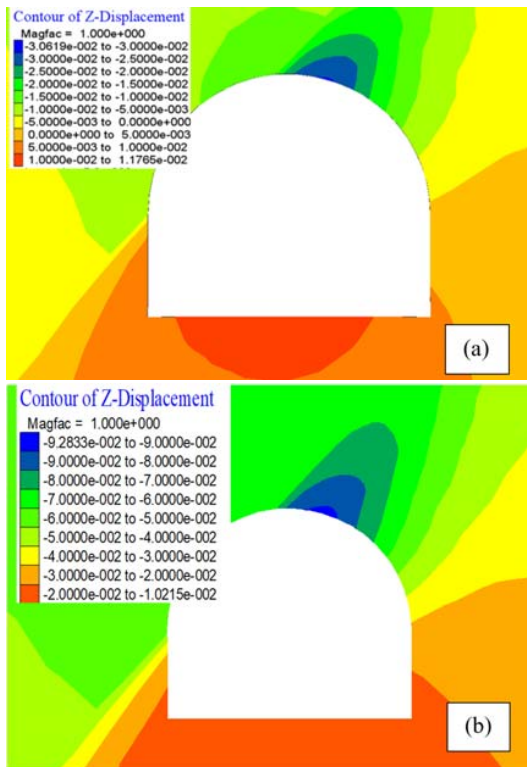
Fig. 7 shows the vertical displacements (in meters) of the model around the gallery. They are represented in the form of isovalues, so each colour is equivalent to an interval of displacements according to the legend that appears on each figure. They are negative when their direction is descending and positive when their direction is ascending (swellings).

The simulation shows displacements of 3 cm in the roof and swellings of 1 cm in the floor. These displacements increase to 9 cm and 2 cm respectively after the longwall exploitation.

Fig. 7 Vertical displacements: (a) during tailgate opening; (b) during longwall exploitation

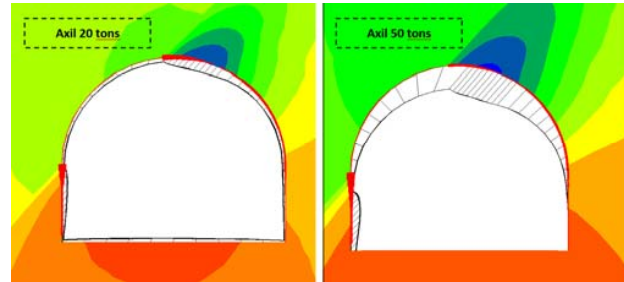
Fig. 8 shows the axial efforts over the support. The efforts go from 20 t before the exploitation until 50 t after the exploitation. In this figure, the geometric deformation of the gallery is represented in a magnified way. It can be noticed that in the intersection with the coal layer the deformation is bigger and this change in the deformation produces cracks in the shotcrete. In this case, less rigid and more flexible supports, as wood, have a better behaviour because they better absorb the deformations.

Fig. 8 Axial efforts over the support and tailgate deformation before and after the exploitation

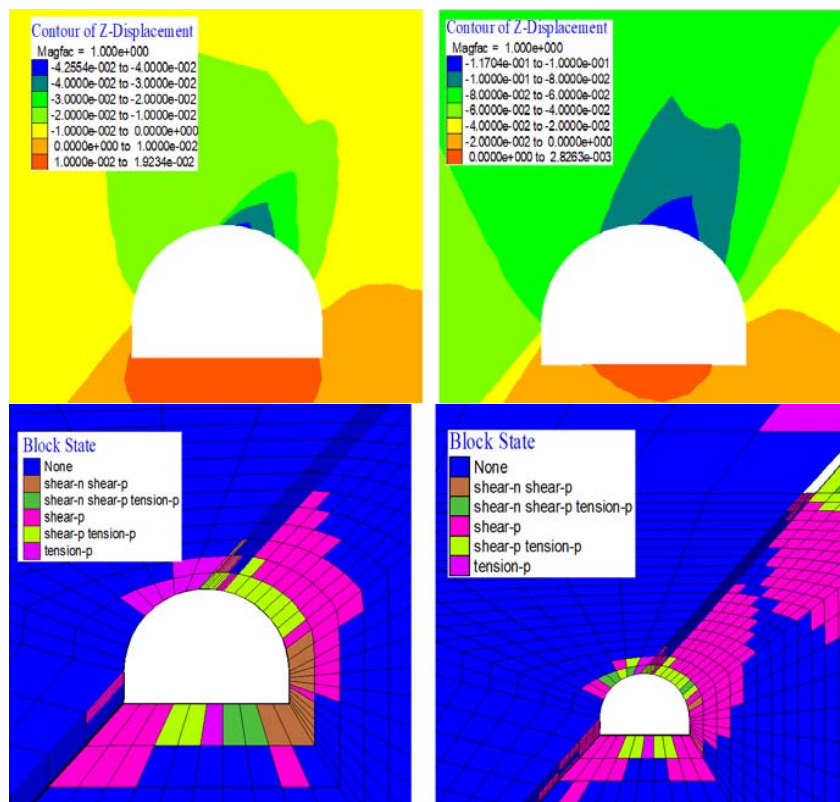
The bigger dimensions of the cross section produce an increase in the vertical displacements until 4 cm. Besides, a plasticized zone around the tailgate appears not only along the exploitation but also before it (Fig. 9).

Fig. 9 Vertical displacements and failure surrounding of the tailgate before and after the exploitation

Again, a change in the deformation appears in the intersection with the coal layer affecting the integrity of the shotcrete and producing cracks and detachments. The axial effort reaches the 24 t bigger than in the first case with one effort of 20 t.

After the exploitation, the displacements and the fractured surrounding increase in an important way and the support is overloaded until 60 t.

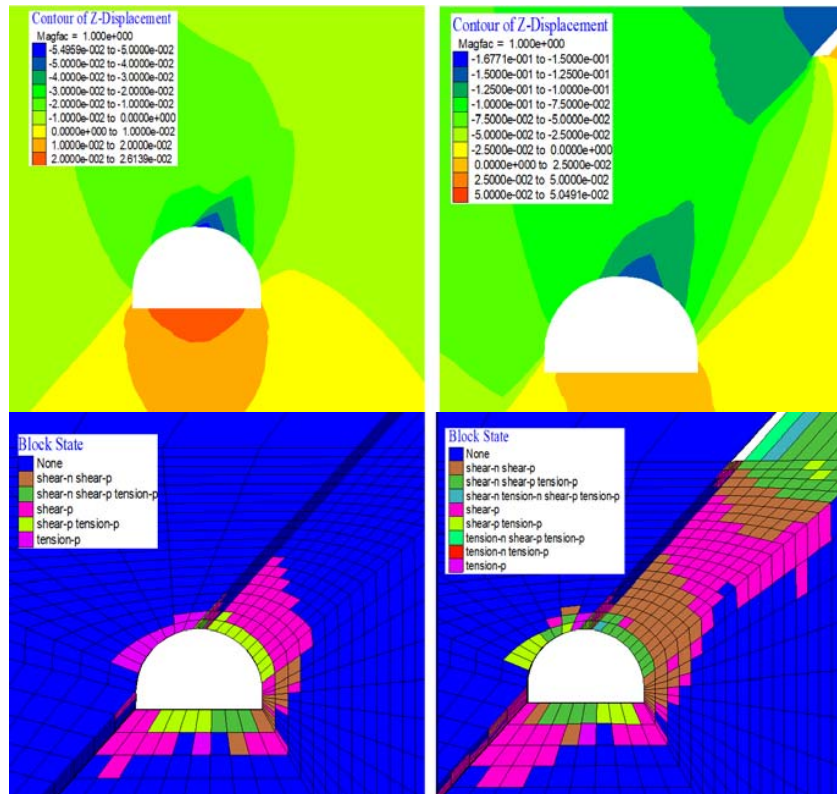
When the dimension of the tailgate is equivalent to the diagonal (14 m), the vertical displacements in the roof reach 5.5 cm and in the floor 2.5 cm. Again, is the wall of the layer the most affected placed with an increase in the fracturing and failure (Fig. 10).

Fig. 10 Vertical displacements and failure surrounding of the tailgate, before and after the exploitation for 14 m of diagonal

Once the workshop is exploited, the vertical displacements in the roof reach 15 cm, while the wall of the layer is totally plasticized between the tailgate and the workshop. There are very significant zones in the figure with a tendency to the break and/or landslide. This indicates that, if a landslide starts, it will take place in the wall of the layer and that the volume of involved material will be considerable, since the affected area has considerable grown compared to the previous situations.

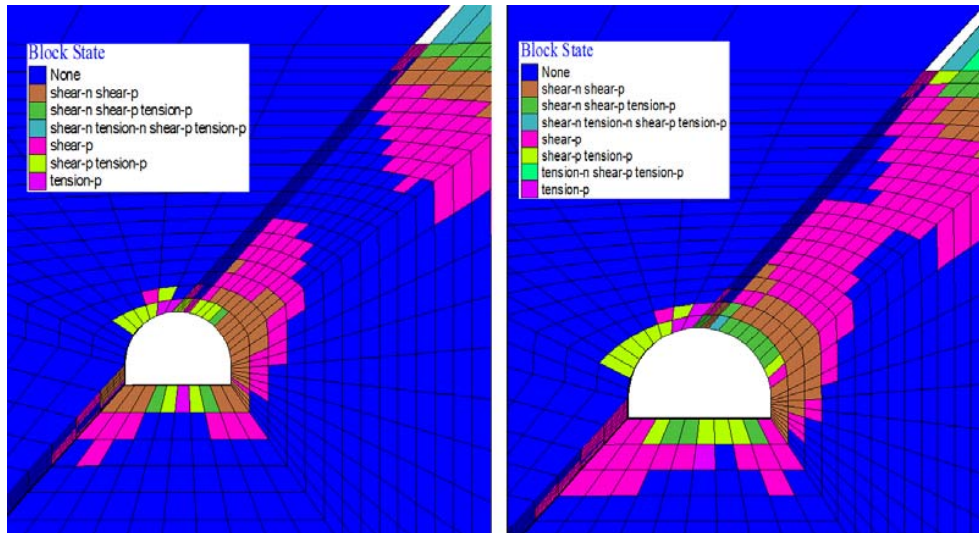
Protection pillars of 70 m could be suitable for gallery widths of up to 10 m (see Fig. 11), but they are insufficient when considering a gallery dimension equivalent to the

diagonal (14 m) because in this case, the plasticizing areas around the tailgate and the exploitation workshop appear again. On the other hand, with 80 m protection pillars, the plasticizing areas around the exploitation workshop and the tailgate are not connected (Fig. 12). Therefore, in case of one slide, it would be a local break in which the volume of material that can fall is much less and the support would

Fig. 11 Failure surrounding after the exploitation for 10 and 14 m and with protection pillar of 70 m

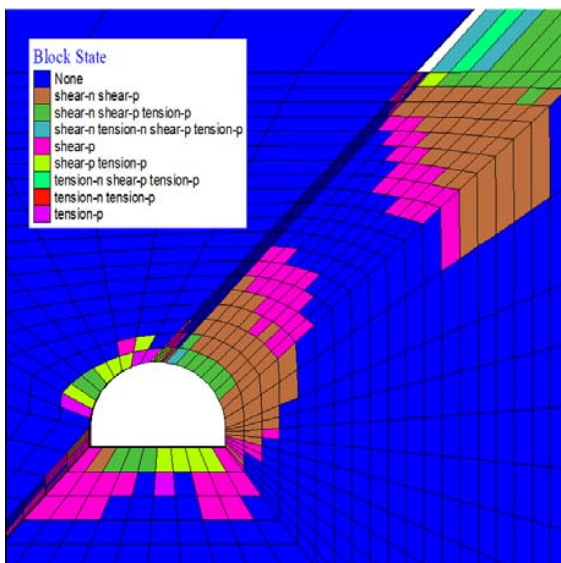
behave better. Based on these observations, it seems to be confirmed that the detachment was originated as a consequence of one sliding in the layer wall, due to the large roof span present in the place of the accident, and probably triggered as a consequence of the existence of a protection pillar insufficient.

Fig. 12 Failure surrounding after the exploitation for 14 m and with protection pillar of 80 m
