Analysis of Surface Spalling on a First Intermediate Roll in Sendzimir Mills

Abstract—A first intermediate roll of Sendzimir mills was failure by surface spalling during operation. After analyzing by visual, stereo microscope, optical microscope, scanning electron microscope, glow-discharged spectrometer and hardness test, respectively, the results show that some voids and cracks existed on the contact surface as well as subsurface. Further examination verified inadequate hardness and inclusions were responsible for the failure of surface spalling.

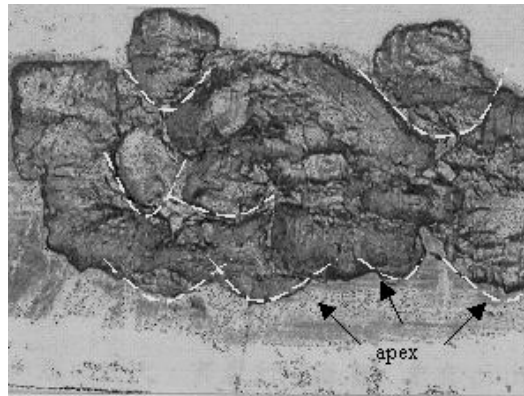
After visual and stereo-microscope observation, it is found that the spalling areas revealed by elongating along the axial direction of the roll and characterized with an "apex" tips, as indicated in Figs. 2 and 3. Meanwhile, there are some small pits and cracks existing on the surface which are located under the spalling areas, please see Fig. 4.

Fig. 3 A stereograph of the spalling area. (8X)

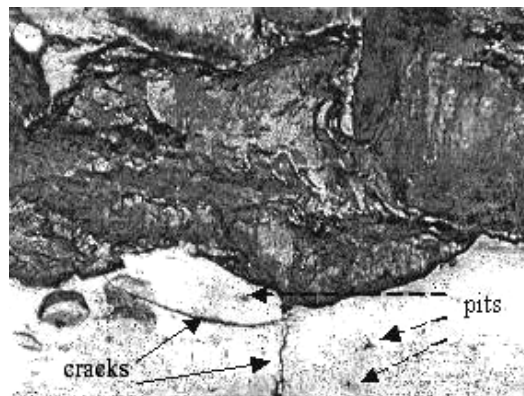
Fig. 4 The lower portion of the spalling area. (32X)

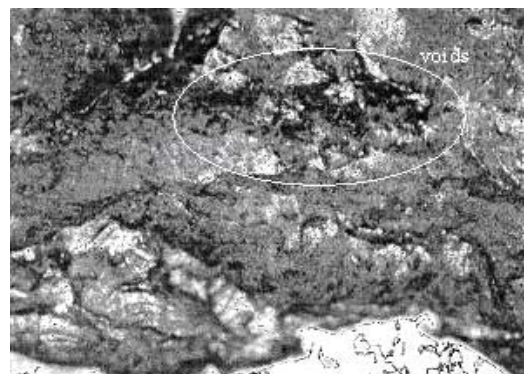
Fig. 5 A higher magnification of the spalling area. (64X)
