# Behavior of RC Buildings to Tsunami Action

Carlos H. Cuadra

**Keywords**—tsunami, RC buildings, East Japan Earthquake, seismic damage

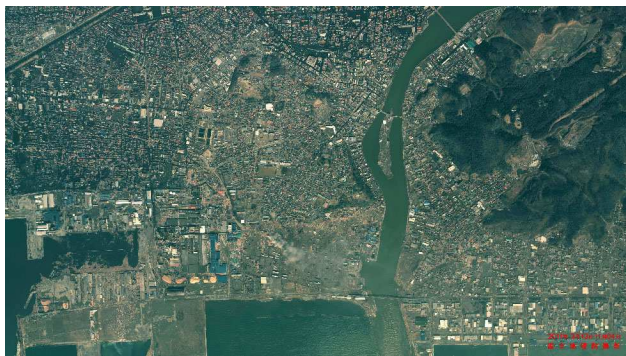
Fig. 2 Detail of Ishinomaki city port affected by the tsunami

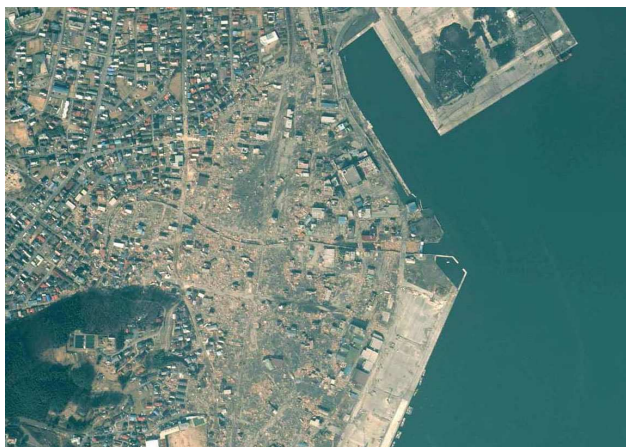
In Fig. 3 a portion of Ofunato city is shown. It is clear from the figure that only large building remains in the inundated zone while small building like wooden houses were washed up. These buildings were steel structures and reinforced concrete structures that resist the lateral forces originated by the inundation of the tsunami. In the left part of the Fig. 3, some intact constructions can be observed. These building are located on a high ground level that was not reached by the tsunami.

Fig. 3 Aerial photograph of Ofunato city after the Tsunami

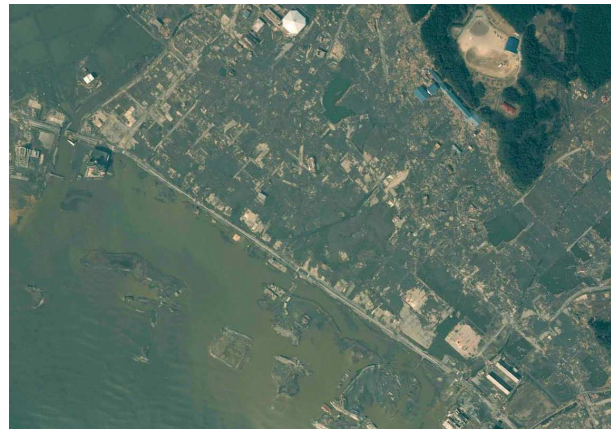
In Fig. 4 a portion of the aerial photograph of Rikuzentakata city can be observed. Near the coast line only few buildings remained after the tsunami attack. The behaviour of the buildings located in the left part that was a hotel and the buildings of the right lower side which correspond to apartment buildings is described in the next section. It can be observed that the tsunami destroyed first a sea wall and now the sea water reaches the road that can be observed as a straight line from the left to the right lower corner. On the right upper corner by observing the color of the vegetation the limit of the inundation area can be inferred. This place corresponds to a high ground level where a school building is located. These school facilities are now used as shelter zone.

Fig. 4 Aerial view of Rikuzentakata city after the tsunami

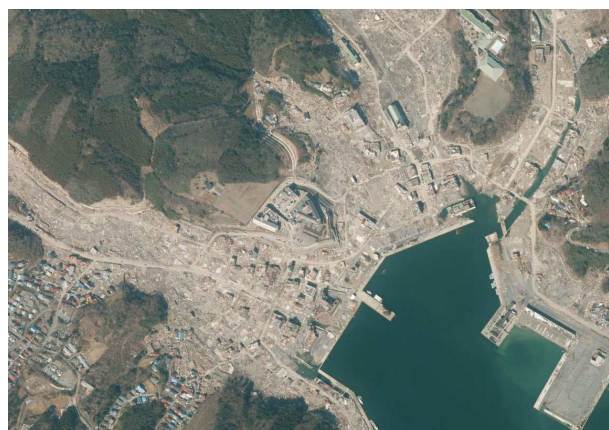
Fig. 5 shows the condition of Onagawa town after the tsunami damage. In this aerial view it is possible to identify clearly the zones of high ground level by observing the condition of the vegetation. As can be observed in the figure, the area between the sea line and high ground level is narrow, and therefore the tsunami reached high inundation depths. This high level of water and poor soil condition originated the overturning of some RC buildings which is described in the next section.

Fig. 5 Aerial view of Onagawa city after tsunami inundation

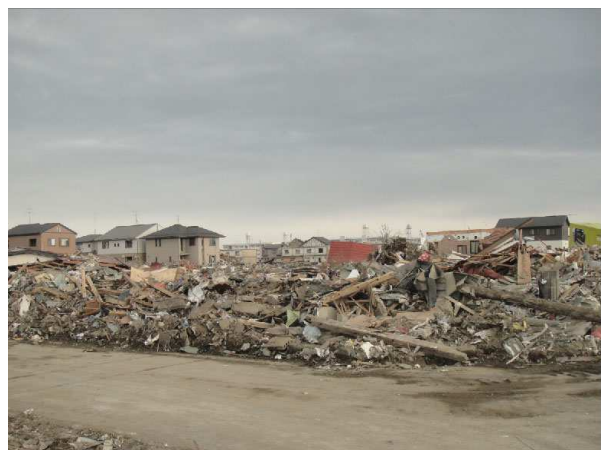
In Fig. 7 to Fig. 10 some typical damages on wooden houses that were produced by the tsunami are shown. In Fig. 7 it can be observed that wooden houses were completely destroyed by the tsunami action. It can be also observed that houses located on high sites are not affected.

Fig. 7 General damages of wooden houses

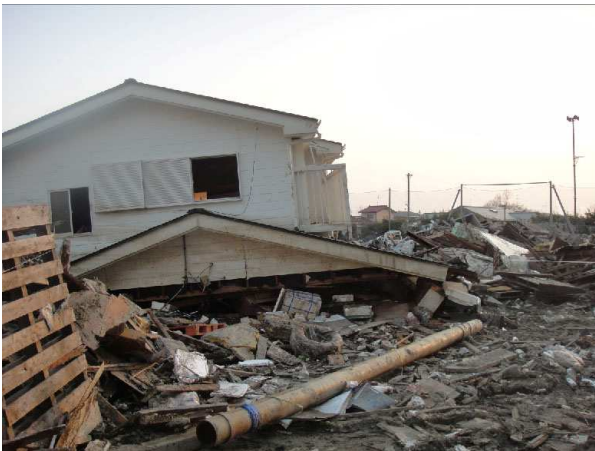
Fig. 8 Failure of the first floor

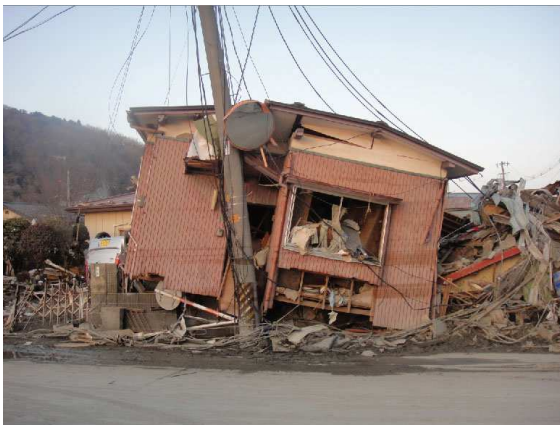
Fig. 9 Transportation of the upper floors

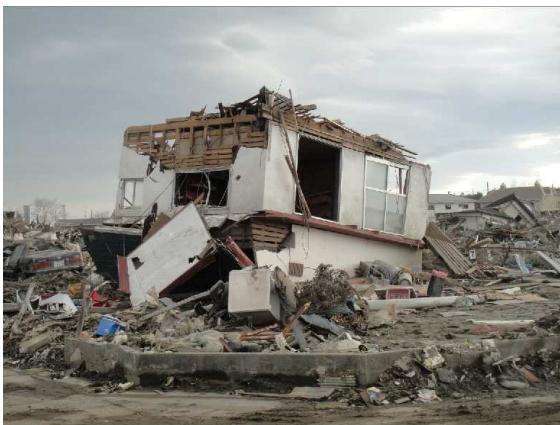
location. In the case of Figure 10(d) the tsunami destroyed the first floor and also produced the overturning of the remaining upper floor.

Fig. 10 Over turning of upper floors

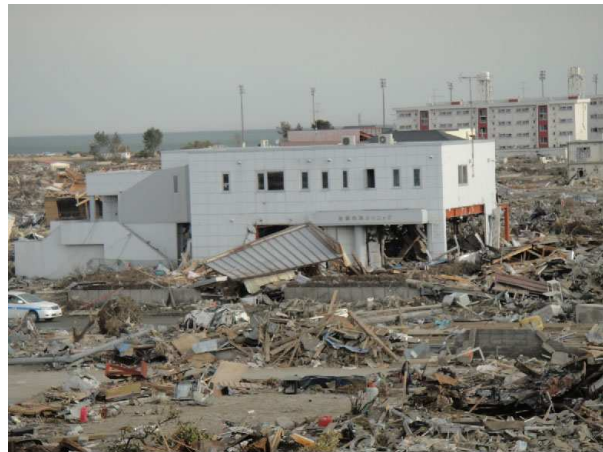
Damages on Steel structures can be observed in Figures 11 to 14. When the inundation depth reaches only the first floor the structure remains almost intact however the wall panels of the first floor suffer some damages as can be observed in Fig. 11. In Fig. 12 and Fig. 13 the inundation depth reached the second floor and wall panels and ceiling are destroyed. In this case the structures remain stand up however some local failure of the structural elements were observed. Fig. 14 shows a total collapse of steel structures. In this case the building was completely covered by the water.

Fig. 11 Steel structure almost intact

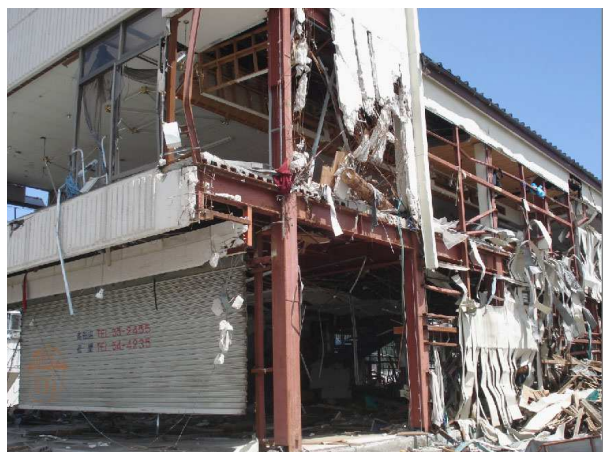
Fig. 12 Destruction of panels

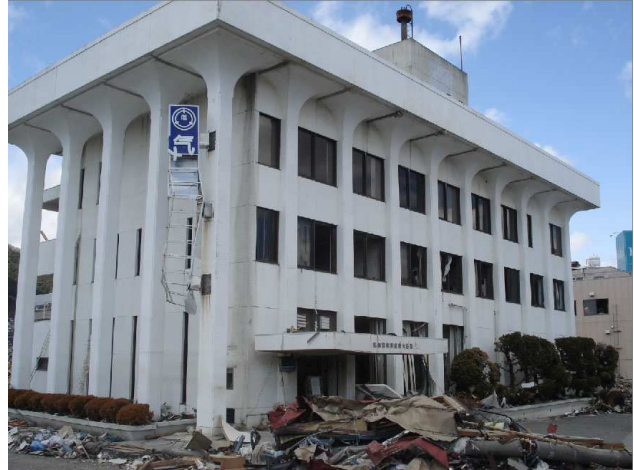
Fig. 15 RC building (Ofunato city)

Many reinforced concrete structures resisted the tsunami action without collapse as can be observed in Figures 15 to 20. Fig. 15 shows the building of a local bank located at Funato city. It can be observed from the damages of the windows and the damage of the advertisement panel of the left corner of the building that the tsunami reaches the third floor.

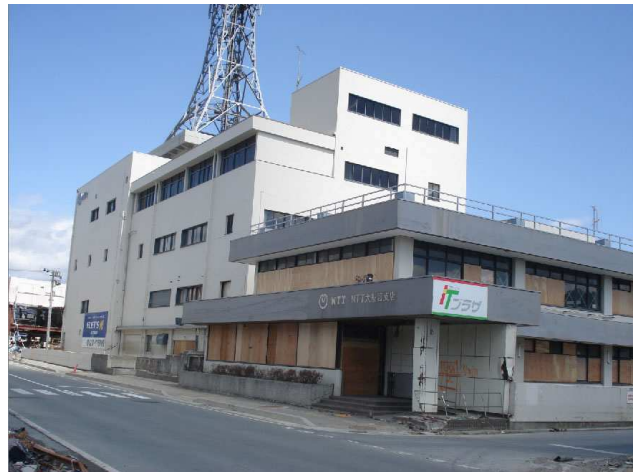
Fig. 16 Two story RC building

In Fig. 16 it is also inferred that the tsunami covered the second story of the building by observing that the windows glasses were destroyed and now are replaced by wood panels.

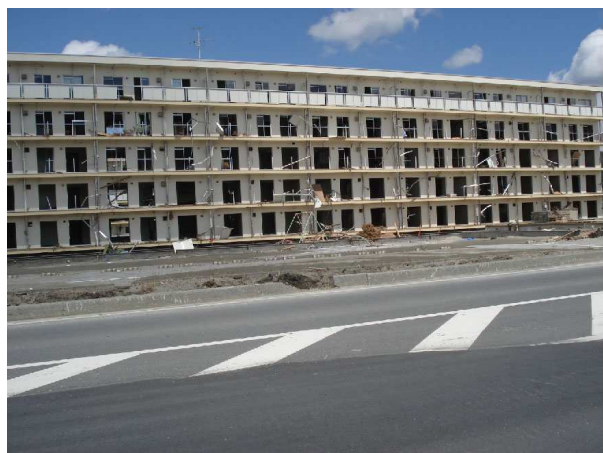
Fig. 17 shows an apartment building located at Rikusentakata city and from the damages of the balconies it is inferred that the tsunami reaches the fourth floor. Detailed of the damages of the balconies can be observed in Fig. 18, where the panels of the balconies of the fifth floor are intact while the panels of the lower floors are completely destroyed.

Fig. 17 Building at Rikusentakata city

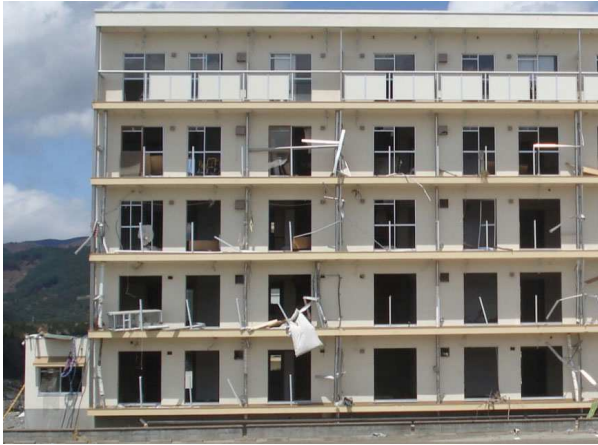
Fig. 18 Detail of damages on balconies

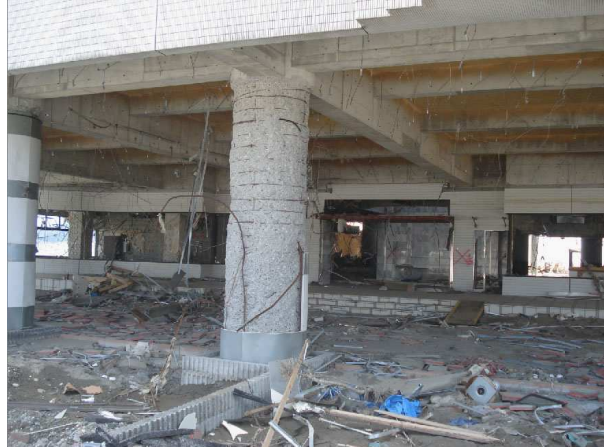
Fig. 20 Detail of RC columns

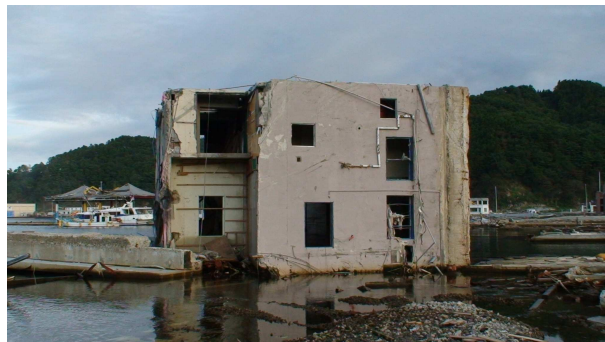
Fig. 21 shows an overturned 3-story building with a shape of box and few openings. This building was completely covered by the tsunami water and as it is shown in Fig. 22 it has a shallow slab foundation that together with the shape of the building facilitates the action of the floating forces.

Fig. 21 Overturning of RC building

If reinforced concrete buildings are intended to be used as refuge, buildings of more than four floors or more than 15 meters are recommend. It is also important to check the condition of the foundation of the structures that are designated as refuge since the failure of the foundation could originate the overturning of the building. Additionally, this selected building must be verified to resist some impact forces or in any case must be located in places where the impact of displaced ships or other building can be avoided.

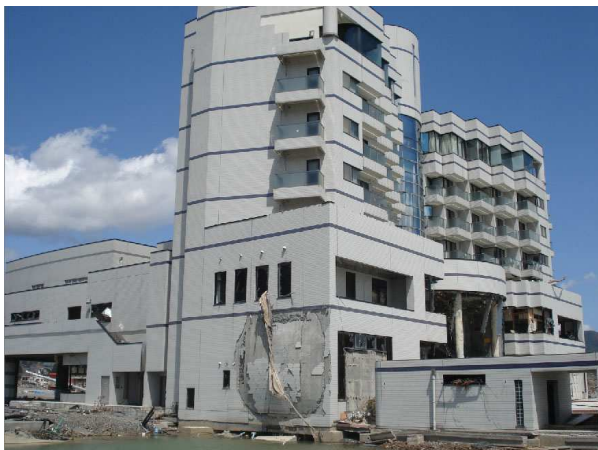
Fig. 19 and Fig. 20 show the condition of a hotel building located very near the shoreline in Rikuzentakata city. The building resists the tsunami attack however the lower floors suffered the destruction of the non-structural elements and also, as it is observed in the Fig. 19, the building suffered the damage of a reinforced concrete wall due to the lateral water pressure. In this building it was also observed that the cover concrete of structural elements of columns was spall-out probably due to a combination of earthquake vibration action and posterior tsunami as can be observed in Fig. 20

Fig. 19 RC building hotel

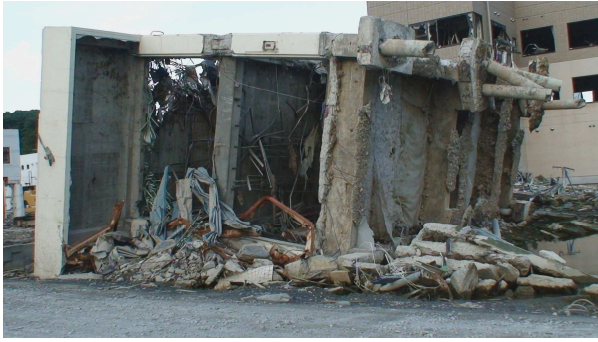
Fig. 23 shows the overturning of a 2-story building with exposition of the pile foundation. The use of piles for lower rise buildings indicates the poor quality of the foundation ground. On the other hand in the Fig. 24 it can be observed that the building has suffered the impact of some body (probably a ship) that could originate the overturning of the building.

Fig. 23 Collapse of 2 story RC building

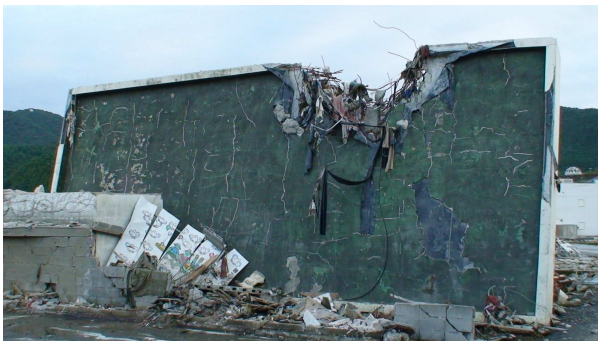
Fig. 24 Detail of impact on the building
