# Causes of Rotor Distortions and Applicable Common Straightening Methods for Turbine Rotors and Shafts

Esmaeil Poursaeidi, Mostafa Kamalzadeh Yazdi

**Key words**—Distortion, FEM, Hot Spot Area, Rotor Straightening

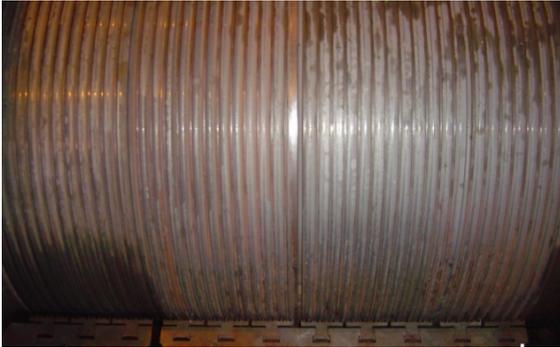
localized thermal expansion and the resultant rotor bend increases the pressure and extent of rubbing in a progressive and unstable manner (Fig. 1). The local thermal expansion is restricted by the cooler bulk of the rotor and an axial compressive stress is thereby set up in the area of the rub. At the same time the local friction lead to reduce the local yield stress by temperature increase, and compressive yielding eventually takes place. Local softening or hardening of rotor body is occurs. The rubbed zone is now permanently displaced leading to a reversed bend when the rotor finally cools to a uniform temperature.

Fig. 1 Effects of rubbing on rotor surface

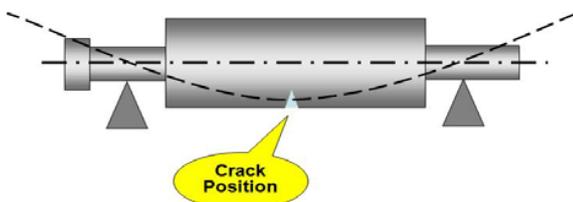
Transverse cracking in rotors can be initiated at surface stress concentrations by corrosion, pitting, thermal fatigue (starts related), or by high cycle fatigue due to self weight rotating bending stresses (Fig. 2). Transverse crack propagation is eventually driven by the bending stresses and this phase can take place over time scales in years. Because they do not directly affect the balance of a rotor, such cracks will not have much effect on normal vibration levels until they occupy a significant portion of the rotor cross section (e.g. 25%). Large cracks can have a sufficient effect in changing the compliance (transverse stiffness) of a rotor that clearances are lost and then rubbing, followed by the bending mechanisms described above takes place.

Fig. 2 Schematic of bending due to cracking

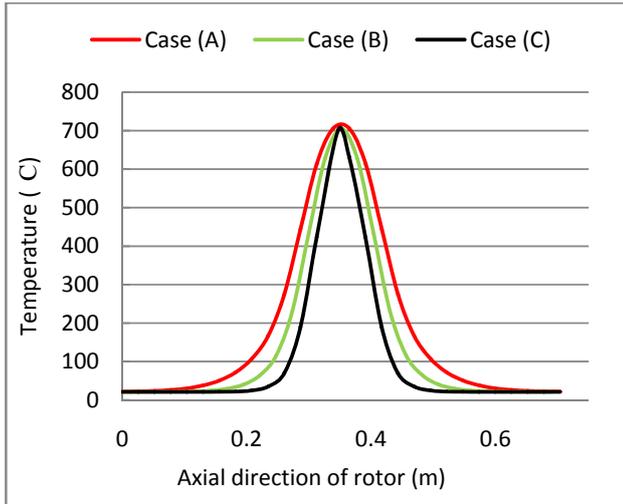
Simulation of hot spotting with three different hot spot areas and heat fluxes was done. The graph of thermal distribution along axial direction of rotor (Fig. 6) shows that the case (C) with the smallest hot spot area has the most thermal gradient between the hot spot area and its surrounding area which is ideal in straightening process but the amount of hot area (cherry red area) is too small to cause required bend. Also it shows that case (A) with the largest hot spot area has the least thermal gradient. The contour of plastic strain magnitude during hot spotting process for three aforementioned cases in Fig. 7 demonstrates that amount of plastic strain in case (A) is not enough to achieve required straightness. In contrast, magnitude of plastic strain in case (C) is the most rather than other cases which may cause some undesirable effects such as thermal shock and phase transformation of the rotor material. Therefore it is resulted that case (B) would cause the most satisfactory straightening effects.

Fig. 6 Thermal distribution along axial direction of rotor

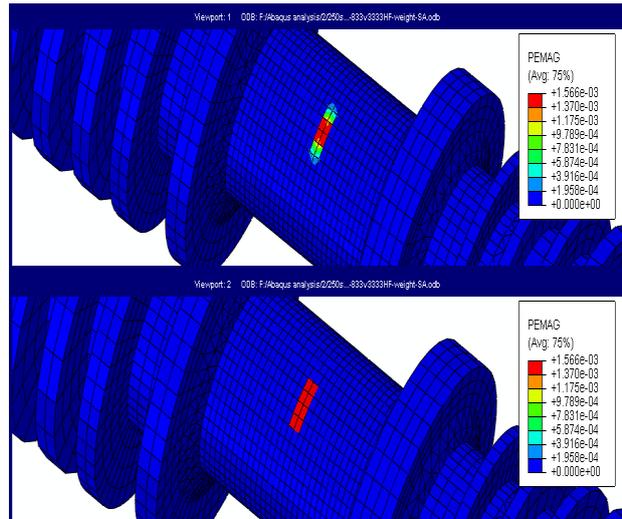
Fig. 8 Contour of plastic strain area at the temperature of (a) 705°C, (b) 750°C

Another simulation was done to investigate the effects of extra heating. Fig. 8 makes a comparison between the size of plastic area at two different temperatures of 705°C and 750°C. It illustrates that extra heating would significantly cause to develop the location of maximum plastic strain along the perimeter of the rotor. Yielding of the material through this large plastic area would contain extra energy to increase distortion of the rotor with no control. On the other hand, according to previous investigations exceeding permutation temperature will cause undesirable sequels on the material structure.

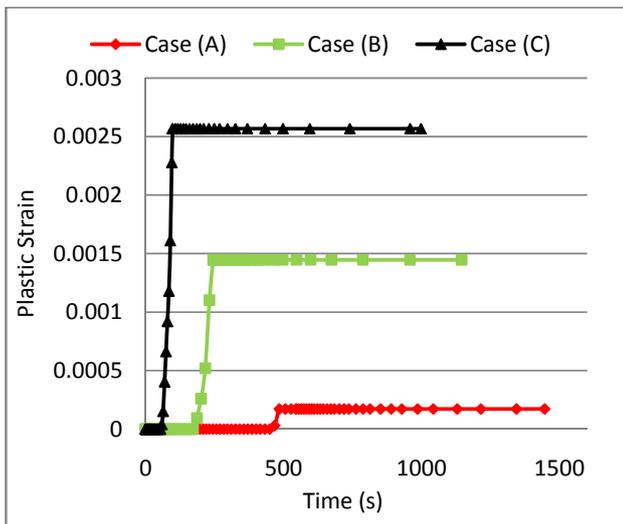
Fig. 7 Magnitude of plastic strain during hot spotting

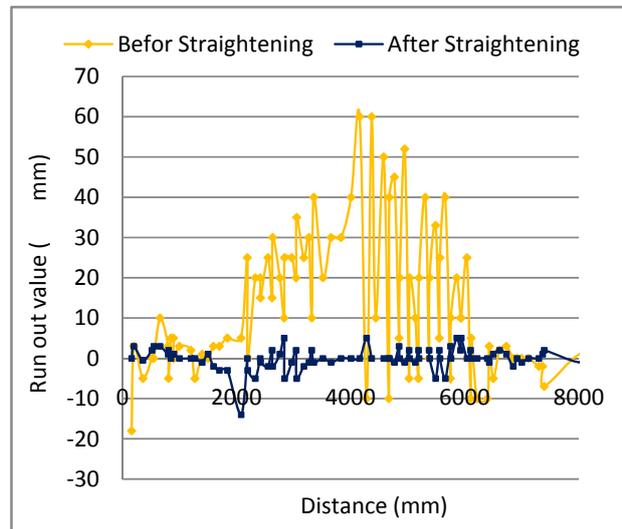
Fig. 9 Results of initial and final run out tests at an angle of 90°

A comparison between received experimental data from initial and final run out tests (Fig. 9) shows that performing the hot spotting execution according to simulated results, has been reduced the rotor eccentricity noticeably. Therefore we recommend using a numerical method before carrying out the selected straightening method.
