Condition Monitoring for Controlling the Stability of the Rotating Machinery

Abstract—In this paper, the experimental study for the instability of a separator rotor is presented, under dynamic loading response in the harmonic analysis condition. The global measurement and analysis of vibration on the cement separator RC500 is carried, the points of measurement used are radial dots, vertical, horizontal and oblique. The measures of trends and spectral analysis for reconnaissance of the main anomalies, the main defects in the separator and manifestation, the results prove that the defects effect has a negative effect on the stability of the rotor. Experimentally the study of the rotor in transient system allowed to determine the vibratory responses due to the unbalances and various excitations.

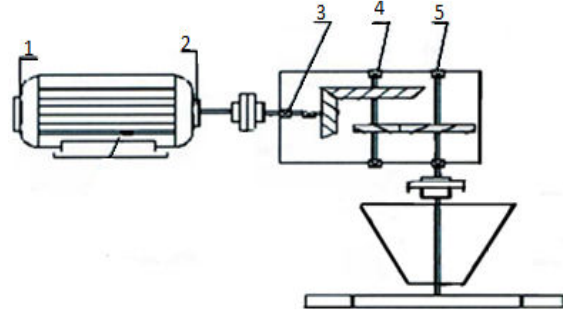
Fig. 3 Measuring points

We noticed that the vibration level by speed measurement in the bearings 02 and No. 03, in the alarm condition, requiring the intervention and the bearings 01 and No. 04 and 05 in alarm status but are acceptable and after the separator Z2 repair we noticed a reduction in the levels velocity and stabilization (correct state) in all bearings the trend curve and the spectrum defined defects in each measuring point.

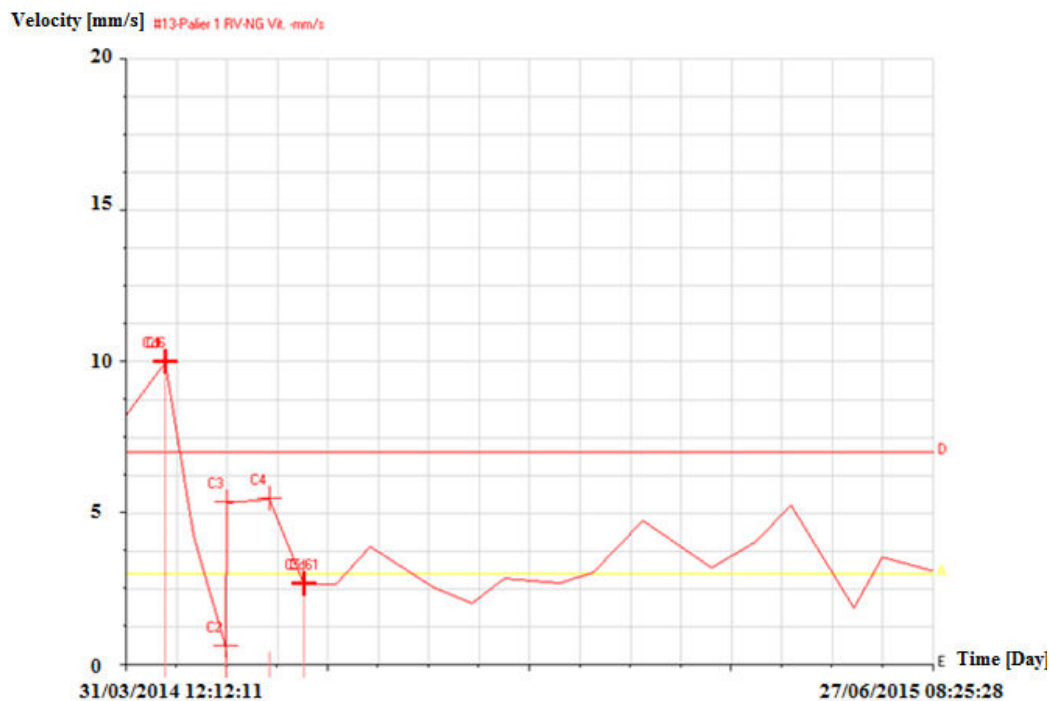
Fig. 4 Trend curve of bearing (01) RV-NG

The trend curve for the bearing N°01 (mm / s) is presented. There was an increase vibratory velocity level which exceeds the alarm threshold in point C4 (5.49 mm / s) which shows the presence of an anomaly, but we do not know their origin, after repair a speed decrease is observed with a reduction in (2.84 mm / s), for diagnosing the origin of the excess passes to spectral analysis.

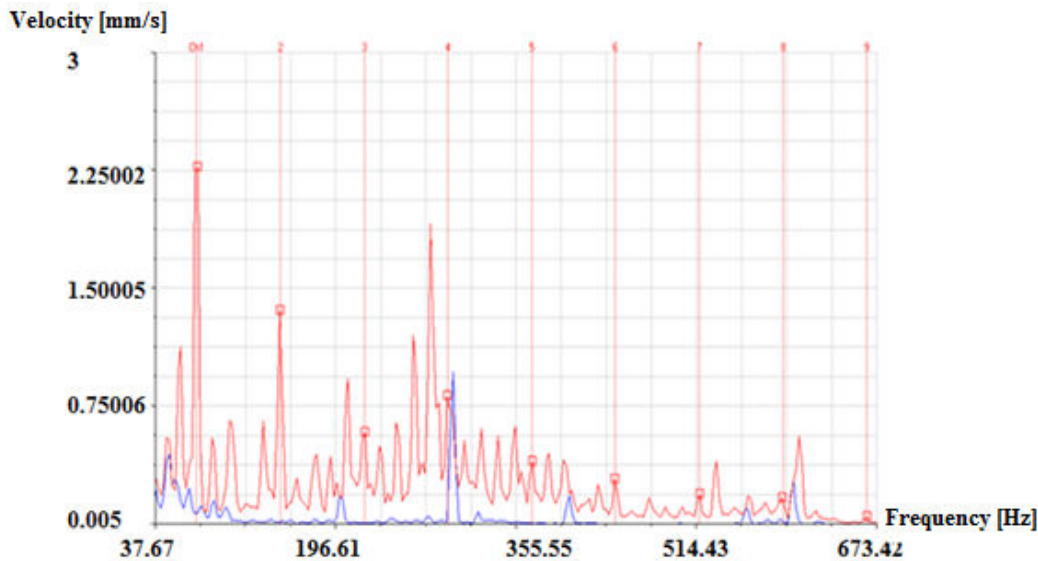
Fig. 5 Linear spectral image superimposed on bearing N°01 RV

■ : spectrum before repair → net level rise in speed
■ : spectrum after repair → net improvement in speed level

The spectral signature represents a net increase of vibrational amplitude level of speed (red spectrum) in the medium frequency domain, corresponds to the frequency value equal to 73.05 Hz, this value corresponds at the same time to the frequency internal bearing ring, which shows a fault bearing inner ring. The recommendation is to change the bearing N°01.

After the repair performed (change bearing) we notice (blue spectrum) a net decrease in the speed level (the fault disappears), which confirms the accuracy of diagnosis.

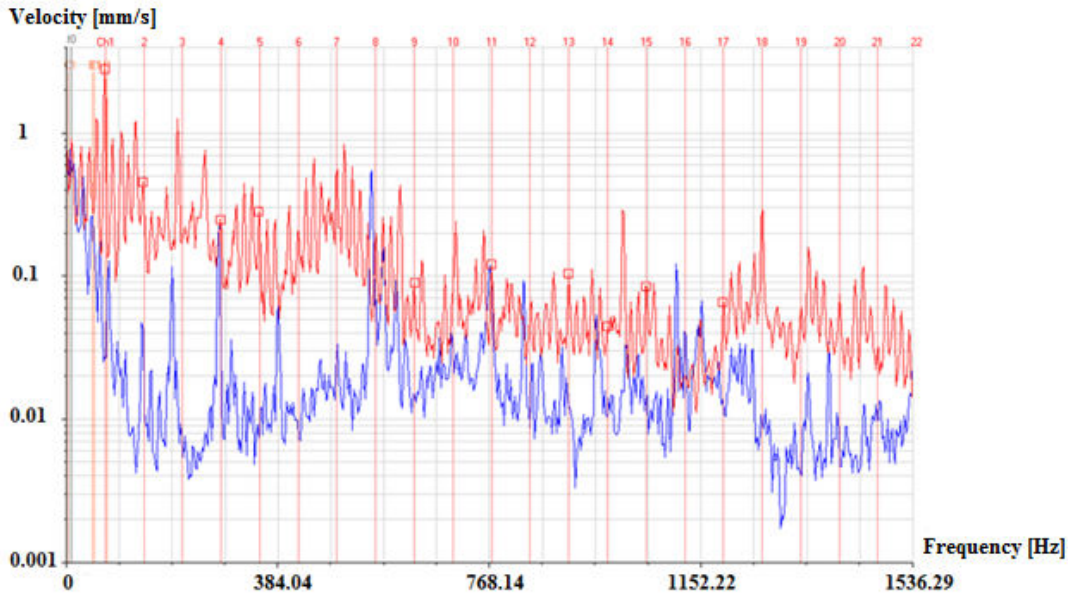
Fig. 8 Spectral Image logarithmic scale superimposed on bearing N°04 RO.

For the bearing N°04, According to the trend line oblique radial extent in remarks at point C2 (4.80 mm / s) an alarm threshold is exceeded, after repairing a decrease until Cd11 (1.86 mm/s), to diagnose original passes to frequency analysis.

The spectrum N°04 (mm/s) is given in Fig. 8. The spectral signature (red spectrum) represents a net increase of amplitude in the medium frequency domain corresponds to a frequency value equal to Ch1 = 70.15 Hz, this value corresponds to a discharge failure of the internal bearing ring.

The recommendations are changing the rolling bearing No 04. After the repair carried out (the gear change) we notice (blue spectrum) a net decrease in the speed level (the fault disappears), which confirms the accuracy of diagnosis.

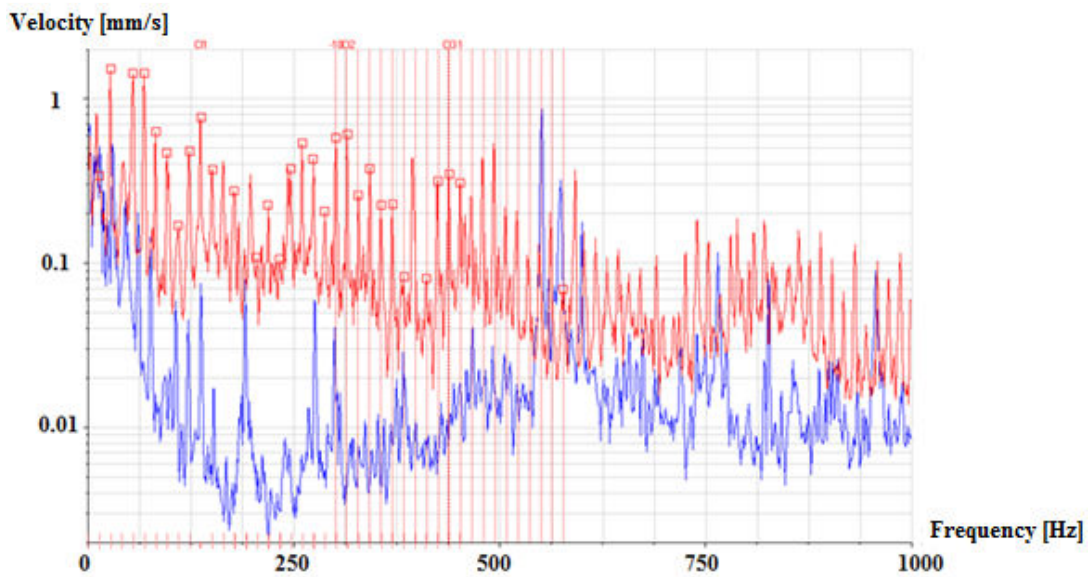
Fig. 9 Spectral Image superimposed on a logarithmic scale on bearing N°05 RO.

For the bearing N°05, According to the oblique radial extent of the bearing 05, we note that the point C2 (4.08 mm / s) an alarm threshold is exceeded, after repair decreased to C3 (1.86 mm / s) is observed. The spectrum of bearing N°05 (mm/s) is given in Fig. 9.

The spectral signature (red spectrum) represents a net increase of the average amplitude in frequency domain corresponding to a shock to the frequency of rotation of the motor on the bearing supporting the shaft of the separator.

The recommendation is changing the rolling bearing No 05. After the repair performed (the change bearing and gearbox) we notice (blue spectrum) a net decrease in the speed level (the fault disappears), which confirms the accuracy of diagnosis.
