# Diagnosis of Intermittent High Vibration Peaks in Industrial Gas Turbine Using Advanced Vibrations Analysis

Abubakar Rashid, Muhammad Saad, Faheem Ahmed

**Abstract**— This paper provides a comprehensive study pertaining to diagnosis of intermittent high vibrations on an industrial gas turbine using detailed vibrations analysis, followed by its rectification. Engro Polymer & Chemicals Limited, a Chlor-Vinyl complex located in Pakistan has a captive combined cycle power plant having two 28 MW gas turbines (make Hitachi) & one 15 MW steam turbine. In 2018, the organization faced an issue of high vibrations on one of the gas turbines. These high vibration peaks appeared intermittently on both compressor's drive end (DE) & turbine's non-drive end (NDE) bearing. The amplitude of high vibration peaks was between 150-170% on the DE bearing & 200-300% on the NDE bearing from baseline values. In one of these episodes, the gas turbine got tripped on "High Vibrations Trip" logic actuated at  $155\mu\text{m}$ . Limited instrumentation is available on the machine, which is monitored with GE Bently Nevada 3300 system having two proximity probes installed at Turbine NDE, Compressor DE & at Gen

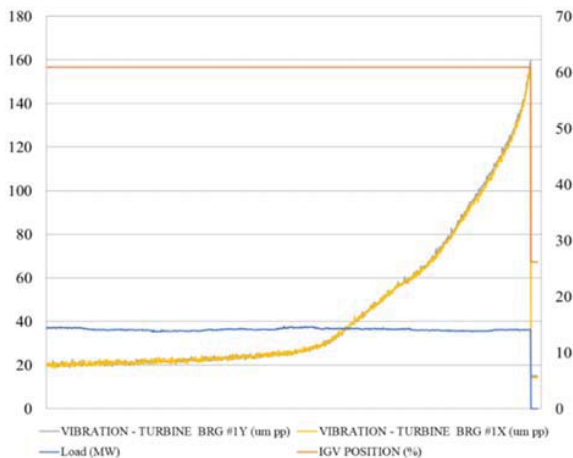
Fig. 2 (a) Bearing#01 vibrations trend against Load & IGV

ambient conditions etc. were trended to find any irregularity or deviation from the normal baseline data (as shown in Fig 2). The only observation was the gradual increase in Bearing#02 vibrations to  $76\mu\text{m pp}$  at the time when Bearing#01 cross the trip limit of  $155\mu\text{m pp}$ . No other anomaly was found in any of the other parameter during the analysis. After necessary checks by machinery, instruments & electrical teams, GT was successfully started again on 30th October, 2018 at 1350 Hrs.

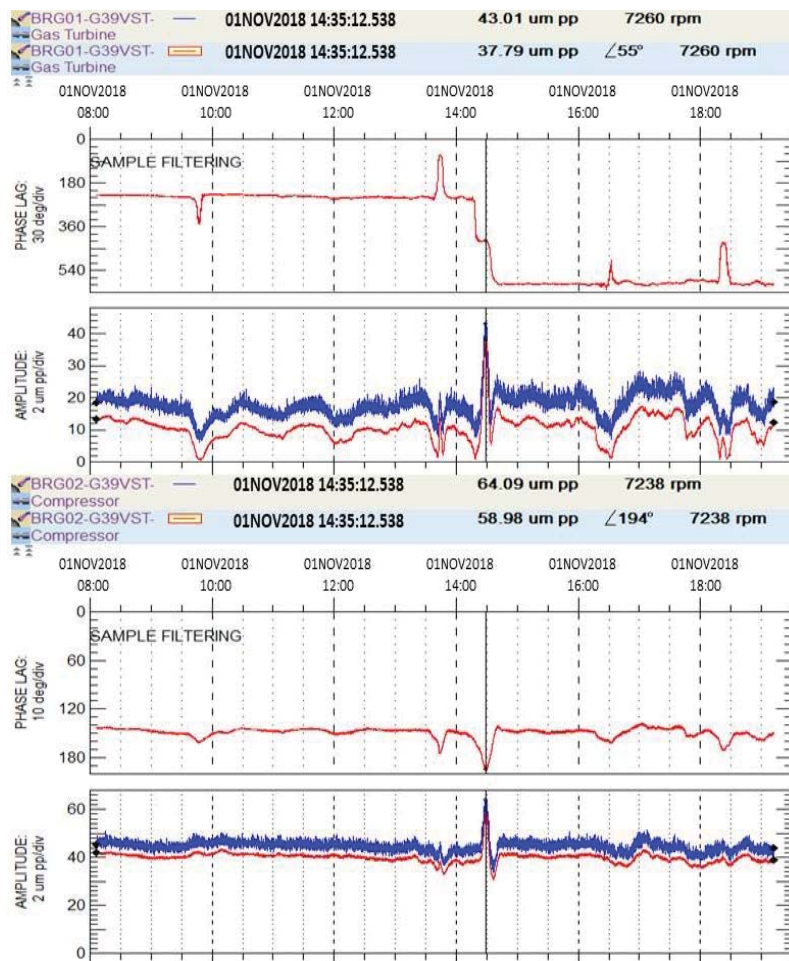
Fig. 4 (a) Time base trend of Bearing#01 & 02 with Phase angle

Vibration peaks was observed during steady state data recorded on 1<sup>st</sup> November 2018. Vibration peak was recorded at 1435hrs up to  $40.09$  &  $35.54\mu\text{m pp}$  at Turbine Bearing#01 against normal vibrations of  $22$  &  $24\mu\text{m pp}$  & at Turbine Bearing#02 up to  $64.09$  &  $58.98\mu\text{m pp}$  against its normal trend of  $43$  &  $45\mu\text{m pp}$ . As per vibration trend data, vibration peaks were observed to appear at different times & the peak lasted for duration of approximately 15 minutes (as shown in Fig. 3).

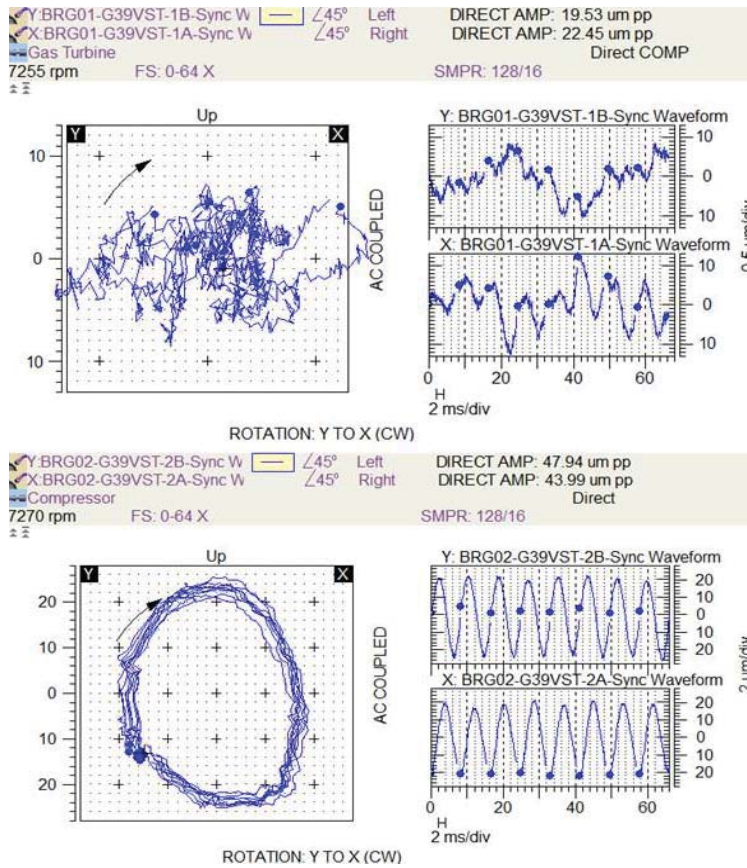
Fig. 4 (b) Orbit Plot of Turbine bearings showing rubbing symptoms at Bearing#01

Basic rotor dynamic theory [3] states that when rotating at constant speed, rotor synchronous response remains constant, both in amplitude & phase. The occurrence of phase changes at constant speed could be caused by several different things, including rubs between stationary & rotating parts, angular shift of shrink fit components, a crack propagating through the rotor. In this case almost all vibration change was observed at frequency of 1X Turbine rpm while significant change in 1X phase (up to full  $360^\circ$  rotation) was also observed at Bearing#01 which most probably corresponds to symptoms of rubbing [4] (as shown in Fig. 4). Also, as per shaft centerline plot, movement of rotor in horizontal plane was evident at Bearing#01 (as shown in Fig. 5)

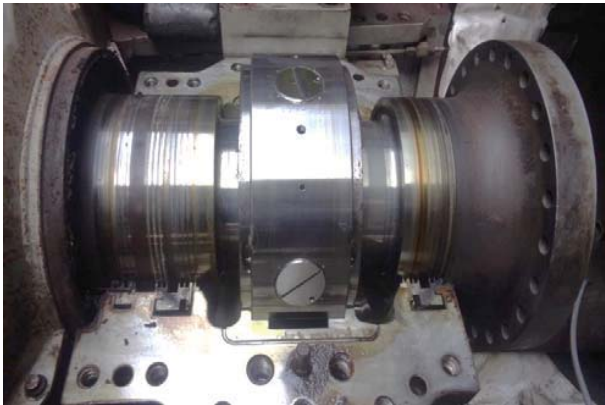
As per diagnosis using advanced vibrational analysis, rubbing symptoms at Bearing#01 were evident [7] although its severity & actual rotor health could not be exactly predicted. Due to this a confident decision could not be made to continue operations with turbine as this could have led to a major failure & would result in larger downtime & hence both production loss & costlier maintenance. So based on recommendations of advanced vibrational analysis, it was decided to inspect & replace the Journal Bearing#01 located at turbine's non-drive end. In parallel, inspection of Bearing#02 (thrust & journal) was also planned installed at compressor's drive end. Historically Bearing#01 usually operates at lower vibrations as compared to Bearing#02 & had earlier no issues so this was the first time this bearing was going to be inspected & replaced since the commissioning of turbine back in 2009. The Bearing#02 had already been replaced in 2016. Access to Bearing#01 was more difficult than the Bearing#02 due to the opening of annular diffuser casing bolts from inside of Bearing#01 tunnel. After getting access, Bearing#01 pedestal's upper half was removed & initial as-found observations were taken before removing the

Fig. 6 Bearing#01 with housing upper half removed

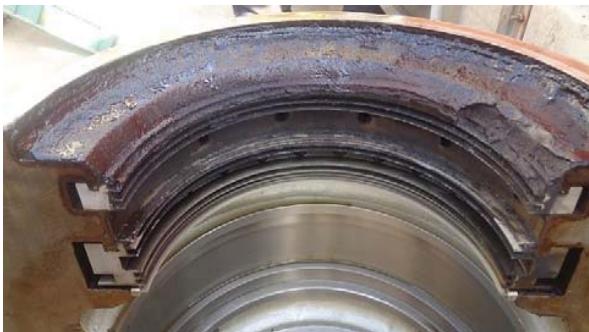
At Bearing#01, two labyrinth seal sets installed in the bearing housing each on forward & after side. In the forward side labyrinth seals clear rubbing marks were present, covering around 25 degrees in the inner radius of bearing housing. The bearing pedestal end & labyrinth seal close to turbine side had excessive coke deposition. A layer of coke varying in thickness from 5 mm on outer radius to 2 mm on inner radius was formed on the forward side bearing pedestal face. The cavities of the first set of labyrinths were completely choked because of heavy coke deposition. This coke was brownish black & was hard but not tough. There was a small area from that layer where coke was removed showing signs of an impact load (as shown in Fig. 7). Coke deposition was also observed on the after-side labyrinth seals, but the severity of deposition was comparatively less. However, the mechanical integrity & geometric profile of labyrinth seals were intact & they were installed back after thorough cleaning followed by inspection.

Fig. 7 Heavy coke deposition, rubbing marks on Bearing#01 housing

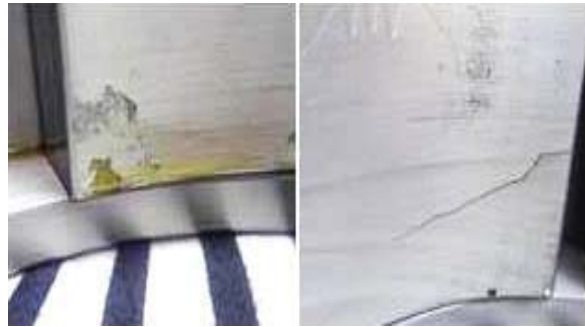
Two out of three shoes in the upper half of the bearing had symptoms of damage on the Babbitt layer. One shoe had a crack on the Babbitt while the other had pitting across its ends (as

shown in Fig. 8). The two shoes in lower half of the bearing had signs of rubbing, oil patches & Babbitt discoloration. The observations on the Bearing#01 pads were quite usual for a bearing with equivalent operating hours of more than eighty-

Fig. 8 Pitting and cracks on Babbitt layer of Bearing#01

After thorough cleaning & following the all quality hold points, new bearing was installed at location. Quality check measurements like semi height, bearing crush & radial clearance were also taken. The radial clearance of bearing was maintained at 0.45mm (shaft journal OD: 184mm). Bearing#02 was also inspected & did not have excessive coke formation like Bearing#01. The radial Bearing#02 at the driving end had minor signs of rubbing & oil marks. Its condition was comparatively better but replaced with new one with the top clearance of 0.40 mm. The thrust bearing was healthy & installed back after quality checks & inspection. Before final box-up, cooling & sealing air lines were thoroughly blown with instrument air to remove any suspected choking & installed back.

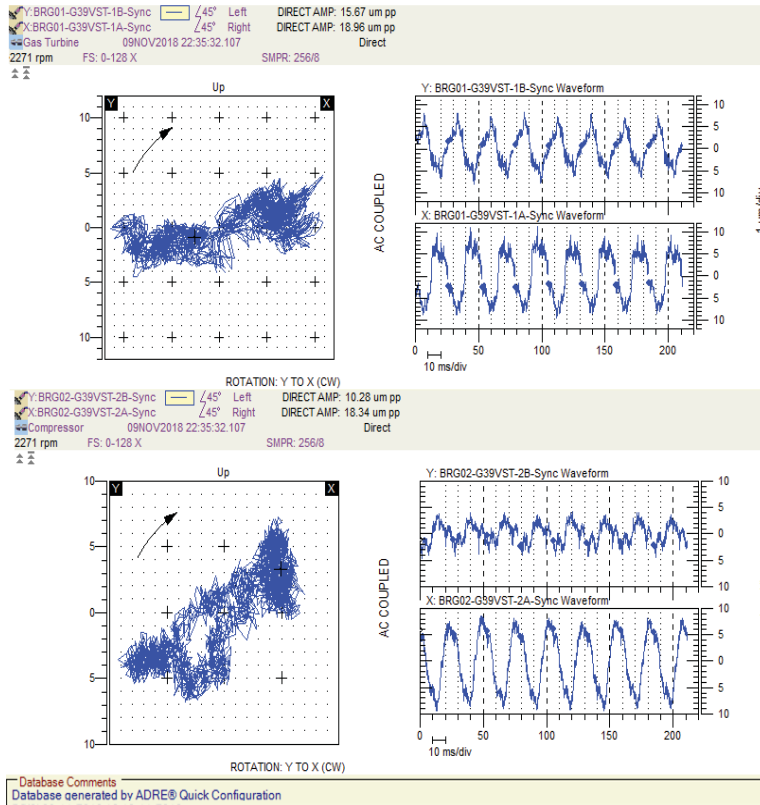
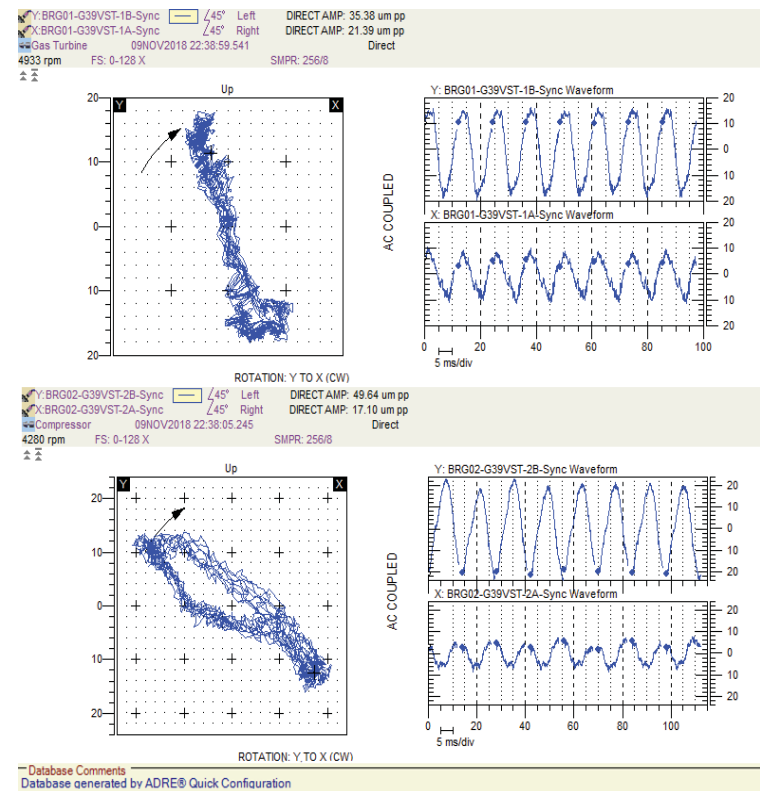
directly related to increasing machine speed, therefore unbalance was not suspected as the cause of vibration & the 1X vibration most probably was related to shaft bow condition during the machine start up. Orbit plots were found indicating 1X orbits & remained highly flat/elliptical throughout speed range from 2000 rpm to 5000 rpm (as shown in Fig. 9) suggesting possible rub during coast up. At operating speed i.e.

Fig. 9 (a) Orbit plot of turbine bearings at 2271 rpm

Fig. 9 (b) Orbit plot of turbine bearings at 4933 rpm

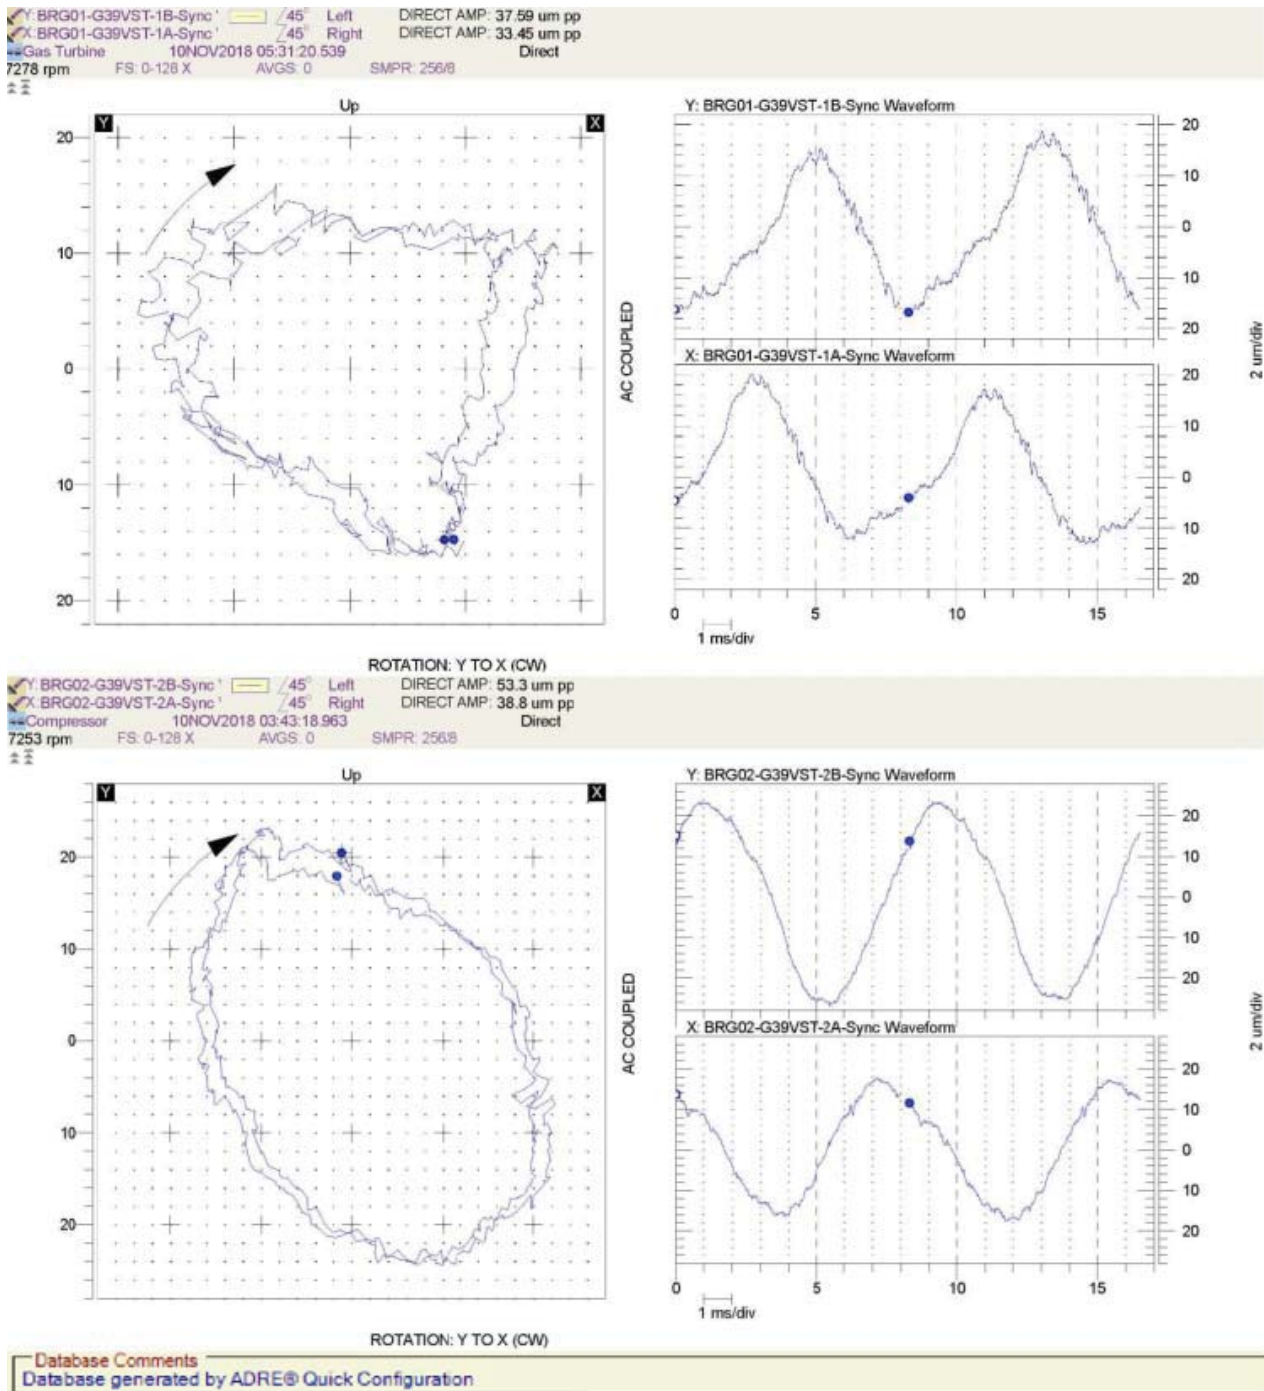
Fig. 10 Orbit plot of turbine bearings at 7278 rpms

7272 rpm no such observation was found in 1x orbit plots (as shown in Fig. 10). As per Shaft center line plots, maximum shaft vertical upward movement of 134 microns was observed at Turbine NE Bearing#01 when machine was loaded from FSNL to 21 MW, which was within bearing clearance boundaries (as shown in Fig 11).

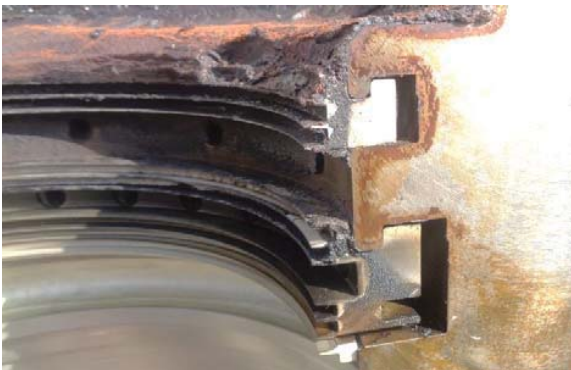
In the subject case puddle formation was observed in the labyrinth of the bearing housing (as shown in Fig. 12). Puddles form from high surface to volume ratio of lube oil layers & by long residence time of oil in a cavity. Physically it's in form of thick chunks of varying size & hardness depending on the age of coking. Its surface texture varies from shiny to matte like finish.

Coking phenomena occurs because of continuous exposure to elevated temperatures and long oil residue time of oil. Operational factors such as hot shutdowns can influence coke formation. Similarly, obstructions to flow or directional changes in lube oil path cause reduction in flow rate & increase the oil residence time.

Fig. 12 Physical texture of Coke puddles

Although coke formation is more of an aging phenomenon and be addressed by timely planning the maintenance of components exposed to lube oil circuit, there are some design phase measures to prevent this from happening. One technique is to introduce scavenge or vent lines in the gas path, this can significantly reduce deposits. Secondly, some coking tests have demonstrated powerful predictive capability and are essential during oil formulation and development phases of lubrication

oils. The cooling and sealing air lines towards bearing housing also to be checked and blown away to remove any suspected choking.

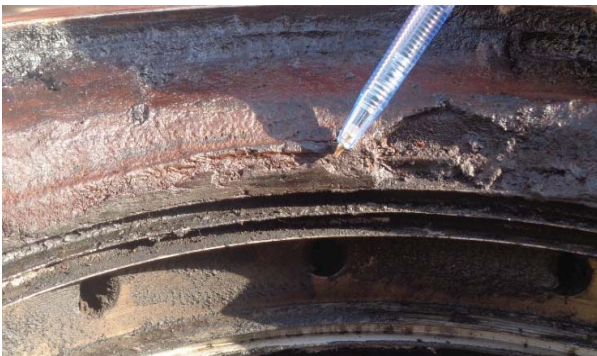
build-up of deposits resulting in localized reduction in seal clearance. Carbon deposits may be formed if lubricating oil comes in contact with high temperature causing oil to overheat. This may cause intermittent contact of rotor with deposits resulting in high vibration which tends to become normal upon clearance of deposits; however, vibration cycle may be repeated upon formation of new deposits.

Fig. 13 Shedding of coke deposits after getting rubbed
