# Diagnosis of Intermittent High Vibration Peaks in Industrial Gas Turbine Using Advanced Vibrations Analysis

Abubakar Rashid, Muhammad Saad, Faheem Ahmed

**Abstract**— This paper provides a comprehensive study pertaining to diagnosis of intermittent high vibrations on an industrial gas turbine using detailed vibrations analysis, followed by its rectification. Engro Polymer & Chemicals Limited, a Chlor-Vinyl complex located in Pakistan has a captive combined cycle power plant having two 28 MW gas turbines (make Hitachi) & one 15 MW steam turbine. In 2018, the organization faced an issue of high vibrations on one of the gas turbines. These high vibration peaks appeared intermittently on both compressor's drive end (DE) & turbine's non-drive end (NDE) bearing. The amplitude of high vibration peaks was between 150-170% on the DE bearing & 200-300% on the NDE bearing from baseline values. In one of these episodes, the gas turbine got tripped on "High Vibrations Trip" logic actuated at  $155\mu\text{m}$ . Limited instrumentation is available on the machine, which is monitored with GE Bently Nevada 3300 system having two proximity probes installed at Turbine NDE, Compressor DE & at Gen

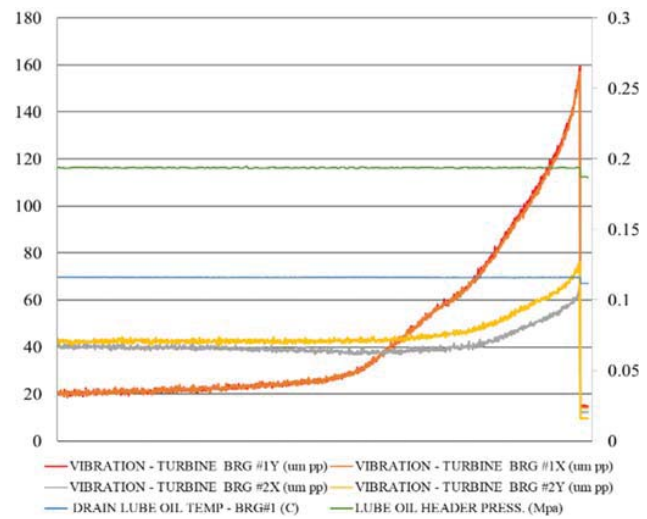
Fig. 2 (b) Turbine Bearings vibration trend against Lube oil drain temperature & header pressure

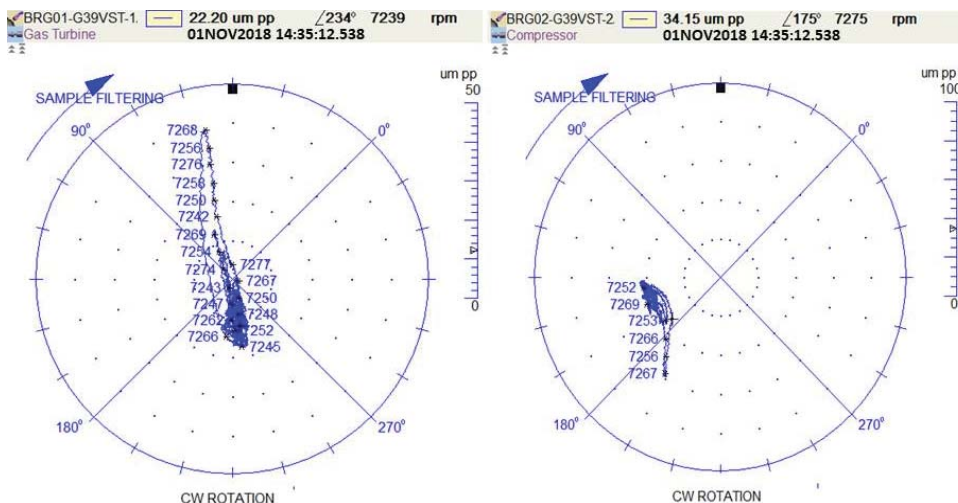
Basic rotor dynamic theory [3] states that when rotating at constant speed, rotor synchronous response remains constant, both in amplitude & phase. The occurrence of phase changes at constant speed could be caused by several different things, including rubs between stationary & rotating parts, angular shift of shrink fit components, a crack propagating through the rotor. In this case almost all vibration change was observed at frequency of 1X Turbine rpm while significant change in 1X phase (up to full  $360^\circ$  rotation) was also observed at Bearing#01 which most probably corresponds to symptoms of rubbing [4] (as shown in Fig. 4). Also, as per shaft centerline plot, movement of rotor in horizontal plane was evident at Bearing#01 (as shown in Fig. 5)

Fig. 4 (c) Polar Plot of Turbine bearings showing phase change of almost 360° at Bearing#01
