Failure Analysis of a Medium Duty Vehicle Leaf Spring

Gül Çevik

Abstract—This paper summarizes the work conducted to assess the root cause of the failure of a medium commercial vehicle leaf spring failed in service. Macro- and micro-fractographic analyses by scanning electron microscope as well as material verification tests were conducted in order to understand the failure mechanisms and root cause of the failure. Findings from the fractographic analyses indicated that failure mechanism is fatigue. Crack initiation was identified to have occurred from a point on the top surface near to the front face and to the left side. Two other crack initiation points were also observed, however, these cracks did not propagate. The propagation mode of the fatigue crack revealed that the cyclic loads resulting in crack initiation and propagation were unidirectional bending. Fractographic analyses have also showed that the root cause of the fatigue crack initiation and propagation was loading the part above design stress. Material properties of the part were also verified by chemical composition analysis, microstructural analysis by optical microscopy and hardness tests.

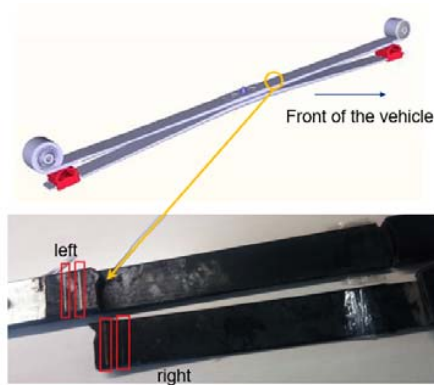
Fig. 1 Failure location

Location of failure is shown on Fig. 1. A complete separation of the upper leaf spring has occurred on vehicle due to fracture. Failure has occurred near to the center to the front side of the leaf. Red rectangles on the picture show the material verification test sample locations.

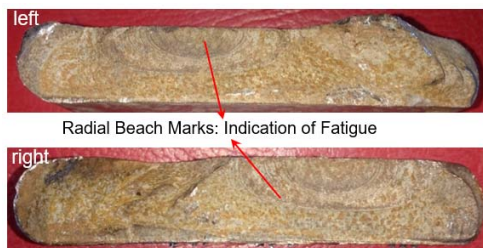
Fig. 2 Fracture surfaces at as-received condition

Fracture surface conditions are shown as-received on Fig. 2. Surfaces were corroded at field. However, radial beach marks which are indications of fatigue could still easily be detected.

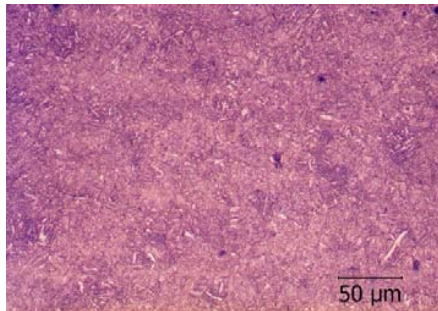
Fig. 3 Microstructure

A microscopical analysis was carried out by optical microscope on samples from 5 mm and 50 mm to the failed section. Observed microstructure is tempered martensite as specified. No remarkable bainite or retained austenite phases were observed within the structure which may reduce mechanical strength and durability of the part under cyclic loading conditions.

Measured grain size is ASTM grade 8 as per ASTM E112 Method or finer which is as required. Fig. 3 shows a representative micrograph from the examined samples.

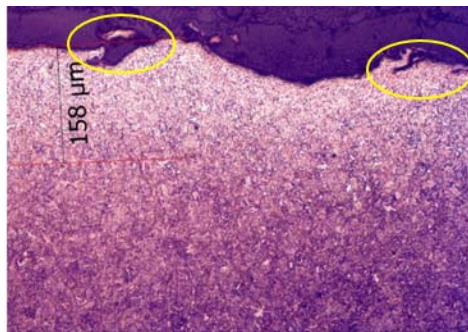
Fig. 4 Decarburization extent and surface condition

The specified level of decarburization depth of the part is 250 μm at maximum and partial type (Type 2). The observed decarburization type was partial and values of decarburization

depths from the examined region are within a range of 158 to 169 μm ; which describes no abnormal decarburization profile of the part surface.

During microstructural studies, small size of oxidized laps is potentially formed by subsequent oxidation of laps originated during hot rolling process. These surface irregularities were further searched for at the crack origin region whether there is a link to the failure mechanism, during fractographic examinations by SEM and will be discussed on the Micro-Fractography section. Fig. 4 shows a representative micrograph from the surface showing both the decarburization depth of 158 μm and oxidized laps.

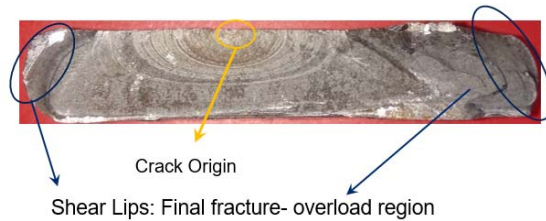
Fig. 5 Fracture surface (left-side) after ultrasonic cleaning

For microscopic examinations, the surfaces were cleaned by ultrasonic cleaning method with the usage of a special cleaning agent. Left-side fracture surface after cleaning is shown on Fig. 5. The thumbnail type of fatigue crack and shear lips at the final fracture region can be differentiated on this figure.

Macro examinations showed that a fatigue crack is present on the failed section. The shear lips and rough surface to the edges describe the final fracture region. Macroscopically observable size of the fatigue crack was found to be

approximately one-fourth of the total cross-sectional area. As the thumbnail shape of the crack is a possible indication of stress-corrosion cracking; further investigations were conducted on the micro-examinations and will be discussed in the micro-fractography section.

The orientation of the failed section and crack propagation plane describes a fatigue type of failure due to unidirectional cyclic bending loading condition.

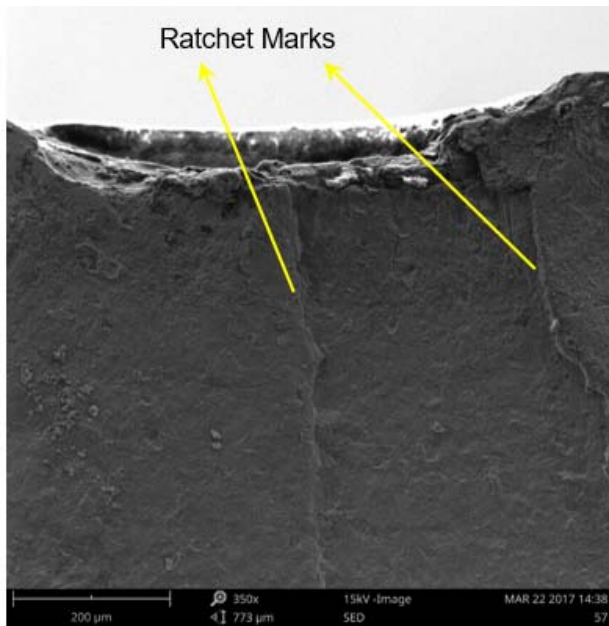
Fig. 7 Crack origin

Fig. 7 shows the fatigue crack origin (point a) at X350 magnification. Ratchet marks which are indications of fatigue crack initiation mechanism were observed at the crack origin. Crack has emanated from a surface collapse of $\sim 500 \mu\text{m}$ which is possibly formed by plastic deformation of the surface during shot peening process. On the other hand, this is accepted as a natural phenomenon as these regions can act as local stress-raisers.

Examinations on crack origin showed that the crack initiation has occurred at single region. Singular crack initiation requires very low stress concentration. Examinations at crack origin region showed that this region is free of pre-existing cracks and metallurgical defects. These findings of low stress concentration and defect-free surface and singular type of crack propagation indicate that the reason of fatigue crack initiation and propagation is high magnitude of cyclic

stresses on the part.

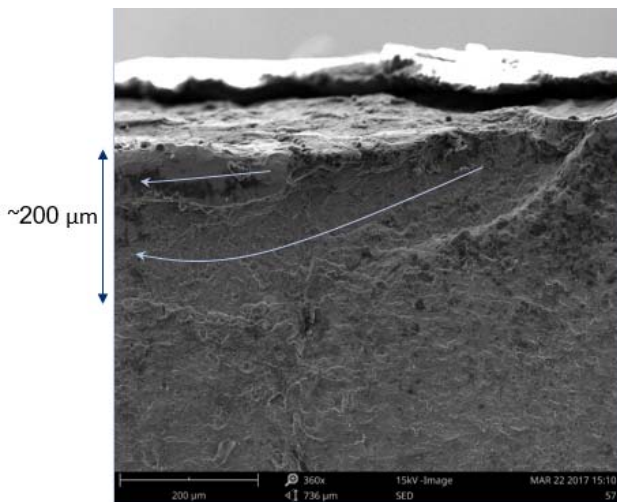
Fig. 8 Extension of multiple crack initiation

Fig. 8 shows the extension of crack initiations further beyond to the left (point b). However these cracks did not propagate and fatigue cracking continued with initial crack starting from point a.

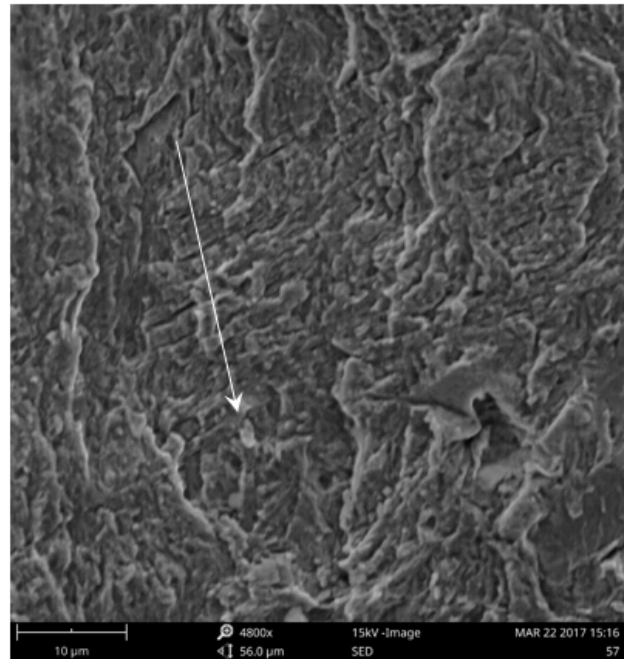
Fig. 9 Fatigue crack propagation direction and striations (point b)

Figs. 9 and 10 show the crack propagation directions. Fatigue striations can also be observed on Fig. 9 which are indications of stable crack propagation.

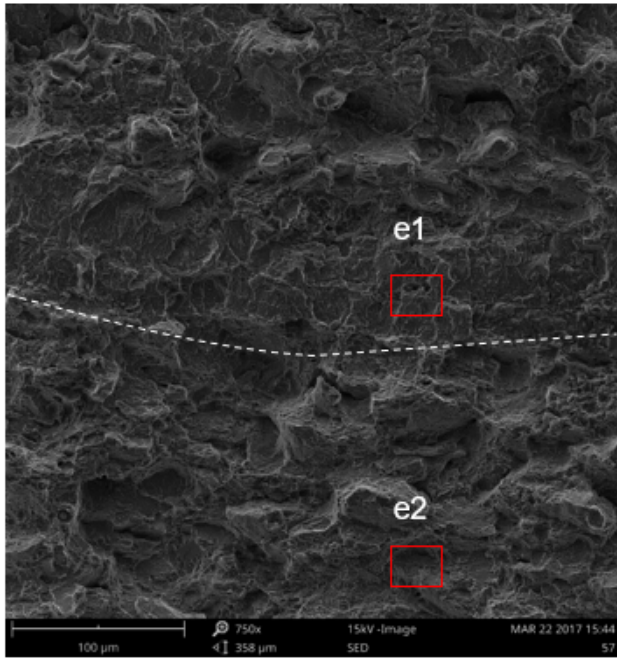
Fig. 11 Fatigue to overloading transition region (point e)

Micro examinations validated that the macroscopic transition from beach marks to rough and dull surface is the transition from fatigue to final overload fracture region. Figs. 11-13 describe the replication of fracture mechanism change from fatigue to ductile failure.

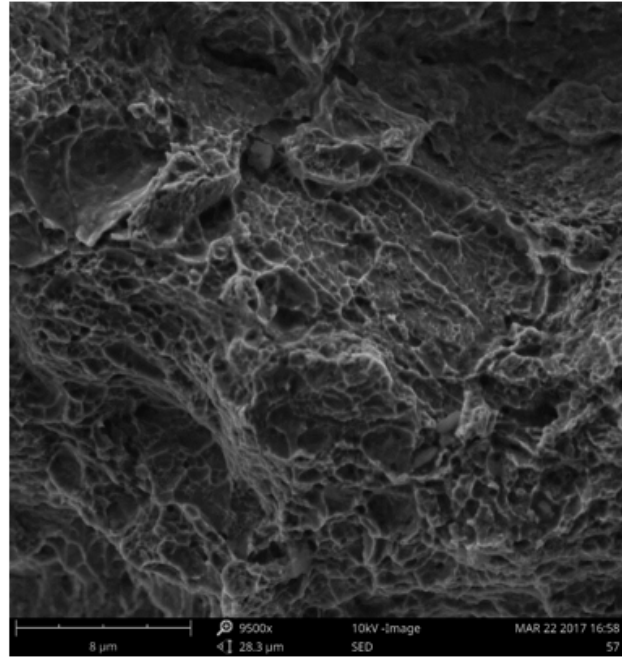
Fig. 13 Ductile dimples due to overloading failure (e2)

Striations and tear ridges were observed in fatigue region whereas dimples were observed on the overloading region.

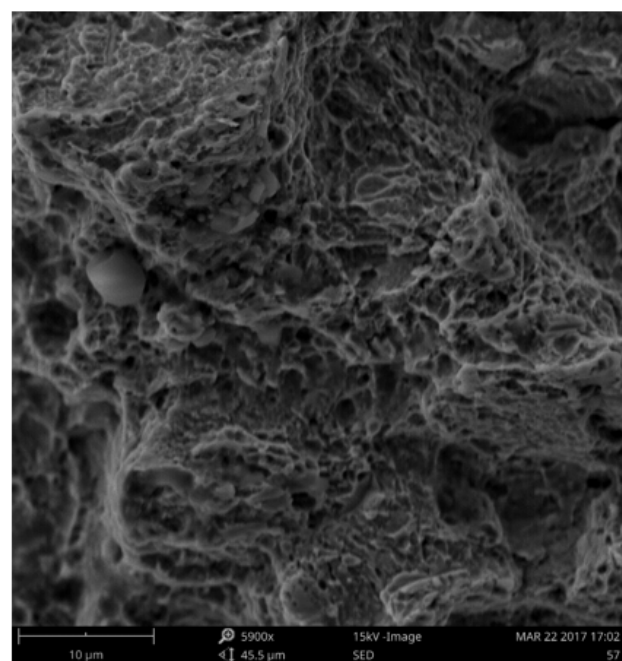
Fig. 14 Ductile dimples at final fracture (point f)

Figs. 14 and 15 show fractographs from the final failure regions. A complete ductile failure was observed near to the crack tip whereas both ductile and brittle features were observed near to the edge of the part. This may have occurred by more than one step of final overloading and increased strain rates at final stage resulting in cleavage plane formation due to brittle failure.
