# Failure Analysis of Pipe System at a Hydroelectric Power Plant

Ali Göksenli, Barlas Eryürek

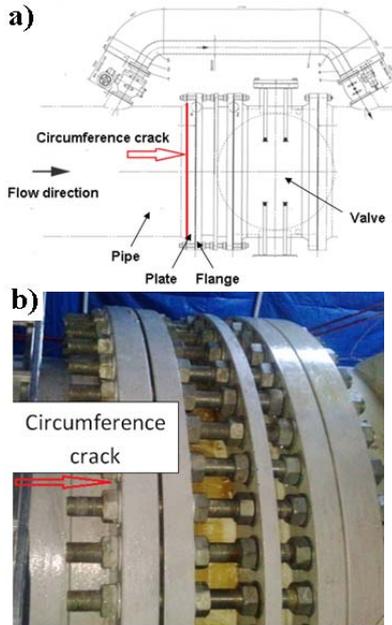
damaging forces [11]. In our case, for maintenance the butterfly valve was shut down resulting in a hammer like noise increase which had lasted for 10 minutes. After the waterfall incident, a circumference crack was detected at the flange-pipe welding zone. Investigations were carried out to determine the procedure after the crack formation.

As can be seen in Fig. 2, circumference crack had been constituted at the flange-pipe welding zone.

Fig. 2 General view of the flange-plate-pipe system and circumference crack

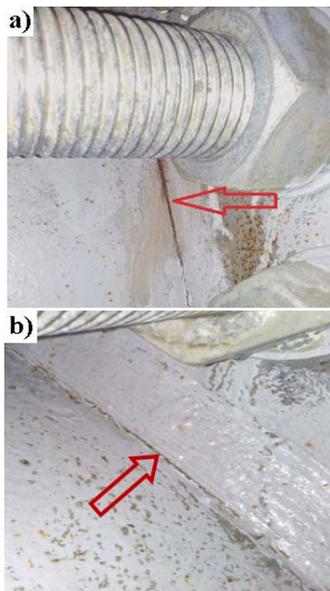
Fig. 3 Crack formation in pipe-plate welding zones

After detailed investigation it is concluded that crack had been propagated in pipe-plate welding zones (Fig. 3) and in pipe-flange plate welding zones (Fig. 4).

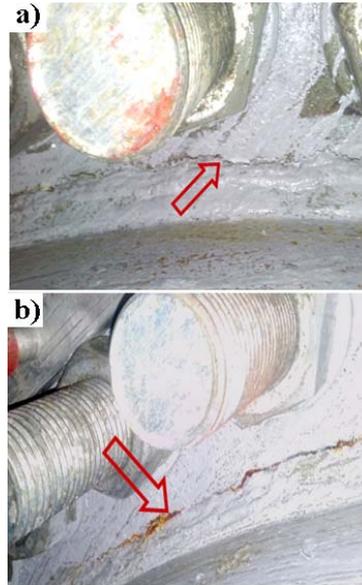
Fig. 4 Crack formation in pipe-flange welding zones

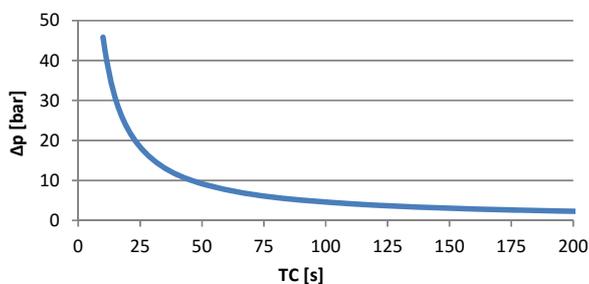
As can be seen in Fig. 6, even a valve closing time of one minute will cause a pressure increase of 7.6 bar. The valve closing time at the accident day is not clear, but it is certain that the shut down time of the valve was not considered by the operator, which had resulted in a water-hammer effect.

Fig. 6 Relation between pressure rise due to water hammer ( $\Delta p$ ) and time to close the main valve ( $T_C$ )

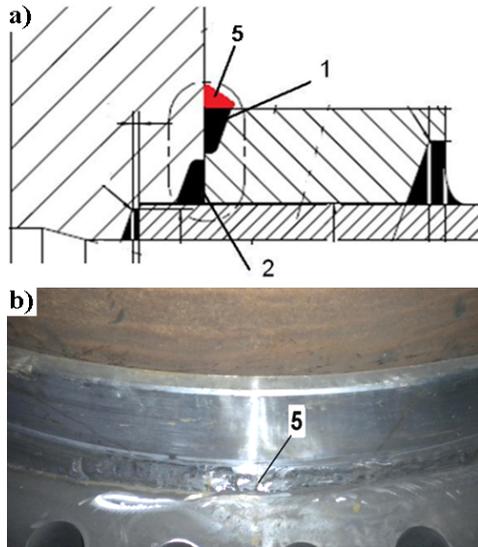
Weld seams 1 and 2 are applied between plate and flange, weld 3 between plate and pipe and weld 4 between pipe and flange as can be seen in Fig. 7. For further detailed weld analysis it is investigated if these mentioned four weld seams are applied correct as can be seen in Fig. 7. During observation an additional weld seam, which was not mentioned in assembly drawing in Fig. 7 was detected, as can be seen in Fig. 8.

Fig. 8 Weld seam no.5 (b), which was not mentioned in assembly drawing as can be seen in Fig. 7

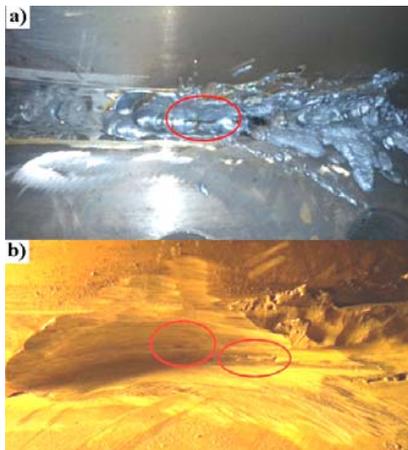
To analyze weld seam 1 and 2, weld seam 5 was grinded. After grinding it is detected that weld groove for weld 1 and 2 was constituted, but no welding process for weld 1 and 2 was applied, as can be seen Fig. 9. Therefore, a gap under weld 5 existed.

After weld seam analysis it is concluded that assembly of the plate-flange-pipe system was not applied correctly. Weld seams 1 and 2 were not applied; only weld grooves of weld 1 and 2 were constituted. The unfilled grooves 1 and 2 acted as inside cracks resulting in a strong notch effect. Stresses raised at this region caused crack propagation to the weld seam 5. By further investigation it is detected that weld groove for weld 3 was prepared incorrect. Groove angle was 70° instead of 20°. This had resulted in an increase of weld thickness from 25 mm to 110 mm, as can be seen in Fig. 10. This has resulted in a decrease of safety of the pipe-plate system, due to the low strength and high brittleness of weld seam according to base material.

Fig. 9 Weld groove of weld seam 1 and no welding process

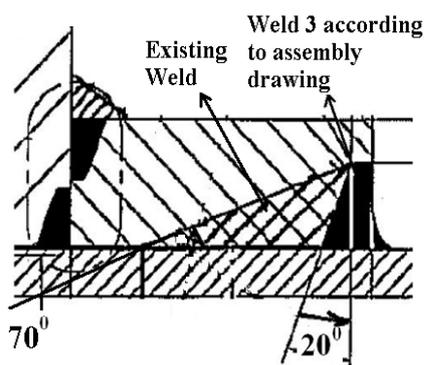
Fig. 10 Incorrect weld groove of weld seam 3
