Fatigue Failure Analysis in AISI 304 Stainless Wind Turbine Shafts

M. F. V. Montezuma, E. P. Deus, M. C. Carvalho

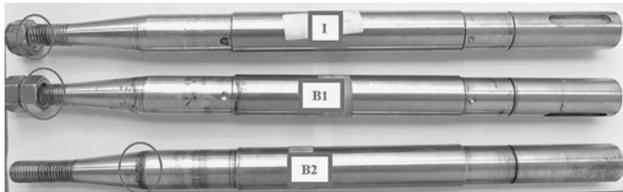
Fig. 3 Wind turbine shafts – Model A3300

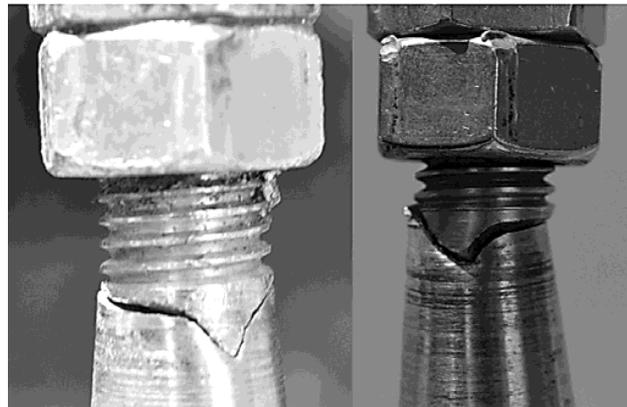
In the visual analysis, different failures morphologies were observed and compared with Metals Handbook [5]. The generator shafts A1700 - AP and RA broke at the beginning of the thread, Fig. 4, with fatigue break marks shown in detail in Figs. 5 and 6.

Fig. 4 AP and RA fractured shafts - Model A1700

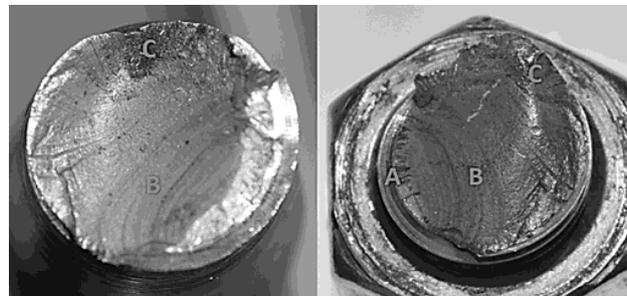
Fig. 5 View of the fatigue fracture region of the RA shaft: A - beginning of the fracture, B - beach marks, and C - final region of the fracture

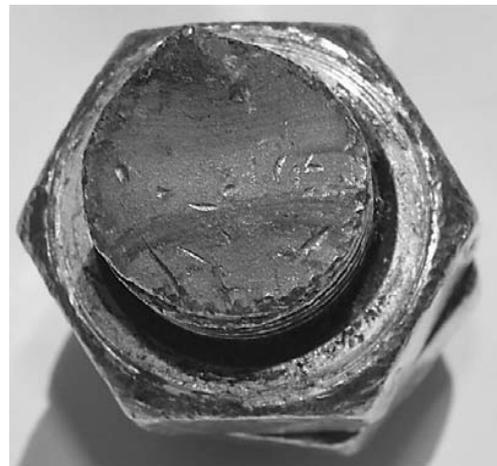
Fig. 6 View of the fatigue fracture region of the AP shaft – verification of beach marks

The visual inspection of the fracture on the AP shaft was compromised due to the numerous tool marks in the fracture regions, Fig. 6. However, it was possible to observe the "beach marks" characteristic of fatigue fracture.

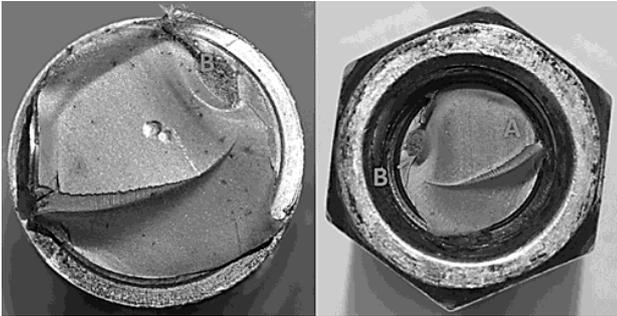
Fig. 7 View of the fatigue fracture region of the shaft I - Model A3300

The shaft I surface observed in Fig. 7 presented a region with a smooth aspect (A), corresponding to the area over which the crack spread slowly, and the smaller area (B) with a fibrous texture corresponds to the region the failure occurred. Quickly (catastrophic), which characterizes a fatigue failure.

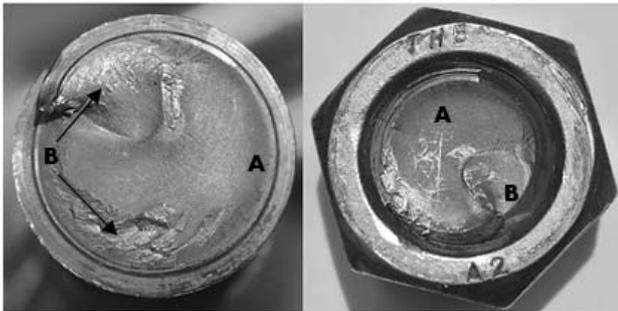
The B1 shaft, Fig. 8, presented two different types of fracture surface. On the right side, smooth surface (A), there is the fatigue zone, while on the other end, rough surface (B), the plastic zone is characterized by the appearance of tearing.

Fig. 8 View of the fatigue fracture region of the B1 shaft - Model A3300

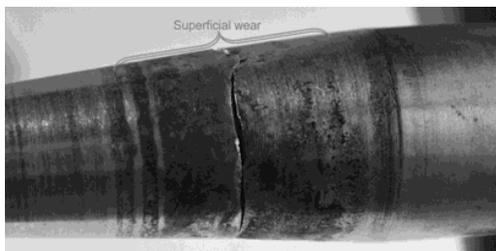
A superficial wear is visible on the PP axis of the A1700 wind turbine, where the part broke in the tapered transition region, favoring the initiation and propagation of cracks and fatigue failure, Fig. 9.

Fig. 9 View of the superficial wear on the fracture region of the PP axis - Model A1700

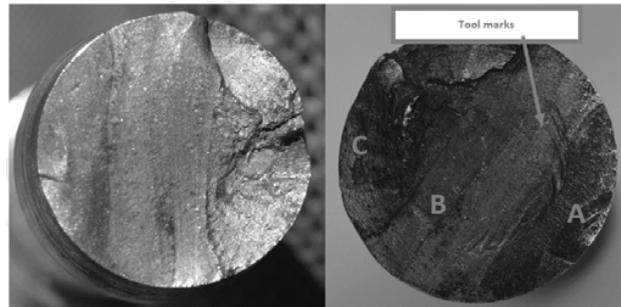
The fracture surface of the PP shaft can be seen in Fig. 10. Point A indicates the beginning of the crack that has spread, leaving "beach marks," indicated by point B and finally point C indicating the final region of the fracture. The fracture or rupture of the material usually occurs with the formation and propagation of a crack that begins at points where there is structural or compositional imperfection or a high-stress concentration, which generally occurs on the surface, as presented in the piece, where the wear marks and the consequent oxidation generated stress concentrating points. The darker coloration at point A shows oxidation and infiltration of contamination during the fracture's relatively long propagation stage.

Fig. 10 View of the fatigue fracture surface of the PP axis - Model A3300

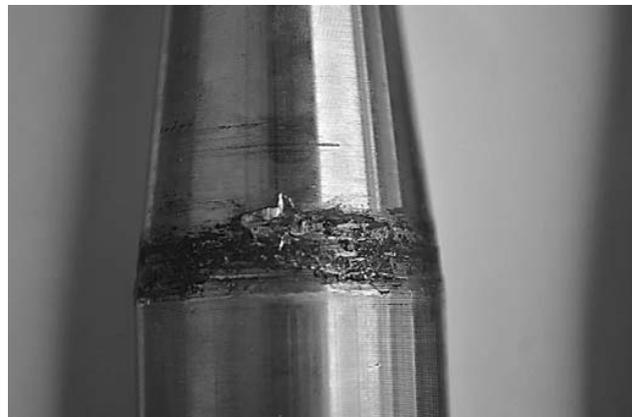
Similar wear was also observed in the B2 axis of the A3300 wind turbine, Fig. 11, and the other axes, however, with less intensity.

Fig. 11 Critical region of axis B2, due to loss of material due to wear (contact marks) and oxidation - Model A3300

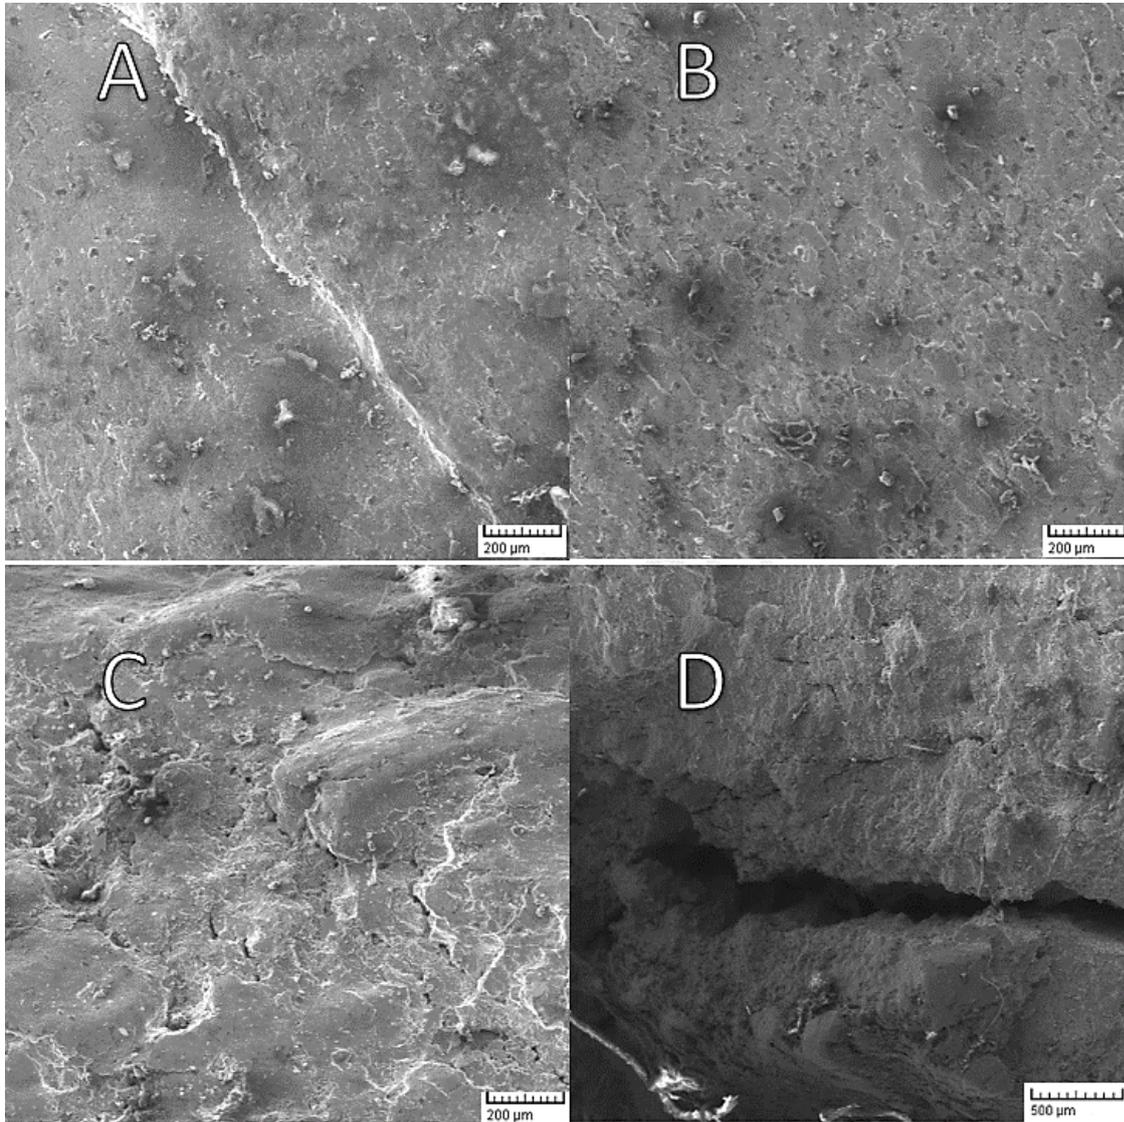
Fig. 12 SEM of the fractured region of the PP axis: A - region of the beginning of the failure, B - a region of the beach marks, C - a region of the catastrophic fracture with several secondary cracks, and D - secondary crack highlighted

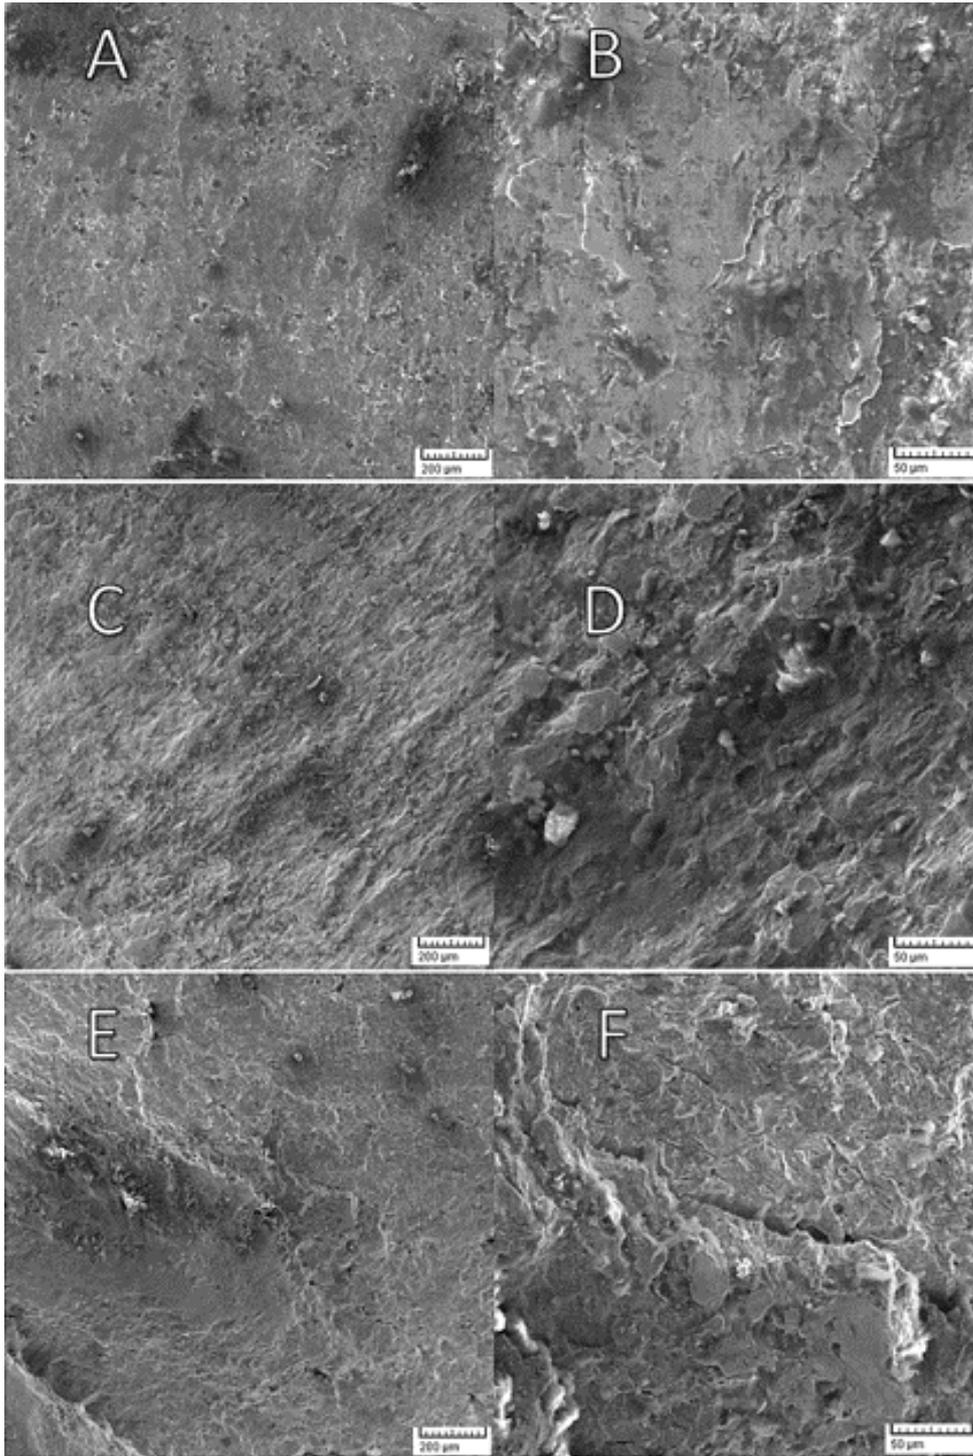
Fig. 13 SEM of the fractured region of the AP axis: A - a region of the beginning of the fatigue failure, B - detail of the region of fatigue in which the crack propagated slowly, C - a region of the beach marks, D - fatigue striation, high rate of deformation, E - catastrophic fracture region with secondary cracks and F - secondary crack highlighted

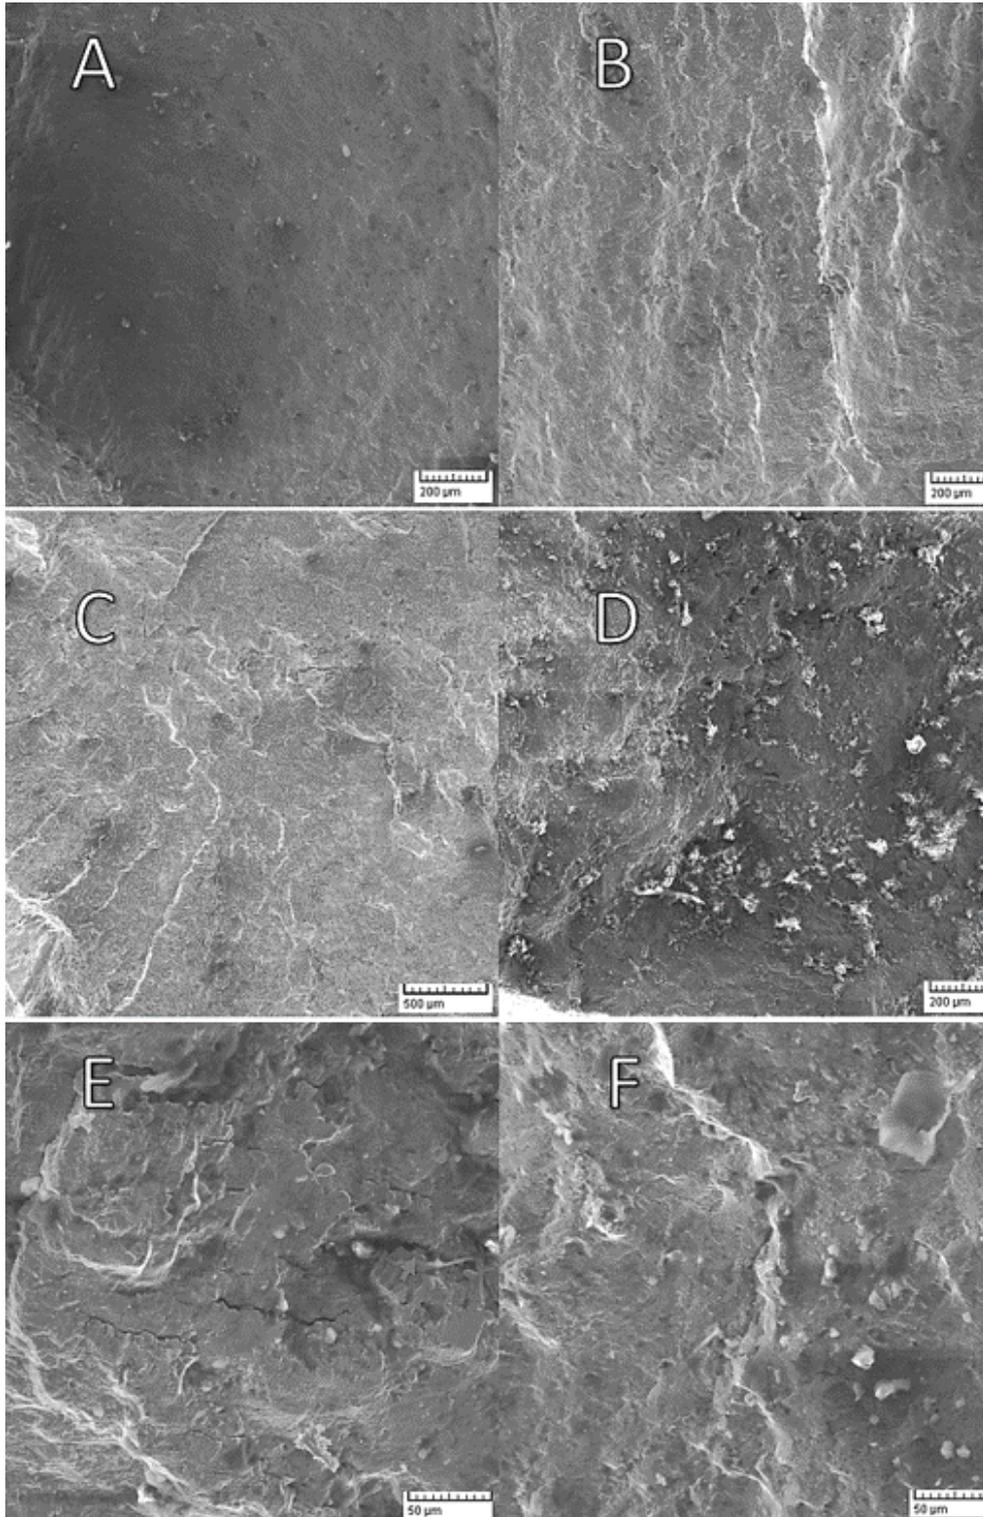
Fig. 14 SEM of the fractured region of the RA axis: A - region of the beginning of the fatigue failure, B - detail of the region of fatigue in which the crack spread slowly, the appearance of beach marks, C - a region of beach marks, D - region beginning of catastrophic fracture, the appearance of secondary cracks, E and F - regions of catastrophic fracture with secondary cracks

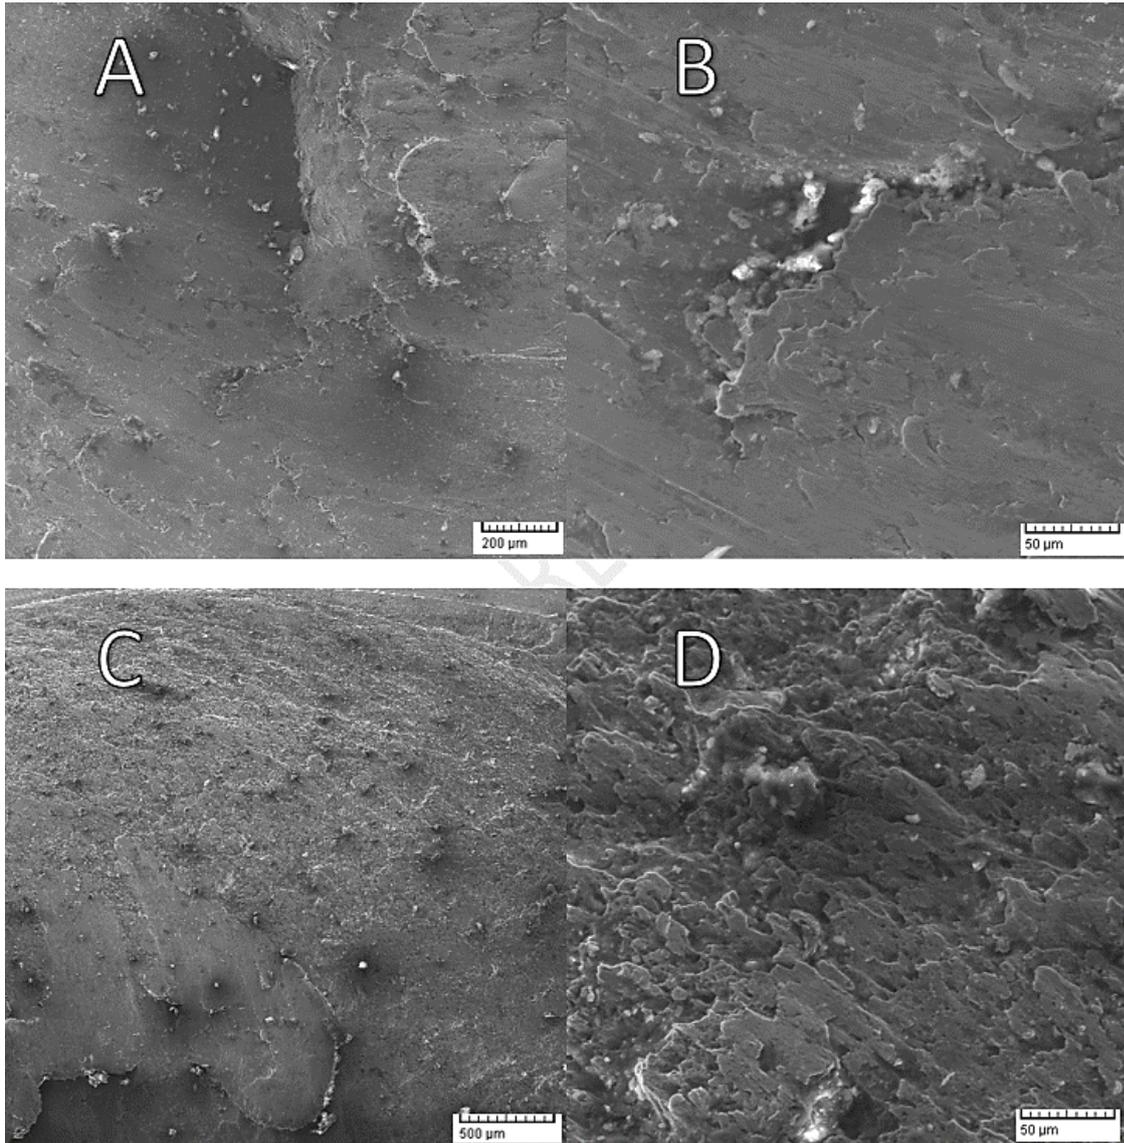
Fig. 15 SEM of the fractured region of axis I: A - region of the beginning of the fatigue failure, B - detail of the region of fatigue in which the crack propagated slowly, C - a region of slow/catastrophic failure transition D - a region of the catastrophic fracture

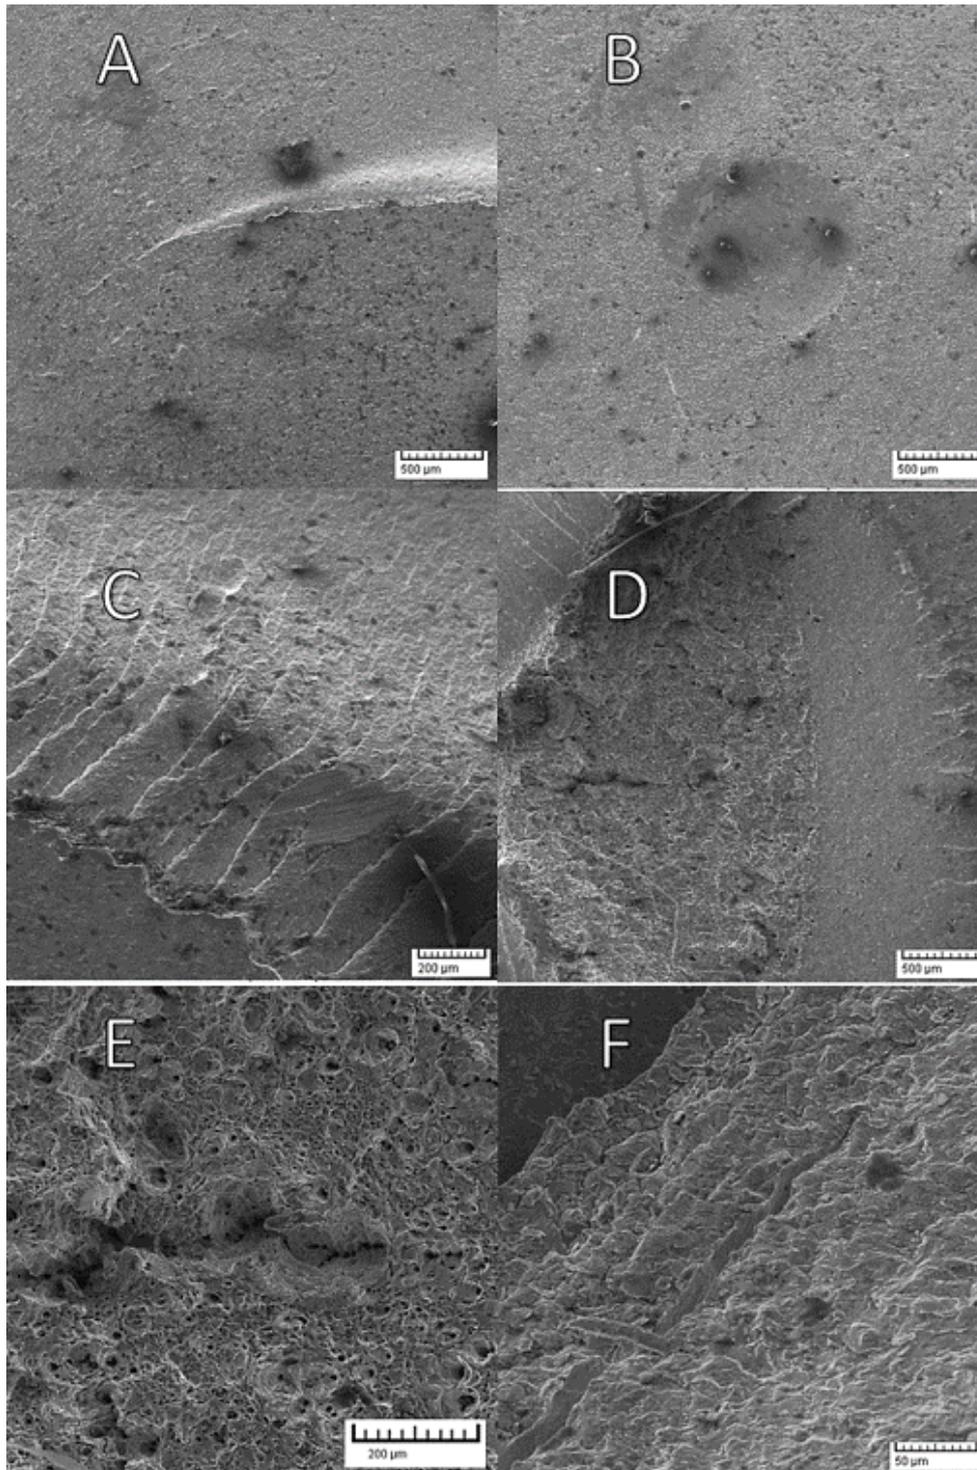
porosity found in the B1 axis demonstrates a possible manufacturing problem, since the presence of gases dissolved in the metal liquid can result both in the presence of various types of oxide inclusions, as well as in the formation of porosities of endogenous origin, that is, metallurgical causes, inherent to the quality of the metal cast in the molds. There are also exogenous origin defects originating from external causes, such as molds and leakage and feeding channel

Fig. 16 SEM of the fractured region of the B1 axis: A - region of the beginning of the fatigue failure, B - Inclusions, C - beach marks, D - a region of the beginning of the catastrophic fracture, the appearance of secondary cracks, E - secondary cracks and porosity and F - secondary crack

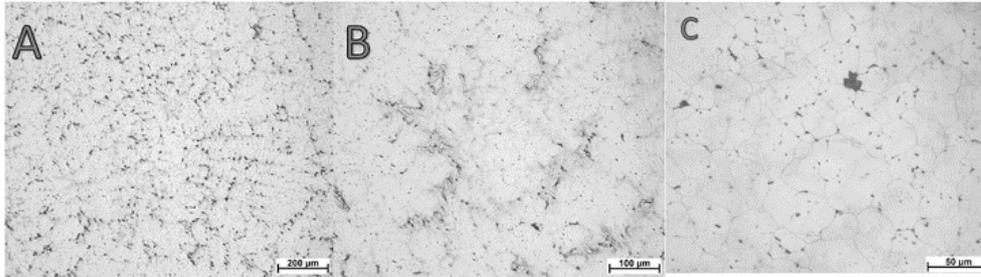
Fig. 17 Metallographic samples of the material

The structure of austenitic steel (stainless steel) with chromium-rich carbides precipitation was observed in the grain boundary region. This type of steel becomes susceptible to intergranular corrosion due to the phenomenon of sensitization, which is a process related to the precipitation of chromium-rich carbides in the grain boundary region, leaving the adjacent region depleted of chromium [8].
