Investigating Causes of Pavement Deterioration in Khartoum State, Sudan

Magdi M. E. Zumrawi

Keywords— Pavement, deterioration, causes, failures.

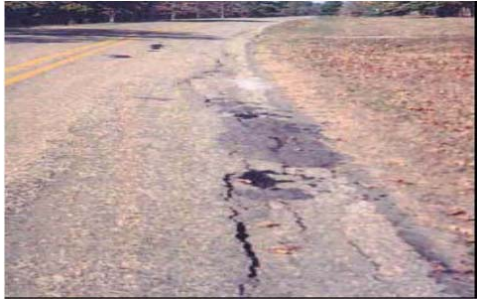
Expansive soil as road subgrade is considered one of the most common causes of pavement distresses. Longitudinal cracking results from the volumetric change of the expansive subgrade, is one of the most common distresses form in low volume roads (see Fig. 1). This type of cracking is initiated from the drying highly plastic subgrade (PI>35) through the pavement structure during the summer [18], [19]. Other forms include fatigue (alligator) cracking, edge cracking, rutting in

Fig. 1 Longitudinal cracking and failure, [19]
