# Metallurgical Analysis of Surface Defect in Telescopic Front Fork

Souvik Das, Janak Lal, Arthita Dey, Goutam Mukhopadhyay, Sandip Bhattacharya

**Keywords**—Telescopic front fork, induction welding, hook crack, internal oxidation.

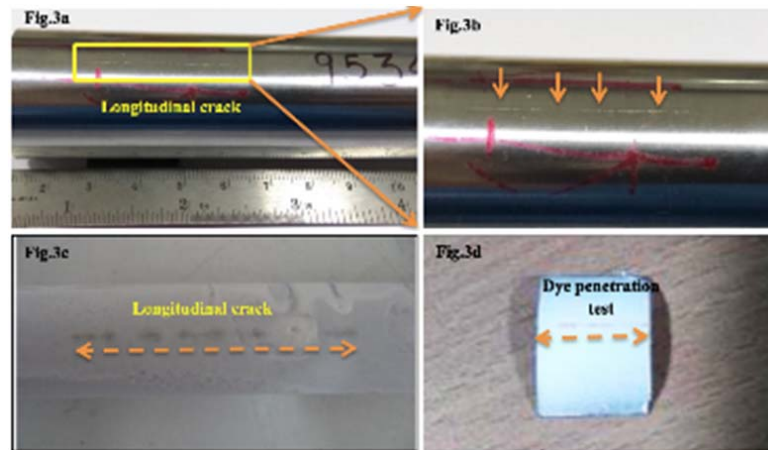
**Sample #1:** Visual observation of the failed fork showed small longitudinal crack along the length of the tube at the circumference close to the weld (Figs. 3 (a) and (b)). The crack was about 4 cm in length and very thin and difficult to detect easily. Crack was very shallow in depth and difficult to detect, so it was detected by dye penetration test (Figs. 3 (c) and (d)).

Fig. 3 (a) and (b) Longitudinal crack along the length of the tube, longitudinal crack was detected through dye penetration test

**Sample #1:** Visual observation of the failed fork tube showed presence of small cracks along the length of the tube at the circumference adjacent the weld flow lines. The crack was about 5 cm in length. The unetched microstructure of crack showed 'J' type hook crack [1], [2]. MnS inclusions were observed in the vicinity of the crack. The overall MnS inclusion was high as shown in Table III. Microstructural analysis further revealed that the hook of the crack was turning toward upward surface. The originator of hook crack is non-metallic inclusion primarily MnS stringers. These flattened non-metallic inclusions are formed during hot rolling of plate. They reduce the ductile toughness of the steel even in their normal position but do not affect the yield or tensile strength of the steel [3]. So, the mechanical properties of the tube under investigation were also satisfactory. Near bondline, these weak layers reorient themselves in such a way that they become subjected to tensile hoop stress when the pipe is pressurized [4] and a small crack originates. The slight upset of the metal at the weld acted to turn the ends of this usually very small subsurface crack in the direction of the upset. Because the metal flow during the upset is toward the both surfaces. The hook of the hook crack may turn toward either the outside or inside surface, depending on which the

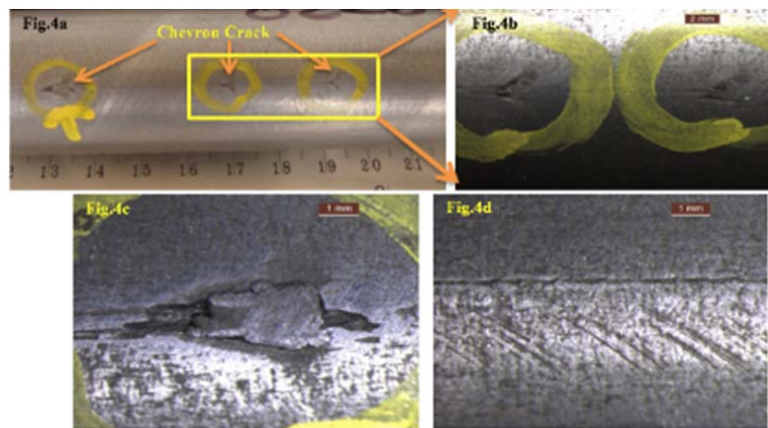
**Sample #2:** General view of the tube sample with defect is shown in Fig. 4 (a). Multiple chevron marks were observed on the surface of the tube. These chevron marks were found to form a single line (Figs. 4 (a) and (b)). Similar marks with less severity and a line mark running through centre of these defects were observed at 180-degree location (Fig. 4 (a)).

Fig. 4 (a)-(c) Chevron cracks on the surface of the tube, (d) Less severity defects were observed at 180-degree location of the chevron crack

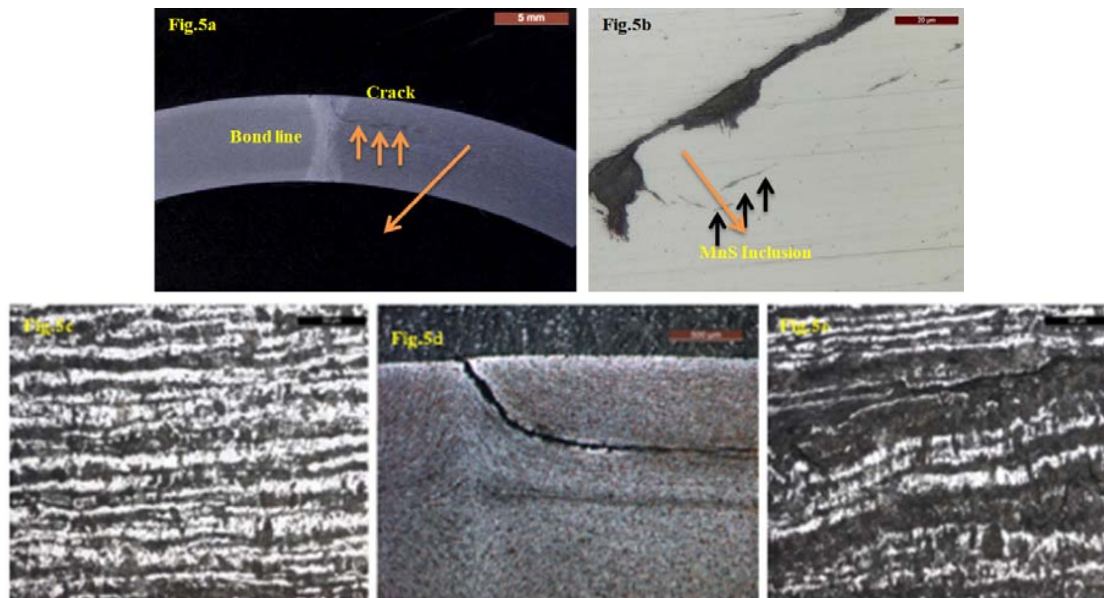
Fig. 5 (a) Chevron cracks on the surface of the tube, (b) Un-etched micro image of the defect location, (c)-(e): Etched micro image of the defect location at different magnifications

**Sample #1:** The un-etched microstructure showed a crack, 'J' type in shape and of 0.5 mm in depth (Fig. 5 (a)), typical to hook cracking [1]. Further the crack was found to be associated with some non-metallic manganese sulfide (MnS) inclusions (Fig. 5 (b)) which were further confirmed through EDS analysis. The macro dual zoom photograph of the micro sample revealed white bond line associated with the crack (Fig. 5 (c)). The 3% nital etched microstructure showed that the crack was slightly offset from the bond line of the Cold drawn Electric resistance Welding (CEW) seam (Fig. 5 (a)), but following the weld flow lines and opened up at the circumference. The hook of the crack turned toward upward, as shown in Fig. 5 (d). The weld flowline of the tubes was compatible to the cold drawn structure (Fig. 5 (d)), and the matrix revealed banded ferrite pearlite structure (Figs. 5 (c) and (e)) common to such high manganese structural steel

manganese and sulfur ratio and in this case favored the formation of MnS inclusion resulted in higher inclusion rating. These MnS inclusions caused imperfection at the edge of the strip which turned toward the outside diameter pipe surface resulting in hook crack formation during upsetting at the time of welding. Thus, the hook crack was originated during tube manufacturing which surfaced out when the tube was put in field service.

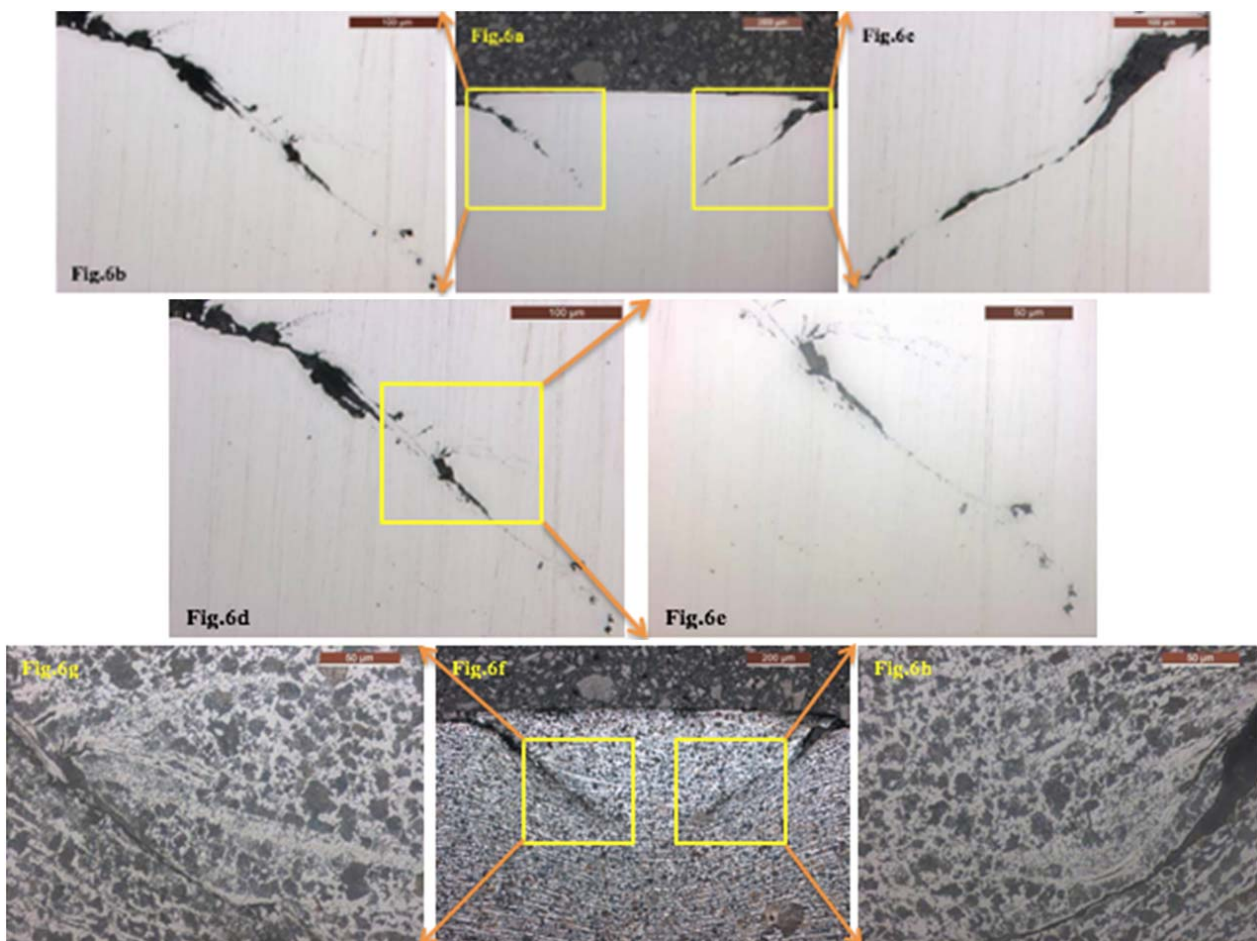
**Sample #2:** Un-etched micro image of the samples from defect area revealed bowl shaped defect. This was formed by chipped-off material as shown in Fig. 6 (a). Figs. 6 (b) and (c) show closer view of the cracks on both edges of the defect. It can be observed that the cracks contain some non-metallic entrapments in it. At higher magnification, as shown in Fig. 6 (e), suspected internal oxidation can be observed in chipped-off material.

The etched microstructure at the defect location is shown in Fig. 7 (a). Banded ferrite - pearlite structure was observed which followed the contours of the defect/chipped-off material. At higher magnification, decarburised grains were observed along the suspected internal oxidation. The chipped-off material does not show any banding or deformation. However, due to accumulation of this material, grains in the matrix below, it got deformed which is cold condition effect.

Fig. 6 (a)-(d) Un-etched micro image of the defect location at different magnifications, (e) Presence of dark brown entrapment along with internal oxidation (f)-(h) Etched micro image of the defect location at different magnifications

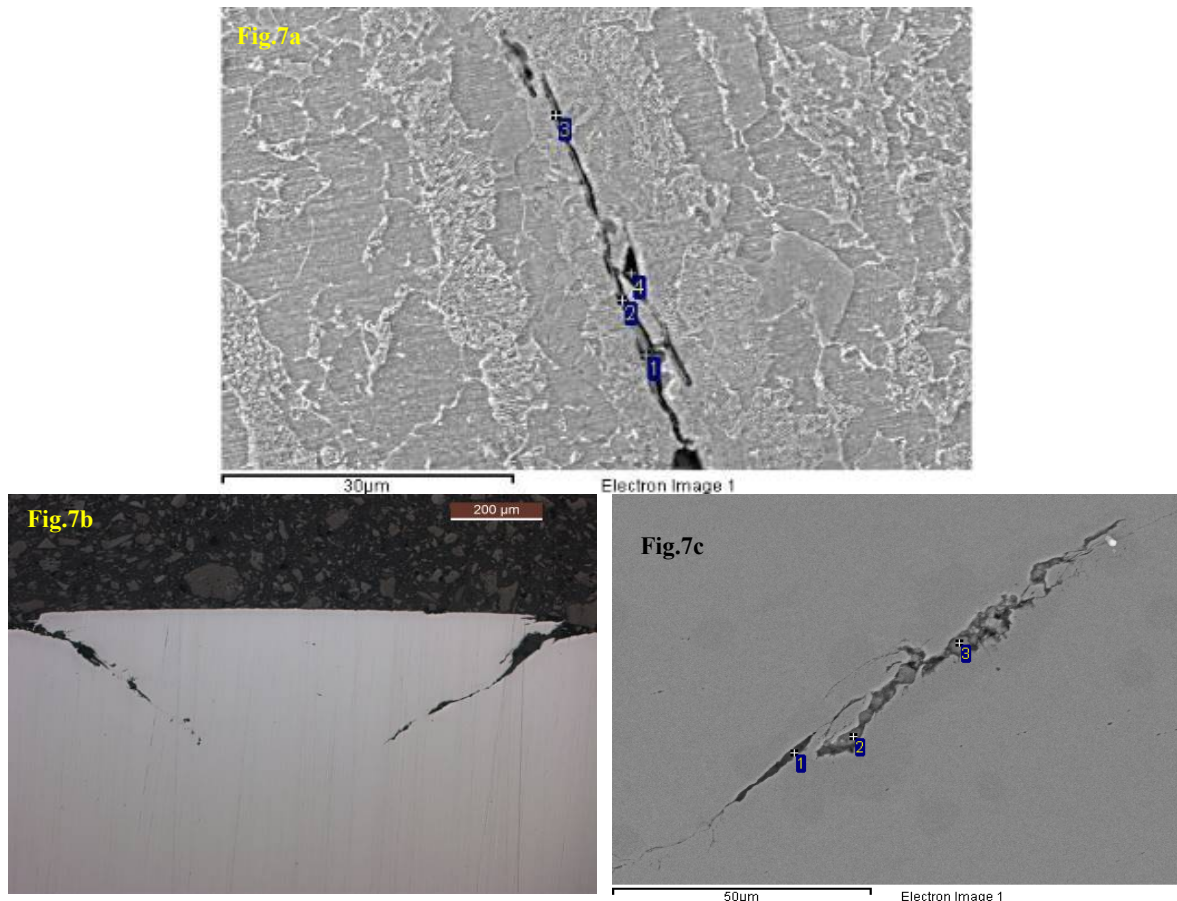
**Sample #1:** EDS analysis was carried out on non-metallic inclusion by Scanning Electron Microscope at an accelerating voltage of 15 kV. EDS analysis confirmed the inclusions as

MnS (Fig. 7 (a), Table II). Then, inclusion rating was also carried out by ASTM E 45 method to check overall cleanliness of the steel. The inclusion rating, shown in Table III, revealed higher MnS inclusions in steel.

Fig. 7 (a) EDS analysis of sample#1 at cracked location, (b) and (c) EDS analysis of sample#2 at defect location

**Sample #2:** EDS analysis of the dark brown entrapment revealed prominent peaks of Ca, Si, Al, Na, F and O which proves that crack has generated due to mould powder entrapment.

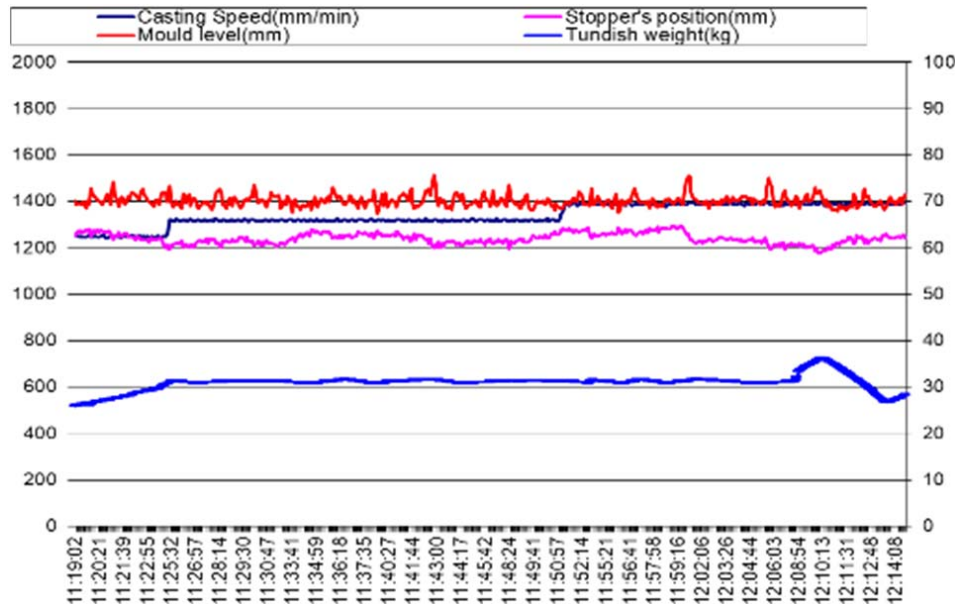
Fig. 8 Casting parameters for sample #2

**Sample #2:** Repeating chevron marks were observed to form a single line at certain interval on the tube surface. Similar marks with less severity and a line mark running through centre of these defects were observed at 180-degree location. Closer observation of the chevron marks in stereo microscope shows accumulation of material at centre of the chevron. Optical microscopy shows grain deformation at the defect contour indicating cold stage deformation. Based on the repetitive nature of the defect, it appears to be originating from the drawing stage itself and that too at exactly diametrically opposite locations of the tube. Decarburised grains along with internal oxidation associated with dark brown entrapment were observed along the cracks. Presence of mould powder entrapment inside the material indicates origin of the defect from slab stage. The morphology and location on the tube suggests that the steel defect got aggravated during drawing forming the chevron mark. Mold powder entrapment mainly occurs in the so-called “transient casting” periods, e.g. the time of casting start, casting end, ladle exchange, mold width change, SEN change, etc. During the unsteady casting periods, usually, the casting speed is largely varied, which disturbs the flow of the liquid steel in the mold and results in severe level fluctuation. Hence, mold powders are easy to be carried into the liquid steel, and some are entrapped by the solidified shell

and exist as non-metallic inclusions in slabs. If the interfacial velocity of steel melt which exceeds tear off velocity results in associated shear stress to become greater than the cohesion forces of the slag. Slag gets torn off and carried over in the form of droplets in the liquid metal. While a part of these droplets immediately floats back towards the meniscus, another part is transported by the metal flow and scattered in the liquid pool [7]. In case of sample #2, it has been observed that higher severity index in this coil is explained due to unstable stopper position shown in the caster (Fig. 8). As seen from the chart given for this slab, there are large fluctuations in casting speed along with large mold level fluctuations. Hence, changing stopper position causes unstable molten steel flow and so entrapment of mold powder.
