Modelling for Roof Failure Analysis in an Underground Cave

Keywords—Forensic analysis, hypothesis modelling, roof failure, seismic monitoring.

This work is the failure analysis of a roof incident in a coal mine in northern Spain and its principal scope is to establish the causes of the accident to improve the security in other mining areas of this exploitation. The followed methodology begins with field works to recognize the area and to characterize geological materials. Then, different hypotheses were developed and a computational simulation was used to evaluate their viability.

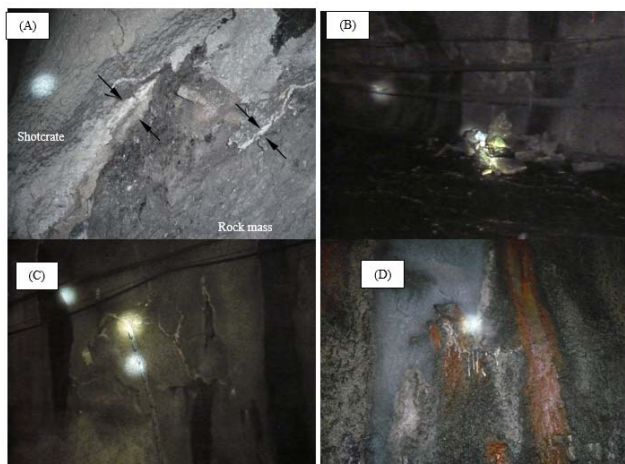
Along the ramp, when coal layers are crossed, the shotcrete support suffers a lot, because when this type of ground is deformed, it cracks and detaches the shotcrete. At some points it was found that the thickness of shotcrete was small and, in others, the shotcrete was not resting on the floor, if not "hung". These situations indicate that the shotcrete was not working properly as support. On the other hand, the infiltrating water produced oxidation problems in the bolts, as well as in the reinforcing fibbers of the shotcrete in the sections they were metallic. These problems are shown in Fig. 1. In some places, the support was reinforced by increasing the bolt density or installing new wood-clad metal frames (Fig. 2).

Fig. 1 Found problems in the shotcrete: (A) poor thickness, (B) detached blocks, (C) cracking, (D) leaks and oxidation

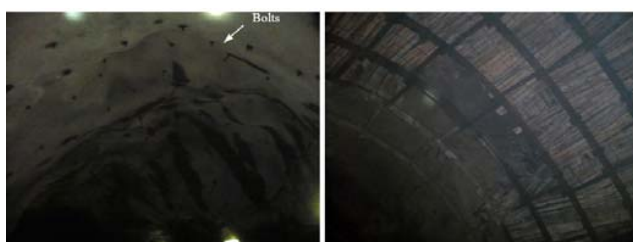
Fig. 2 Places with reinforced support in the ramp

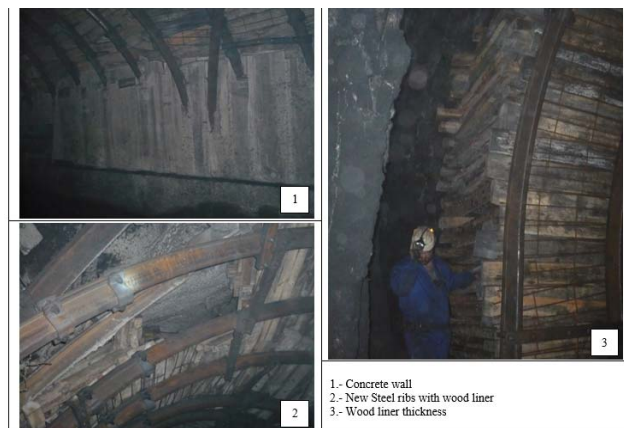
Fig. 3 Reinforced support after the accident

The area of the collapse was entirely reinforced after the incident, with new metallic frames (type Th29) and a coating of wood that in some areas exceeded one meter of thickness (see Fig. 3). The coating wood produces a reduction of the size of the section. On the right wall, where the detachment of

material happened, the metal frames were braced by embedding them in a concrete wall.

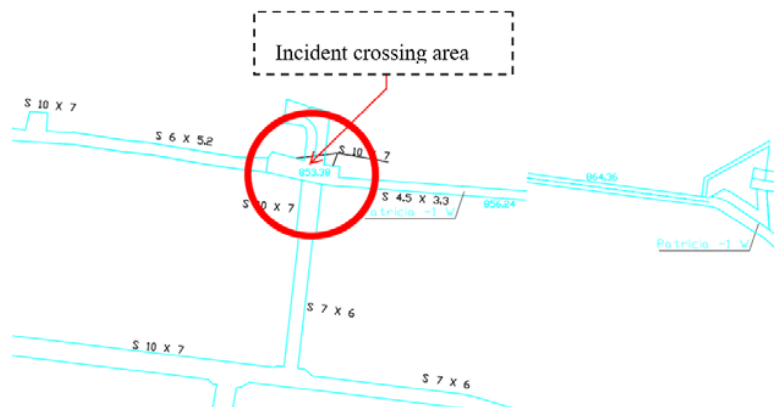
As indicated above, the accident occurred in the called "Morena Oeste". This gallery with a height of 853 m has a cross section of 6 m of width and 5.2 m of height, with the exception of the collapsed area where the section increases to 10 m of width and 7 m of height. This bigger size allows creating a transference place where the coal is loaded and evacuated to the outside.

- 1) Case 1: The tailgate has the most common dimensions in this type of infrastructure, that is to say, 6 m of width and 5.2 m of height.
- 2) Case 2: The tailgate has a bigger cross section, 10 m of width and 7 m of height. These dimensions are the dimensions of the collapsed place (Fig. 5).

Fig. 5 Dimensions of the galleries in the collapsed area

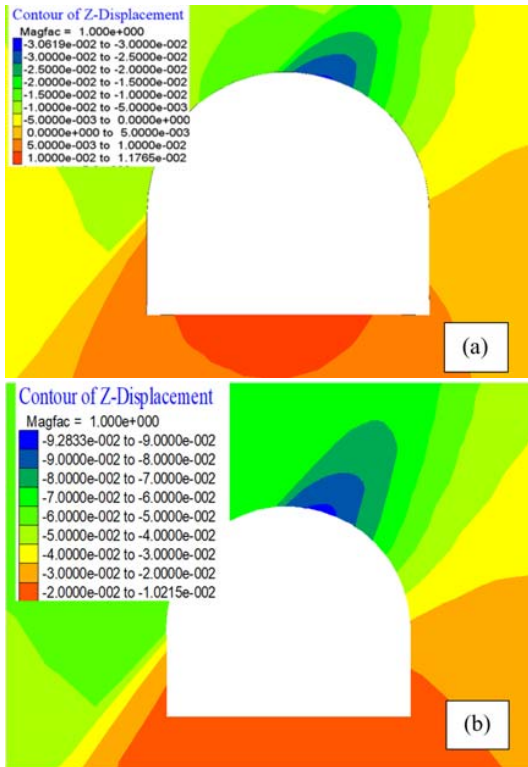
Fig. 7 shows the vertical displacements (in meters) of the model around the gallery. They are represented in the form of isovalues, so each colour is equivalent to an interval of displacements according to the legend that appears on each figure. They are negative when their direction is descending and positive when their direction is ascending (swellings).

The simulation shows displacements of 3 cm in the roof and swellings of 1 cm in the floor. These displacements increase to 9 cm and 2 cm respectively after the longwall exploitation.

Fig. 7 Vertical displacements: (a) during tailgate opening;(b) during longwall exploitation

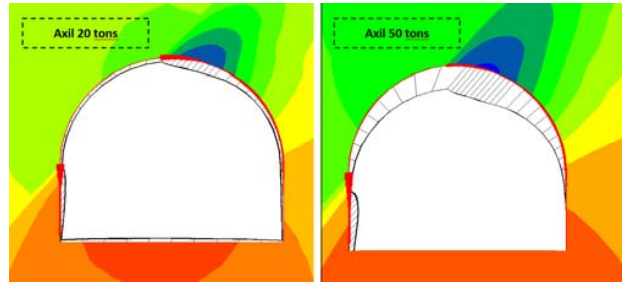
Fig. 8 shows the axial efforts over the support. The efforts go from 20 t before the exploitation until 50 t after the exploitation. In this figure, the geometric deformation of the gallery is represented in a magnified way. It can be noticed that in the intersection with the coal layer the deformation is bigger and this change in the deformation produces cracks in the shotcrete. In this case, less rigid and more flexible supports, as wood, have a better behaviour because they better absorb the deformations.

Fig. 8 Axial efforts over the support and tailgate deformation before and after the exploitation

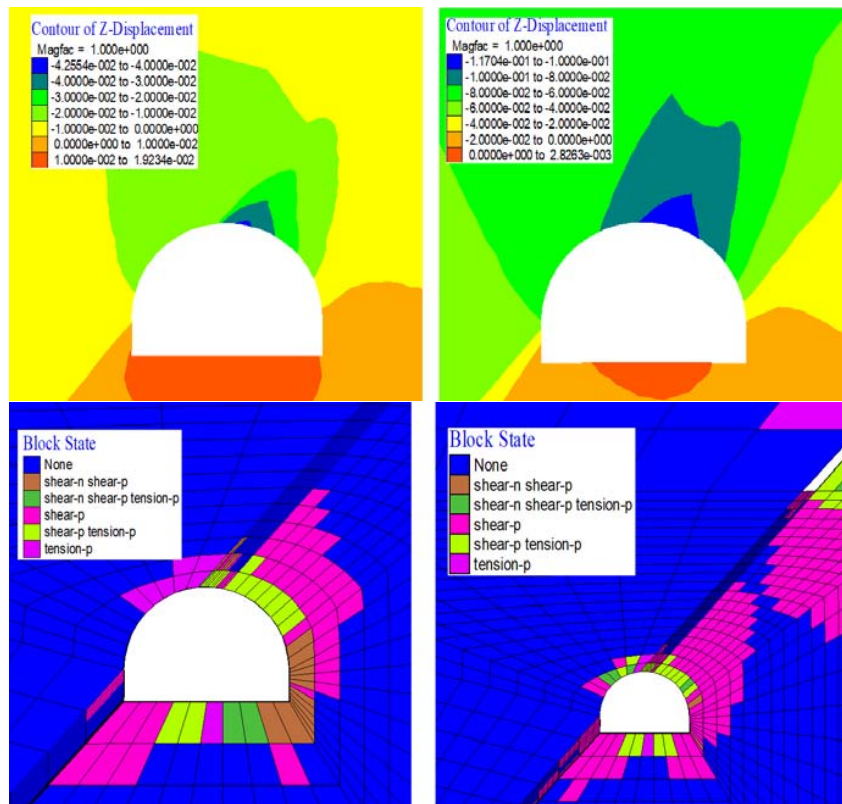
The bigger dimensions of the cross section produce an increase in the vertical displacements until 4 cm. Besides, a plasticized zone around the tailgate appears not only along the exploitation but also before it (Fig. 9).

Fig. 9 Vertical displacements and failure surrounding of the tailgate before and after the exploitation

Again, a change in the deformation appears in the intersection with the coal layer affecting the integrity of the shotcrete and producing cracks and detachments. The axial effort reaches the 24 t bigger than in the first case with one effort of 20 t.

After the exploitation, the displacements and the fractured surrounding increase in an important way and the support is overloaded until 60 t.

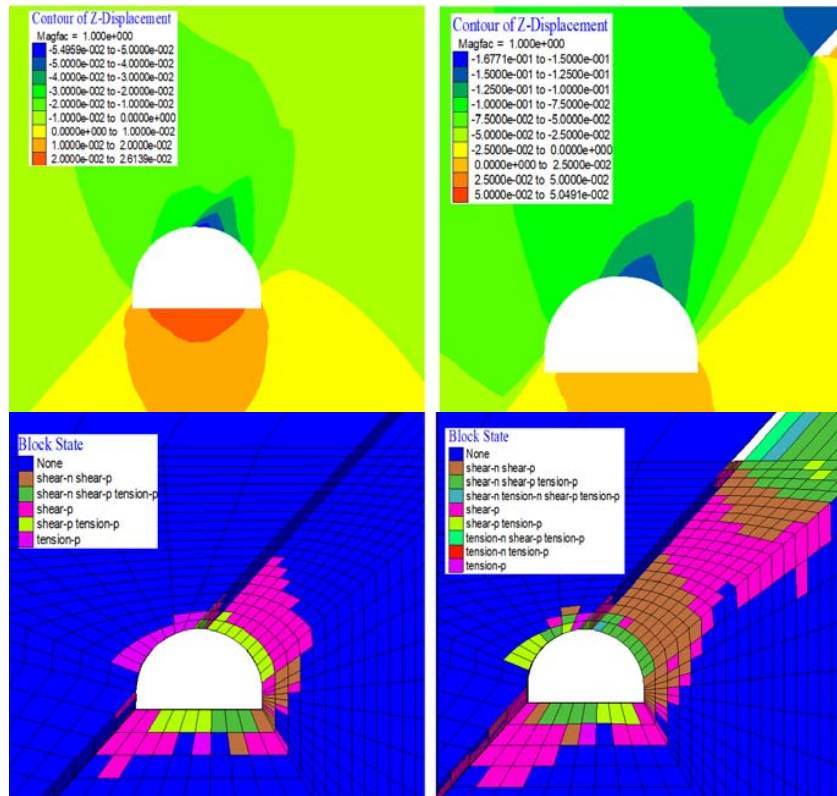
When the dimension of the tailgate is equivalent to the diagonal (14 m), the vertical displacements in the roof reach 5.5 cm and in the floor 2.5 cm. Again, is the wall of the layer the most affected placed with an increase in the fracturing and failure (Fig. 10).

Fig. 10 Vertical displacements and failure surrounding of the tailgate, before and after the exploitation for 14 m of diagonal

Once the workshop is exploited, the vertical displacements in the roof reach 15 cm, while the wall of the layer is totally plasticized between the tailgate and the workshop. There are very significant zones in the figure with a tendency to the break and/or landslide. This indicates that, if a landslide starts, it will take place in the wall of the layer and that the volume of involved material will be considerable, since the affected area has considerable grown compared to the previous situations.

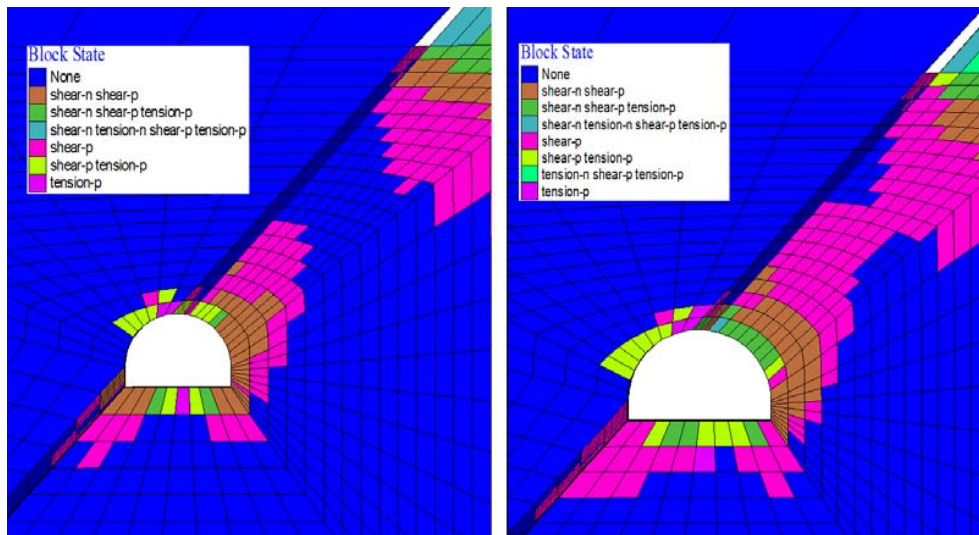
Protection pillars of 70 m could be suitable for gallery widths of up to 10 m (see Fig. 11), but they are insufficient when considering a gallery dimension equivalent to the

diagonal (14 m) because in this case, the plasticizing areas around the tailgate and the exploitation workshop appear again. On the other hand, with 80 m protection pillars, the plasticizing areas around the exploitation workshop and the tailgate are not connected (Fig. 12). Therefore, in case of one slide, it would be a local break in which the volume of material that can fall is much less and the support would

Fig. 11 Failure surrounding after the exploitation for 10 and 14 m and with protection pillar of 70 m

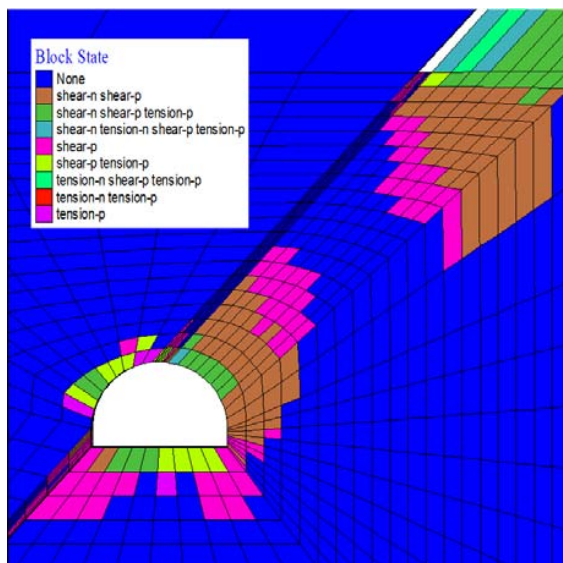
behave better. Based on these observations, it seems to be confirmed that the detachment was originated as a consequence of one sliding in the layer wall, due to the large roof span present in the place of the accident, and probably triggered as a consequence of the existence of a protection pillar insufficient.

Fig. 12 Failure surrounding after the exploitation for 14 m and with protection pillar of 80 m
