Railway Crane Accident: A Comparative Metallographic Test on Pins Fractured during Operation

Abstract—Eventually train accidents occur on railways and for some specific cases it is necessary to use a train rescue with a crane positioned under a platform wagon. These tumbled machines are collected and sent to the machine shop or scrap yard. In one of these cranes that were being used to rescue a wagon, occurred a fall of hoist due to fracture of two large pins. The two pins were collected and sent for failure analysis. This work investigates the main cause and the secondary causes for the initiation of the fatigue crack. All standard failure analysis procedures were applied, with careful evaluation of the characteristics of the material, fractured surfaces and, mainly, metallographic tests using an optical microscope to compare the geometry of the peaks and valleys of the thread of the pins and their respective seats. By metallographic analysis, it was concluded that the fatigue cracks were started from a notch (stress concentration) in the valley of the threads of the pin applied to the right side of the crane (pin 1). In this, it was verified that the peaks of the threads of the

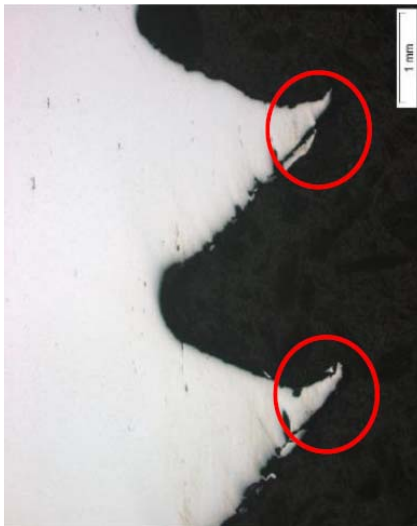
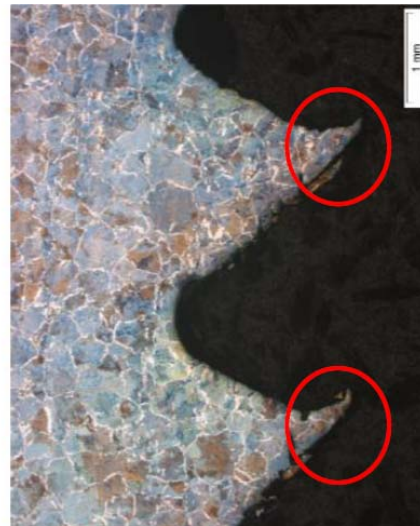
The metallographic examination of all three pins and of the three sites showed is formed by a perlite, as was already expected to be SAE 1045 steel. No irregularities were found in the microstructure. However, the anomaly in the peak of the threads of the seat of the fractured pin 1 was corroborated due to the presence of a cutting edge (Fig. 10). In addition, in the valleys of pin 1 threads several fatigue cracks were found in the beginning of propagation phase (Fig. 11).

Fig. 10 The presence of a sharp edge in the peaks of the threads of the seat of the fracture pin 1

- Perform visual tests with magnifying glass and/or non-destructive tests (dye penetrant, ultrasonic, etc.) on all the pins applied on the crane in order to detect notches and/or crack initiation.
- Calculate efforts to determine whether SAE 1045 steel (with or without heat treatment) and/or the entire crane is sufficient for the mechanical stresses imposed by the operation. Same for the seat.
- Elaborate technical drawing of the pin and seat, as well as elaborate technical specification containing various details including the design, material and type of heat treatment.
- Adapt the mechanical forming process of the seat and/or pin threads in order to eliminate sharp edges on the thread peaks.

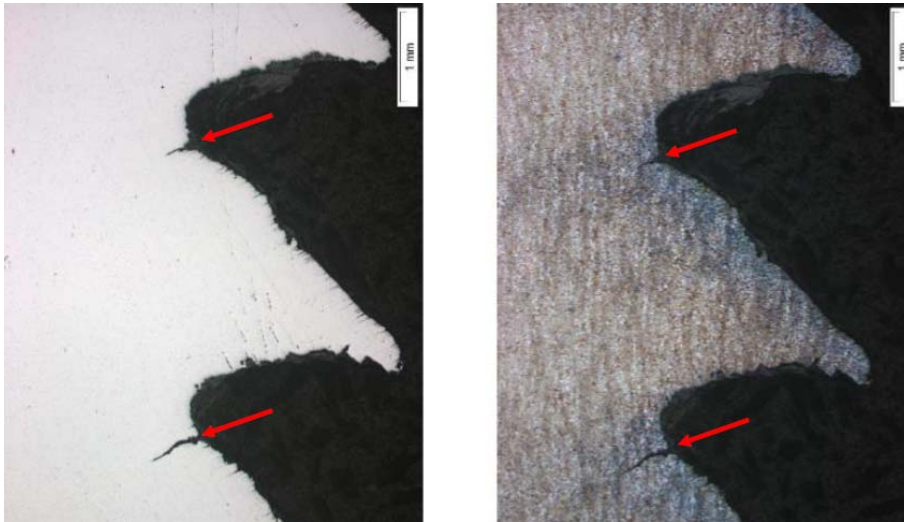
Fig. 11 Recording of several cracks found in some of the valleys of the threads of the fractured pin 1. The threads of pin 1, as well as that of its seat, were probably deformed plastically after the fracture occurred

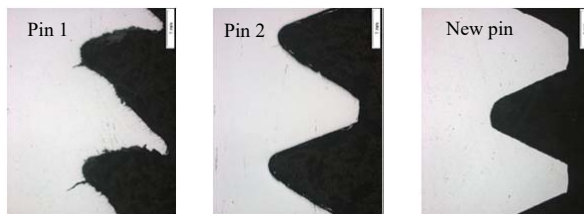
Fig. 12 Pin threads

The threads of the pin/seat 2 and the pin/new seat were shown with thread geometry to the satisfaction (without cutting edge) and without the presence of cracks and/or plastic deformations. An exception is that only a small crack was found in a valley of the pin 2 thread, most likely as a

consequence of the overload imposed after the fracture of pin 1. The comparative table in Fig. 12 shows the comparison

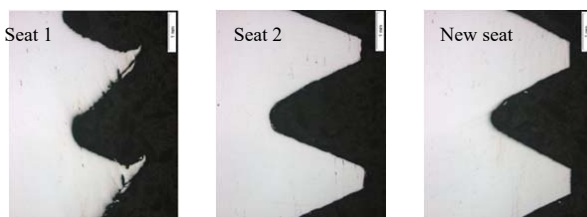
Fig. 13 Seat threads of pins

between the pin threads and Fig. 13 shows the comparison between the seat threads.
