Restoring Trees Damaged by Cyclone Hudhud at Visakhapatnam, India

Mohan Kotamrazu

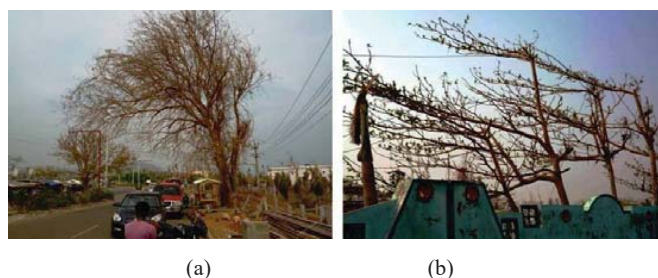
recover fast from damage due to defoliation. Defoliated *Ficus religiosa* trees at Rushikonda and defoliated *Terminalia catappa* trees at a park in Bheemli are shown in Figs. 1 (a) and (b) respectively. Fresh sprouts on a *Terminalia catappa* tree at Tenneti Park soon after the storm are shown in Fig. 2 (a) and the same tree regained most of its foliage two months after the storm as shown in Fig. 2 (b).

Fig. 1 (a) Defoliated *Ficus religiosa* tree at Rushikonda, Visakhapatnam (b) Defoliated *Terminalia catappa* tree in a park at Bheemunipatnam

Defoliated trees should be saved as usually they will re-foliate. If the tap root of a fallen tree is intact, then the chances of its survival are good. Leaning trees and trees with roots severed roots which are a source of hazard for buildings or for the movement of pedestrians should be removed.

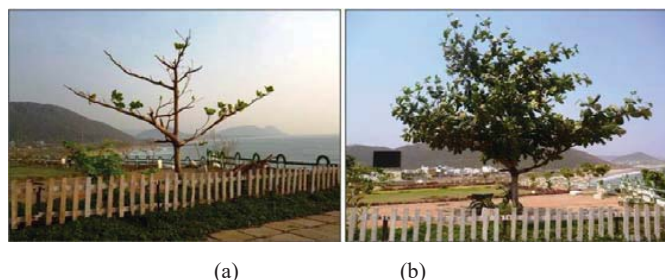
Fig. 2 (a) Fresh sprouts on a *Terminalia catappa* tree at Tenneti park (b) Defoliated *Terminalia* tree with foliage regained two months later

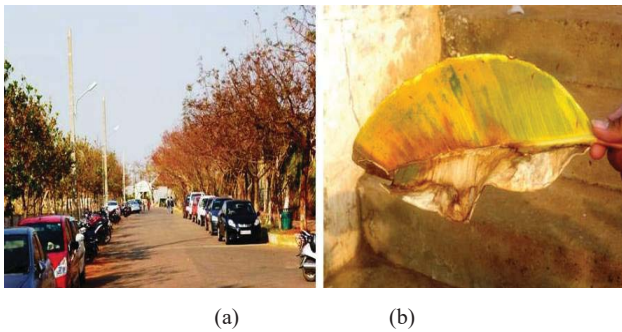
One peculiar type of damage to the majority of the trees was observed in the aftermath of the cyclonic storm. Most of the leaves of the trees turned black. This phenomenon occurs due to the deposition of salt laden water droplets on trees and shrubs. All parts of the plant including leaves, stems, roots and fruits, may be reduced in size [1]-[3]. Damage due to salt spray can be reduced if the plants are washed with water or in the event of rains occurring immediately in the aftermath of a cyclonic storm. Fig. 3 (a) shows salt spray damage to the *Calophyllum inophyllum* and *Tecoma castanifolia* trees in the Gitam University campus. Fig. 3 (b) shows a salt burnt leaf of *Ficus elastica* tree in the Tenneti Park at Visakhapatnam. In the Gitam University campus at Visakhapatnam the leaves of *Mimunsops elengi* trees (Fig. 4 (a)), *Polyalthia longifolia*

Fig. 3 (a) Salt spray damage to trees in Gitam University (b) Salt spray damage to *Ficus elastica* leaf at Tenneti Park, Visakhapatnam

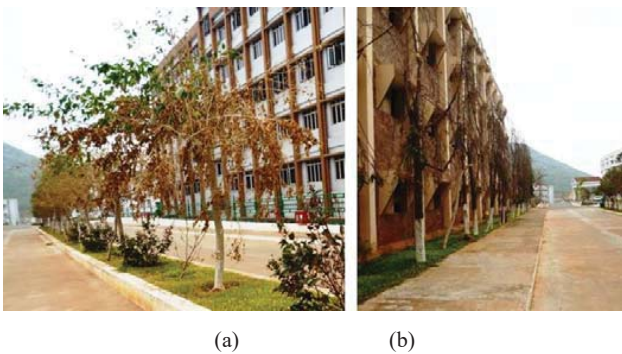
(Fig. 4 (b)) and *Ionophyllum callophyllum* (Fig. 5) suffered extensively from salt-spray damage.

Fig. 4 (a) Salt spray damage to trees in Gitam University (b) Salt spray damage to *Ficus elastica* leaf at Tenneti Park, Visakhapatnam

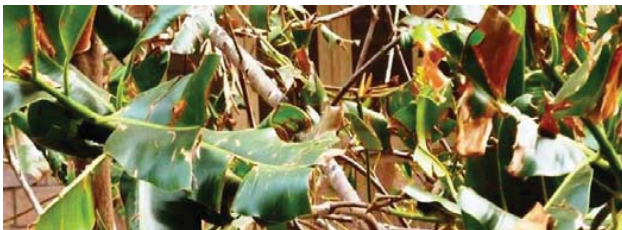
Fig. 5 Leaves of *Ionophyllum cannophyllum* trees in the Gitam University Campus showing signs of damage by salt spray

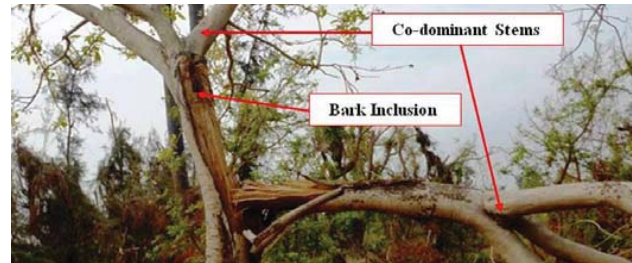
A tree with two or more trunks of similar size is said to have co-dominant stems. Trees with co-dominant stems are usually weaker than trees with a single upright stem as inferior quality bark is often deposited in the joints of the co-dominant stems which results in failure of the branches in the face of strong winds [5], [6]. According to [7], co dominant stems are prone to failure as the included bark between these stems do not from a connective tissue. Damage to the co-dominant stems of a *Ficus religiosa* tree along the beach road near Rushikonda is shown in Fig. 6. Fig. 7 (a) shows damaged Peltophorum trees in Gitam University campus at Visakhapatnam. Fig. 7 (b) shows a Peltophorum tree at Kailashgiri in Visakhapatnam where cyclone Hudhud made its

Fig. 6 Damage to co-dominant stems of a *Ficus religiosa* tree on the beach road near Rushikonda, Visakhapatnam

landfall. Fig. 8 shows views of Eucalyptus trees before and after the cyclone. Majority of the trees damaged by strong cyclonic winds such as Peltophorum, *Ficus religiosa*, *Acacia auriculiformis*, etc. were trees with co-dominant stems. The solution to reduce storm damage to such trees is through structural pruning where competing stems are pruned.

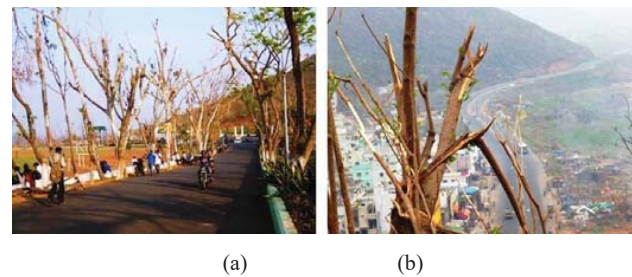
Fig. 7 (a) Damaged Peltophorum trees in Gitam University (b) Damaged Peltophorum at Kailashgiri, Visakhapatnam

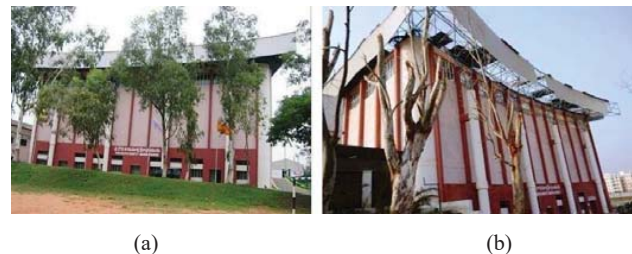
Fig. 8 Views of the Eucalyptus trees at Gitam University campus before and after the cyclone

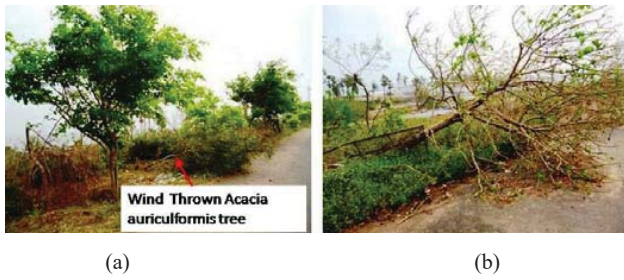
Tall trees that are top heavy and possess shallow roots such as *Sweitenia mahagoni*, *Spathodea campanulata*, *Greviella robusta* are more prone to wind throw and uprooting than smaller trees with deep roots [4]. Tall trees with deep roots, widely spaced branches and a symmetrical, tapering crown such as *Araucaria heterophylla* are less vulnerable to damage from wind throw [5]. Trees whose roots get cut during the laying of roads or pavements are also susceptible to damage from wind throw. Wind thrown *Acacia auriculiformis* and *Thespesia populnea* trees along the Visakha-Bheemli Beach Road are shown in Fig. 9. An uprooted *Ficus religiosa* tree along a road at Andhra University Campus in Visakhapatnam is shown in Fig. 10 (a). Wind thrown *Sweitenia mahagoni*

Fig. 9 (a) Wind thrown *Acacia auriculiformis* tree along the Beach Road at Visakhapatnam (b) Wind thrown *Thespesia populnea* tree along the Beach Road at Visakhapatnam.

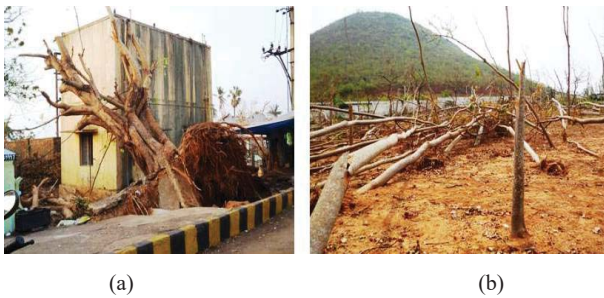
trees in the Gitam University Campus at Visakhapatnam are shown in Fig. 10 (b).

Fig. 10 (a) Uprooted *Ficus religiosa* tree at Andhra University Campus (b) Wind thrown *Sweitenia mahagoni* trees at Gitam University Campus

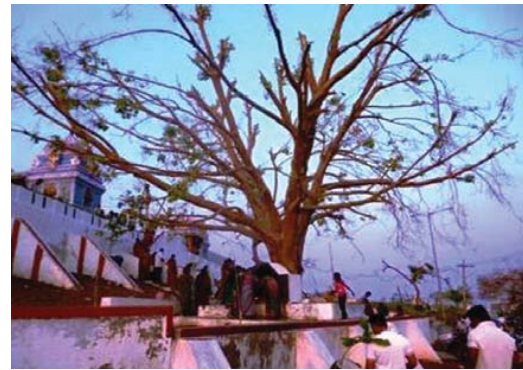
Soon after a cyclonic storm an assessment of the damage to trees, shrubs and landscape elements should be carried out and various actions have to be taken to rescue damaged trees. As pointed out by [1], at least four factors should be evaluated prior to making a decision to save a damaged tree: sentimental value, growth rate, condition of the tree and transplantability. Fig. 11 shows a partially damaged *Ficus religiosa* (Peepal) tree at Visalakshmi Nagar at Visakhapatnam. This tree, located at the entrance of a temple has sentimental value and is worshipped by people who visit the temple.

Fig. 11 A partially damaged *Ficus religiosa* (Peepal) at the entrance of a temple at Visalakshinagar

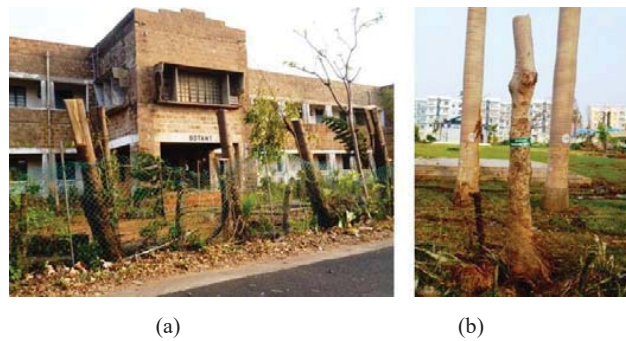
Pre-disaster pruning of the foliage can save trees, especially top-heavy trees, from blowing over and make them more wind resistant. Trees with damaged co-dominant stems should be pruned rather than topped. Topping (Fig. 12) is a harmful practice where the entire canopy of a tree is severely reduced with heading cuts and leads to tree decay [8].

Fig. 12 (a) Topped *Polyalthia longifolia* trees in the Botany department at the Andhra University campus (b) Topped *Delonix regia* tree in the Vuda Park at Visakhapatnam

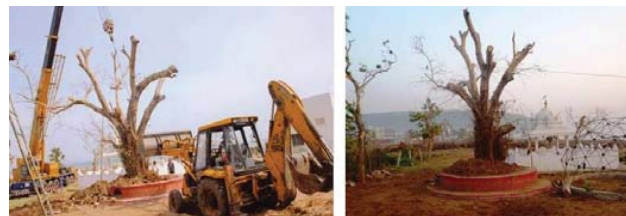
Fig. 13 A restored *Ficus religiosa* tree at Shanti Ashram at Visakhapatnam. Photo Credit: C. V. Subhramanyam

A fifty year old *Ficus religiosa* tree at the Shanti Ashram was completely uprooted and given up for dead has been

given a new life through careful restoration efforts. The tree had sentimental value for the inmates of the Ashram as it was planted by its founder Swami Omkar. Fig. 13. shows the restoration efforts for the *Ficus religiosa* tree. Earth was dug six feet deep with the help of an earthmover. By crane and some strong ropes were used to provide support and the huge trunk was covered with heaps of soil for replanting the fallen tree. Fig. 14 shows the restored tree with regained foliage one year after the cyclonic storm.

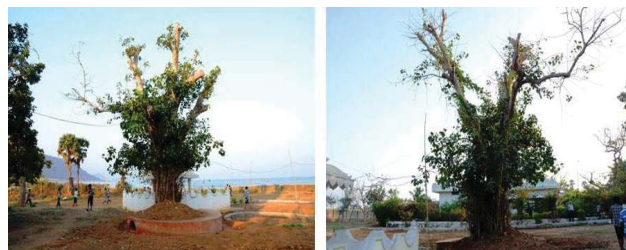
Fig. 14 Restored *Ficus religiosa* tree with regained foliage one year after the cyclone Hudhud

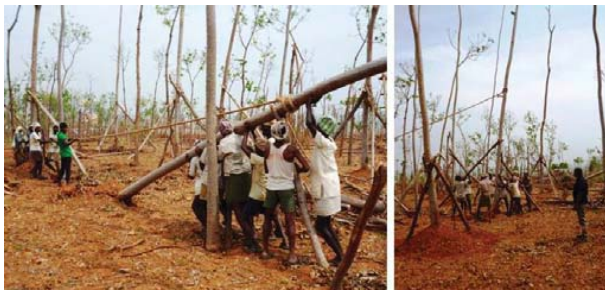
Fig. 15 Restoration of *Sweitenia mahagoni* trees at Gitam University, Visakhapatnam

Most of the tall and top heavy Mahagoni trees which got uprooted in the Gitam Campus have been uplifted and staked and have been completely restored as shown in Fig. 15. Restoration of collapsed *Greviella robusta* trees is shown in Figs. 16, 17. Restoration efforts in Shivaji Park, Vuda Park and Andhra University are shown in Figs. 18-20.

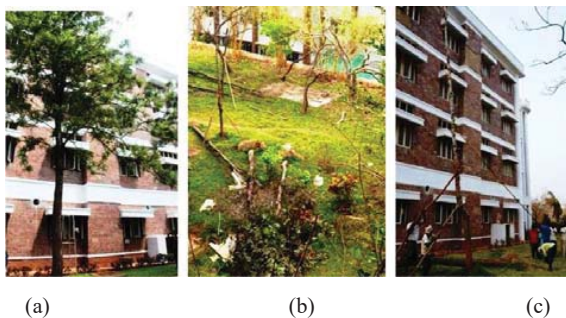
Fig. 16 (a) A *Greviella robusta* tree before the cyclone Hud-Hud (b) Uprooted *Greviella robusta* trees (c) A restored *Greviella robusta* tree

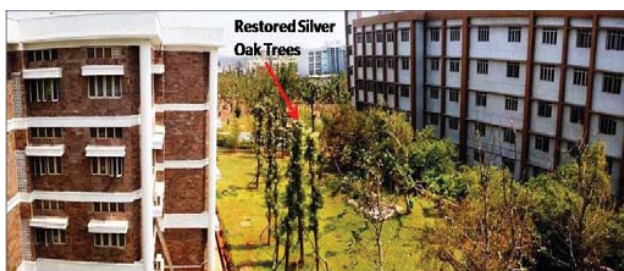
Fig. 17 Restored *Greviella robusta* trees in the Gitam University Campus at Visakhapatnam

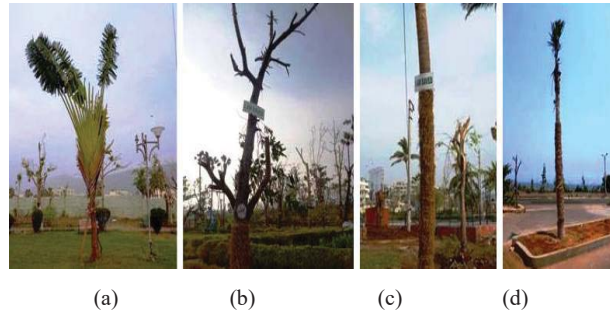
Fig. 18 (a) A restored *Ravenelia madagascarens* palm at Shivaji Park (b) A restored *Terminalia catappa* tree at Vuda Park (c) and (d) Restored *Borassus flabifer* palms in Vuda Park

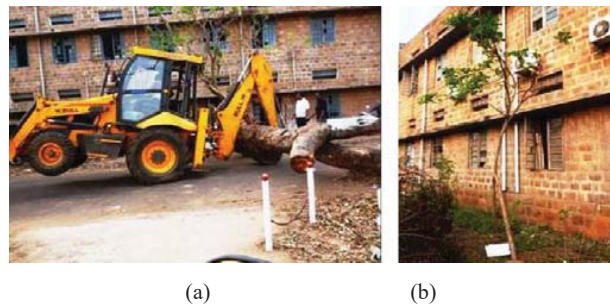
Fig. 19 (a) Removal of debris of fallen trees at Andhra University (b) A restored *Phyllanthus embilica* tree in the Botany Department at Andhra University Campus

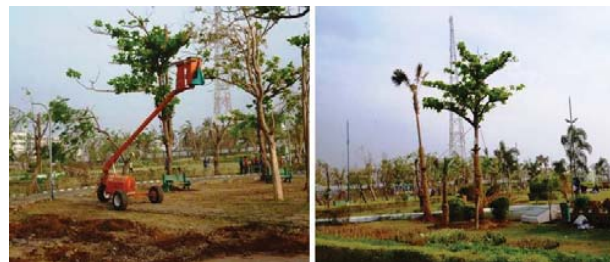
Fig. 20 Structural pruning and restoration of *Terminalia catappa* trees at Vuda Park
