The Collapse of a Crane on Site: A Case Study

T. Teruzzi, S. Antonietti, C. Mosca, C. Paglia

Abstract—This paper discusses the causes of the structural failure in a tower crane. The structural collapse occurred at the upper joints of the extension element used to increase the height of the crane. The extension element consists of a steel lattice structure made with angular profiles and plates joined to the tower element by arc welding. Macroscopic inspection of the sections showed that the break was always observed on the angular profiles at the weld bead edge. The case study shows how, using mechanical characterization, chemical analysis of the steel and macroscopic and microscopic metallographic examinations, it was possible to obtain significant evidence that identified the mechanism causing the breakage. The analyses identified the causes of the structural failure as the use of materials that were not suitable for welding and poor performance in the welding joints.

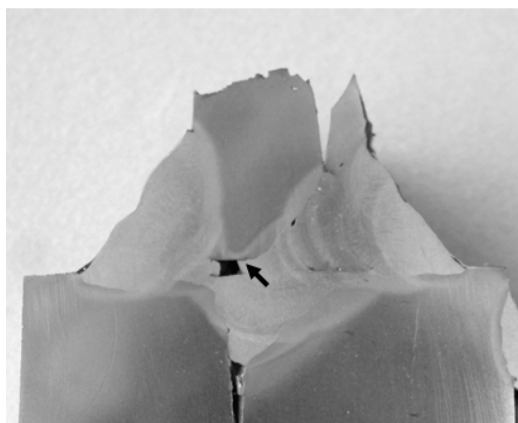
Fig. 6 Joint 4, Welding seam between the corner profile and the plate overlaps to the joint between the two elements making up the plates. Lack of penetration of the filler metal and lack of fusion (arrows)

The examination of the connection plates corresponding to the broken joints revealed that they are not monolithic, but they were obtained by joining two elements by welding. Locally, the welding seam between the corner profile and the plate overlaps the joint between the two elements making up the plates (Fig. 6). Welding on an existing welded joint is not in accordance with practice and is not recommended.

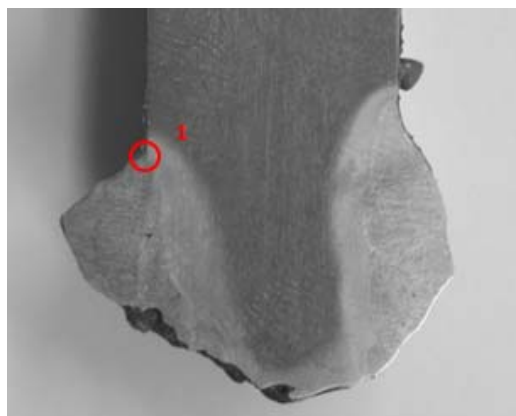
Fig. 10 Joint 2B, Corner profile, location micrograph #.1

At joint no. 2, in particular on specimen 2B, the presence of a marginal crack inside the HAZ of the corner profile is observed (Figs. 10, 11). It propagates from the upper edge of the weld seam and initially runs along the border line with the FZ, and then continues towards the core of the profile. It is a cold crack. This two-dimensional defect is unacceptable as it represents a discontinuity which, over time can lead to the failure of the joint, depending on the operating stress.

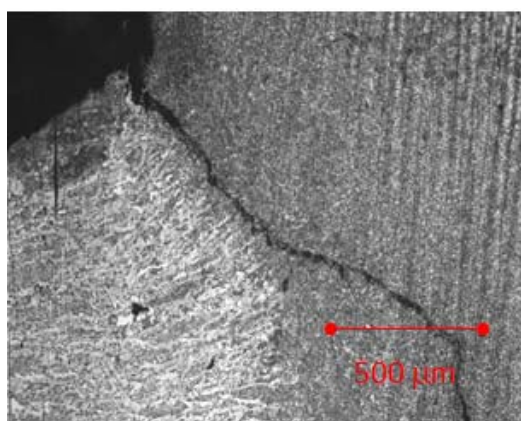
Fig. 11 Joint 2B, corner profile, HAZ: micrograph #.1. Cold cracking
