# The High Temperature Damage of DV – 2 Turbine Blade Made from Ni – Base Superalloy

Juraj Belan, Lenka Hurtalová, Eva Tillová, Alan Vaško, Milan Uhrčík

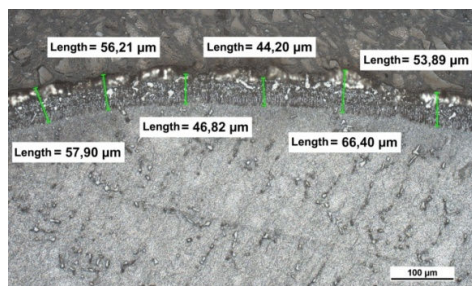
Fig. 4 Al – Si protective layer thickness measurement, non-etched specimen: (a) leading edge with average coating thickness of 50  $\mu\text{m}$ , (b) turbine blade back with average coating thickness of 36  $\mu\text{m}$ , (c) flow edge with average coating thickness of 45  $\mu\text{m}$

The Al – Si layer on the surface of blade is significantly coarsened and lost its homogeneity due to high temperature degradation and abrasive wearing. Degradation as itself shows in layer thickness increasing. Al – Si layer thickness  $h$  depending from spraying thickness at its application and can be easily determined from dependence  $h = 0.7\delta$ , where  $\delta$  is for spraying thickness. Then for starting stage Al – Si layer thickness is around  $h = 24.5 \mu\text{m}$  (an optimum spraying thickness for annealing at 950°C is up-to  $\delta = 35 \mu\text{m}$ ). The thickness of Al – Si layer is higher in all observed areas what indicates higher temperature of loading than reported 751°C. The highest degree of degradation was observed at three areas from all four observed, namely leading edge with average thickness 50  $\mu\text{m}$ , Fig. 4 (a); turbine blade back with average thickness 36  $\mu\text{m}$ , Fig. 4 (b); and flow edge (in some parts of flow edge was not Al – Si layer identified at all, a huge degradation due to abrasive wearing at high temperatures) with average thickness of 45  $\mu\text{m}$ , Fig. 4 (c).

- Protective Al – Si layer is significantly degraded all around the surface, its thickness on leading edge is average  $50\ \mu\text{m}$ , and on the back is  $36\ \mu\text{m}$  and flow edge with average thickness  $45\ \mu\text{m}$ , so Al – Si layer is inconvenient. A needle like Cr rich carbides and blocky form of primary Ti rich carbides are forming. In this area is a high expectation of crack initiation at further working cycle of blades.
- Base material, Ni – base superalloy ŽS6K, also shows significant level of degradation, especially on strengthening intermetallic precipitate  $\gamma'$ , which has formed *rafts* and changes its morphology, from cubic to spheroidal shape. The morphology changing of  $\gamma'$  has influence on creep rupture life of blades due to decreasing of precipitation hardening effect and increasing of  $\gamma/\gamma'$  mismatch.

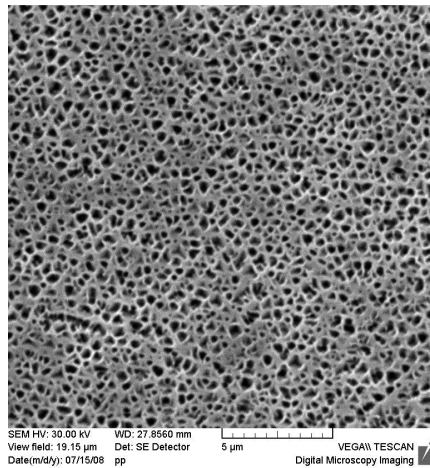
Fig. 6 Degradation of  $\gamma'$  precipitate at high temperature ( $751^\circ\text{C}/2\text{s}$ ) loading compared to starting stage microstructure: (a)  $\gamma'$  - phase morphology, initial stage, (b) after  $751^\circ\text{C}/2\text{s}$  for 600 hours of loading, etch. Marble, SEM

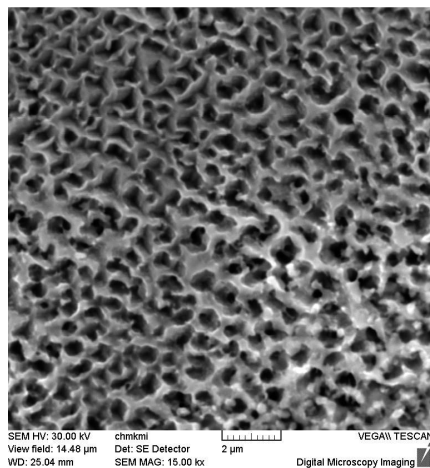
(b)

secondary  $M_{23}C_6$  carbides formed and lowering creep resistance of base material. The strengthening intermetallic  $\gamma'$  precipitate also degrades by changing its morphology from previous cubic shape like onto coarse spheroidal particles with average size  $0.6\ \mu\text{m}$ , Fig. 6.

This shape and size changes cause decreasing creep rupture life of alloy, Fig. 7 [8]. As a matter of a fact, creep at high temperatures is driven mainly by diffusion mechanism and deformation rate increases with higher amount of dislocations and their easier slip, which have been previously blocked by tide distribution of cubic morphology of  $\gamma'$  precipitates. Coarsening and spheroiding of  $\gamma'$  precipitates leads to creation of wider channels between  $\gamma'$  particles and dislocations can easier move, so deformation of base material can propagate.

All reported changes indicate that temperature of overheating was not  $751^\circ\text{C}/2\text{s}$ . This kind of degradation occurred after longer time exposition at temperatures close to  $900^\circ\text{C}$ .
