The Significance of the Radiography Technique in the Non-Destructive Evaluation of the Integrity and Reliability of Cast Interconnects

Keshav Pujeri, Pranesh Jain, and Krutibas Panda

IV. CASE STUDY OF AN INTERCONNECT FAILURE IN THE FIELD

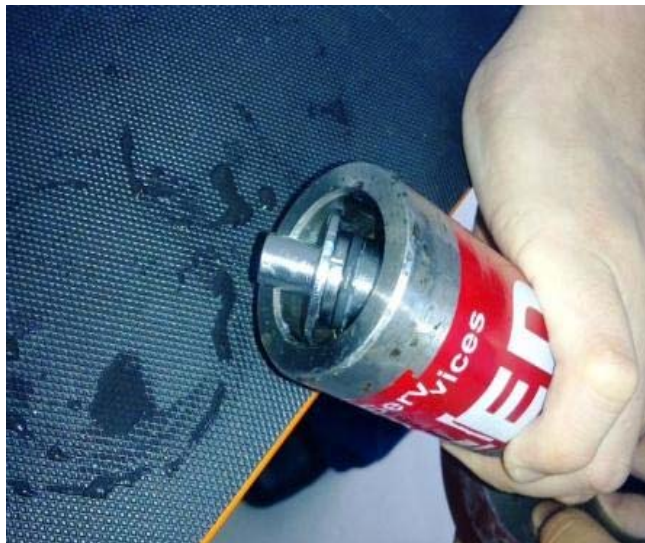
When internal parts of the interconnect assembly were removed; traces of drilling fluid were observed which could have caused the electrical failure (Fig. 3). Further visual inspection of the interconnect revealed a deformity at the inner neck area close to the wire-way. When combined with the evidence of the drilling fluid, we suspected that there was a casting defect in the interconnect body. This defect could have been exposed after the downhole run and drilling fluid would have leaked into wire-way (Fig. 4).

Fig. 3 Leakage inside the connector

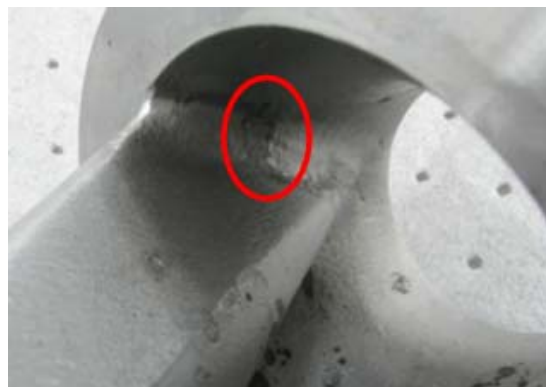
Fig. 4 Suspected casting defect area

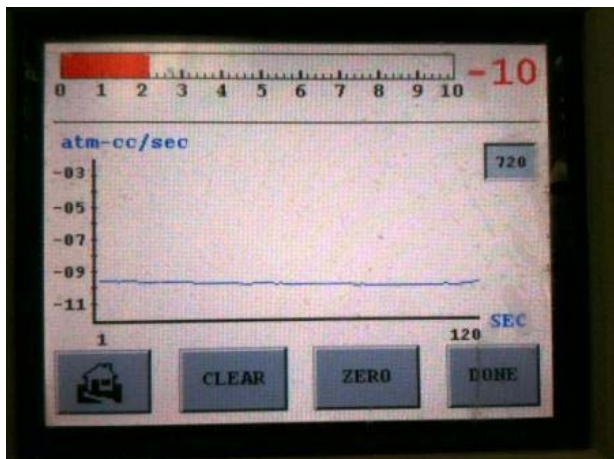
The component was tested for Helium leak with appropriate sealing and fixtures; the leak graph showed no spikes on the sensor/detector monitor (Fig. 5). Hence HLT couldn't detect any defect with the failed interconnect.

Fig. 5 Graph: Rate of Helium leak v/s time

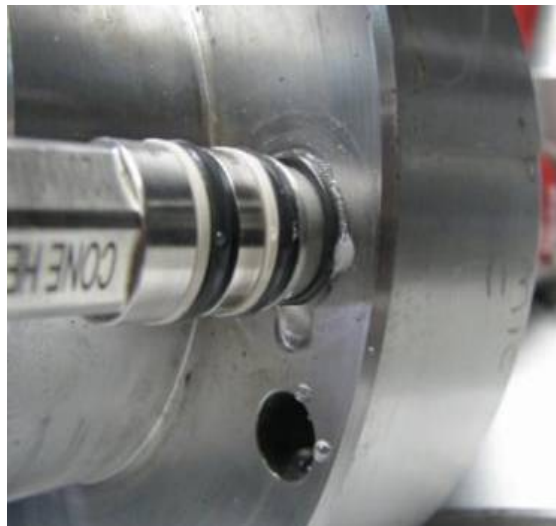
The interconnect was tested three times by applying pressure of 25 ksi twice and 30 ksi once for about 30 minutes each time. We saw that the component had leaked water droplets after the pressure test fixtures were removed but that the fixtures didn't have water drops on them, indicating that the leakage probably did not occur from the fixture side (Figs. 6 and 7).

Fig. 6 Gas escapes while removing fixture

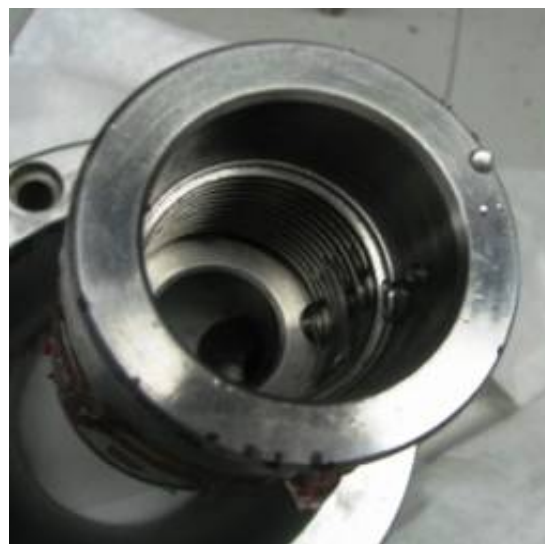
Fig. 7 Water droplets leaked deep in interconnect

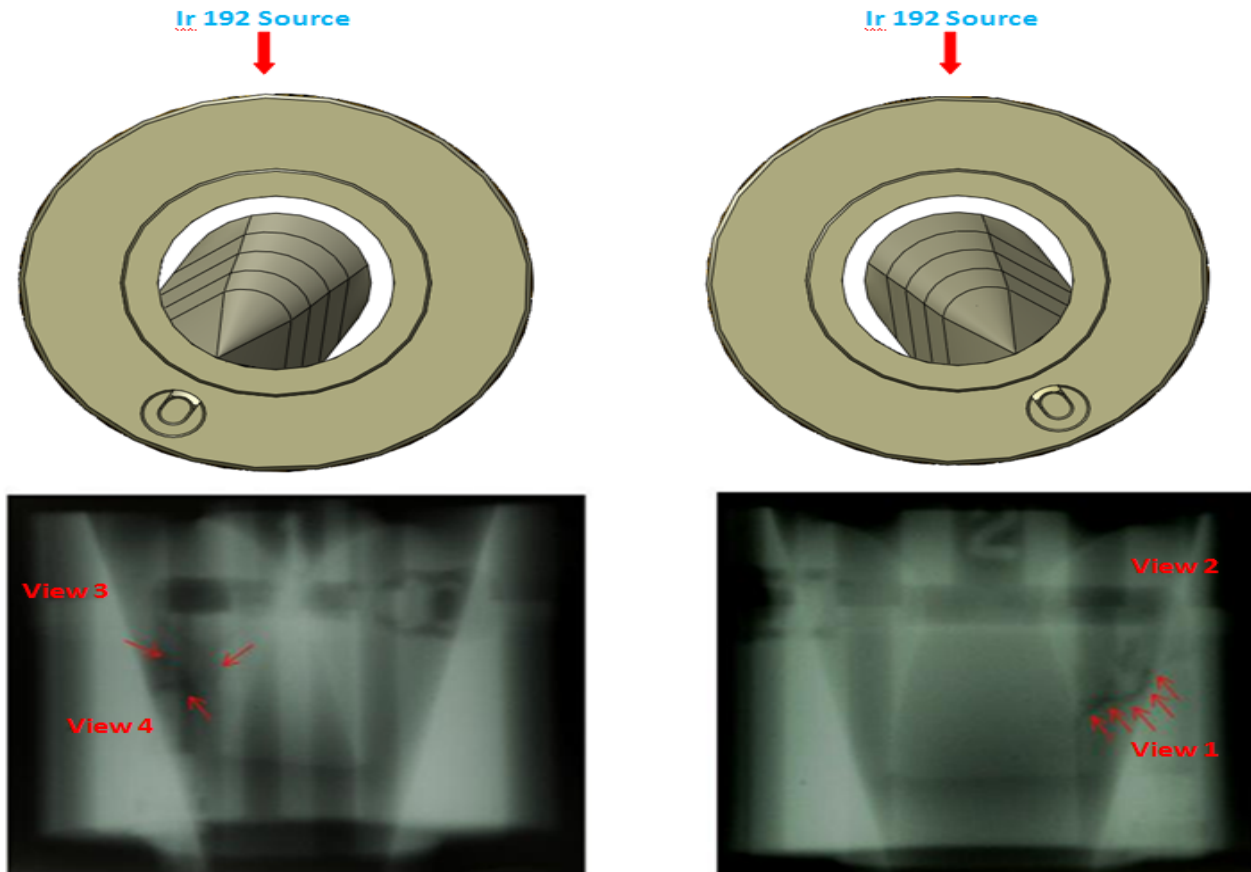
A radiography test was conducted on the component as per ASTM standard E1742/ E1742M [5]. Iridium-192 was used as the source of the gamma rays. The images were captured on radiography films and compared with standard ASTM Radiographs E446-10 [3]. The nature and intensity of the contrasting areas on the radiographs led to the conclusion that the defect was shrinkage porosity type 'CB' and severity level '3' (Fig. 8).

Fig. 8 Radiography test on the defect interconnect

Based on the radiography results, the mold design was improved by introducing a new gating system. Additionally, radiographic inspection was added to test all components in 'as cast' condition irrespective of their class; as testing each component is much less expensive than a down-hole failure.

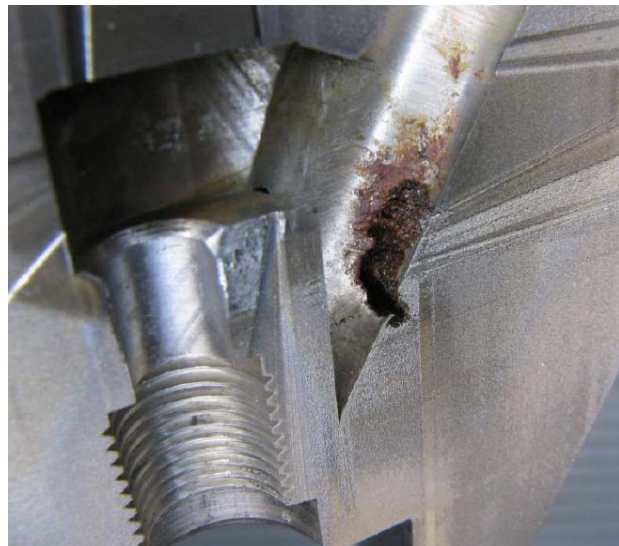
The component was sectioned into two halves by Electric Discharge Machining (EDM) and further metallurgical characterization studies were performed. Cross-sectional analysis near the defect location indicated a hole with brown residue surrounding it as illustrated in Fig. 9. High-resolution electron micrographs at this location indicated solidification of the dendrite structure as shown in Fig. 10. This is indicative of a shrinkage defect. Energy dispersive X-ray spectroscopy performed on the brown residue surrounding this defect indicated a significant presence of carbon, likely grease or oil residue near the defect. The shrinkage porosity was not isolated to a small area but was rather spread across the entire thickness as seen in certain cross-sectional views (Fig. 11).

Fig. 9 Cavity found at defect location

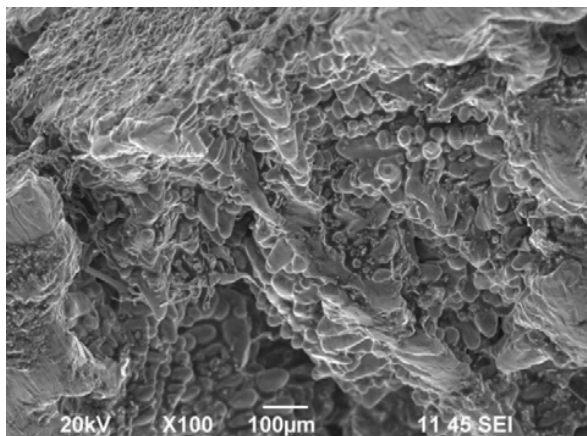
Fig. 10 Microscopic view of the dendrite structure at the shrinkage

In summary, the metallurgical characterization identified the location of the defect and high-resolution microscopy confirmed that the defect was a result of shrinkage porosity. The shrinkage porosity was found to occupy a comparatively larger volume fraction.
