# The Significance of the Radiography Technique in the Non-Destructive Evaluation of the Integrity and Reliability of Cast Interconnects

Keshav Pujeri, Pranesh Jain, and Krutibas Panda

#### IV. CASE STUDY OF AN INTERCONNECT FAILURE IN THE FIELD

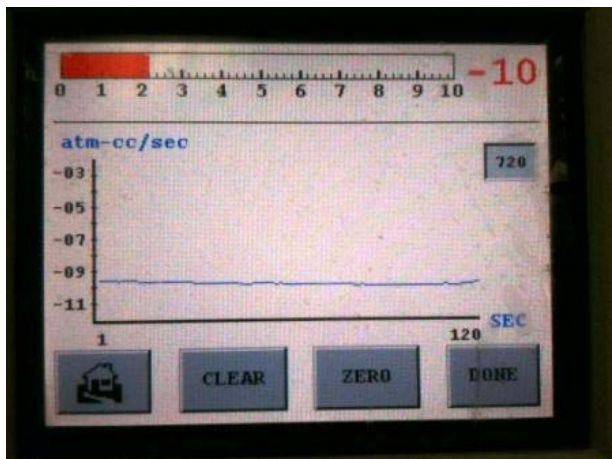
The component was tested for Helium leak with appropriate sealing and fixtures; the leak graph showed no spikes on the sensor/detector monitor (Fig. 5). Hence HLT couldn't detect any defect with the failed interconnect.

Fig. 5 Graph: Rate of Helium leak v/s time
