Analysis and Preservation of Lime-Kilns in Corsica

A. Papalou, K. Vozikis

IV. PRESENTATION OF TWO LIME KILNS AT THE POINT OF CAP CORSE

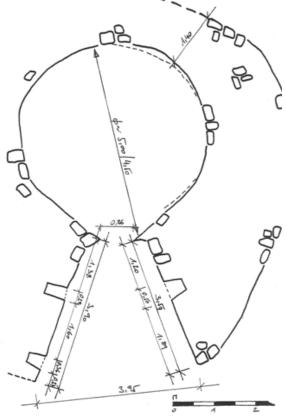
Fig. 4 Ground plan of Lime Kiln 1

This kiln has been partly built adherent to the hillside (almost two thirds of it). The rest of the kiln is constructed of stone walls with mortar. The thickness of the walls varies from 1.4 up to 3.6 m close to the entrance. The inside diameter of the chimney is around 5 m at the bottom (Fig. 4), narrowing gradually and reaching 4.5 m at the top. The entrance foyer of this lime kiln is almost 4 m long. The gate for entering the foyer is also almost 4 m wide, narrowing gradually until the door where the firing occurred. This firing door is today around 0.85 m wide. In this foyer, three 0.5 x 0.5 m niches still exist.

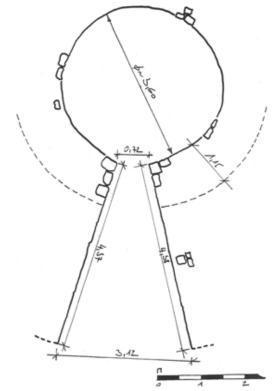
Fig. 7 Ground plan of Lime Kiln 2

Lime kiln 2 (Fig. 6) also belongs to the Community of Rogliano and is located next to lime kiln 1. This lime kiln is much smaller than lime kiln 1. The inside diameter of the kiln's shaft measures only 3.6 m, and is constant from bottom to top (Fig. 7). This structure has also been partly built into the hillside. The rest of the kiln form walls built with mortar of 1.15 m wide. An entrance fover is still visible, but not so well maintained. The entrance width is about 3 m and the distance from the corridor to the firing door almost 4.5 m. The firing door is 0.72 m wide and 1.60 m tall and is better preserved than the previous one (Fig. 8). The firing door dimensions of these two lime kilns are similar, although the shaft's dimensions vary considerably. The shaft of this kiln is in good condition in contrast to the outside part of the foyer. The kiln's height is today approximately 5 m. Two wooden beams still exist at the firing door opening. Lime kiln 2 was probably using the same quarry as lime kiln 1. This kiln is also visible and easily reachable from the custom footpath although its outside part is completely covered by maquis.

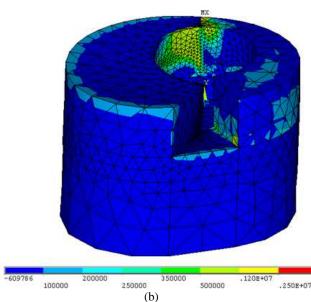
Structural analysis was performed on a typical limn kiln using the finite element method. The dimensions used for the model are representative of the dimensions of the lime kilns of Corsica and are based on the dimensions of lime kiln 1. In the finite element model the soil underneath the kiln was considered to extend up to 4 m. The thickness of the soil was 1.5 m at the junction of the thick stone wall with the soil, 10 m in the middle and 4 m next to the entrance (Fig. 9(a)). Extended dimensions of the soil were considered so that the kiln's existence had small influence on the soil at the end of the model where the boundary was considered fixed. A masonry wall of 0.20 m thickness was attached to the soil inside the shaft. Based on observations of the soil and masonry walls of the lime kilns in Corsica, the following properties were used to represent appropriately the materials that compose the lime kilns: the soil's density was 1800 kg/m³, the modulus of elasticity 35 MPa, and the Poisson's ratio 0.24. The masonry's wall density was 2100 kg/m³, the modulus of elasticity 2500 MPa, the Poisson's ratio 0.24, the compressive strength 2.5 MPa, and the tensile strength 0.25 MPa. The materials were considered homogeneous and isotropic. Only dead load was considered. Static analysis was performed using the structural analysis software Ansys. The masonry and the soil were modeled using a 10 node, 3-D solid element. The results are presented in the form of contour plots of the first principal stress (in Pa). Fig. 9(b) shows that the masonry walls are the most stressed parts of the lime kiln. Most of these high stresses are due to the pressure that the existing soil exerts on the masonry structure. In particular, the most stressed areas are the area around the junction of the thick wall with the soil (extended to the thin wall inside the shaft), and the lower part of the thick masonry wall at the entrance. At these areas the stresses exceed the tensile strength of the wall. These results explain the damages appearing on the lime kilns not only in Corsica but elsewhere also (Fig. 6) where the stones have fallen inside the shaft and the entrance wall has been destroyed.

Fig. 9 (a) Finite element model of the lime kiln and the surrounding soil examined (light blue colour represents the soil and dark purple the masonry) (b) First principal stress (in Pa) of the lime kiln and the surrounding soil

Lime kilns are historical structures of every country's industrial heritage and an effort must be made for their restoration and preservation. This can be accomplished by removing any vegetation that has grown, replacing the mortar and stones that have been fallen or are in poor condition, and strengthening the areas of high stress. Several methods can be considered for increasing the strength of this structure and reducing the danger of future damage. One of these methods is the post-tensioning that has been used to strengthen several historical structures in the past [11]. A significant advantage of this method is its reversibility, keeping the structure in its original form something highly desirable for historical structures according to the directions of the Charter of Venice [12]. In this method stainless steel tendons are placed in any direction needed and are tensed with an initial stress that can

tie the structure and reduce the danger of failure. The tendons not only stabilize the structure but also apply compressive stresses to the walls they are tied on, reducing the tensile stresses that may exist. The post-tensioning system must be designed for the case in hand, selecting appropriately not only the properties of the tendons but also their location and the anchoring technique.
