Behavior of RC Buildings to Tsunami Action

Carlos H. Cuadra

Abstract—The present report describes the characteristics of damages and behavior of reinforced concrete buildings during the tsunami action. The discussion is based on the field damage survey in selected cities located on the coast of the zone affected by the Great East Japan Earthquake on March 11, 2011. This earthquake is the most powerful know earthquake that has hit Japan with a magnitude 9.0 and with epicenter located at 129 km of Sendai city (off the coast). The earthquake triggered a destructive tsunami with run up height of up to 40 meters that mainly affect cities located on the Pacific Ocean coast of the Tohoku region (north-east region of Japan). Reinforced concrete buildings in general resist the tsunami without collapse however the non-structural elements like panels and ceilings were severely damaged. The analysis of damages has permitted to understand the behavior of RC buildings under tsunami attack, and has also permitted to establish recommendations for their use to take refuge from tsunami in places where natural topography makes impossible to reach hilltops or other safer places.

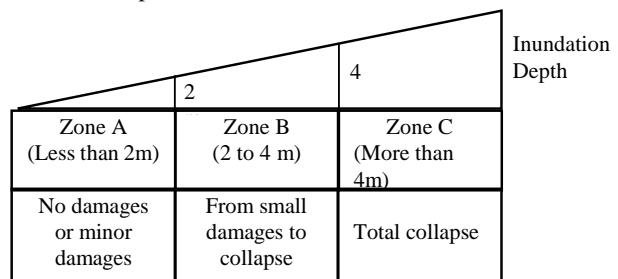
Fig. 6 Inundation depth and damages on wooden houses

recognized that in general the wooden houses collapse or present damages due to the tsunami action when the inundation depth is larger than 2 meters. As is presented in Fig. 6, the damages on wooden houses are divided into three zones according to the inundation depth. Zone A correspond to a places where the inundation depth is smaller than 2 meters and structural damages are not observed, that is the wooden houses are safe in this case. Zone B correspond to a zone where the inundation zone ranges from 2 to 4 meters, and depending on the structural shape, condition of the structural elements, etc, the houses can suffer from light damages to severe damages. From the field observation it can be said that when the water level cover the first floor of the wooden house the structures collapse not only due to the lateral force of the water but also due to the water pressure on the ceiling of the first floor causing floating of the upper floors. Zone C correspond to a zone where the inundation depth is large that 4 meters and total collapse of the structure is expected to occur.

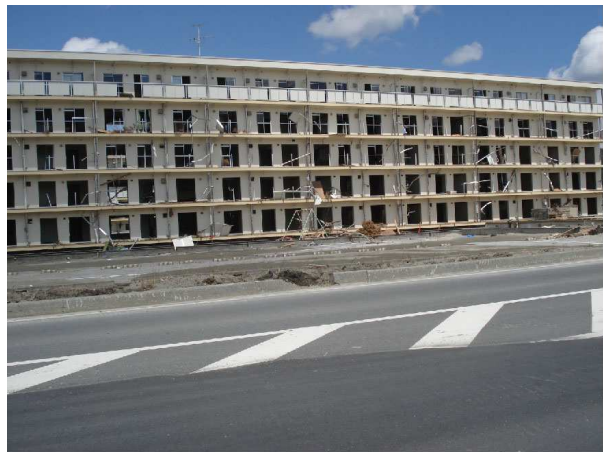
Fig. 17 Building at Rikusentakata city

Fig. 17 shows an apartment building located at Rikusentakata city and from the damages of the balconies it is inferred that the tsunami reaches the fourth floor. Detailed of the damages of the balconies can be observed in Fig. 18, where the panels of the balconies of the fifth floor are intact while the panels of the lower floors are completely destroyed.

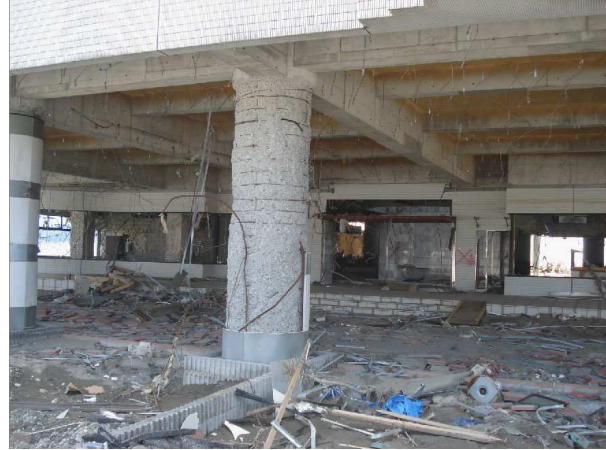
Fig. 20 Detail of RC columns

Fig. 19 and Fig. 20 show the condition of a hotel building located very near the shoreline in Rikuzentakata city. The building resists the tsunami attack however the lower floors suffered the destruction of the non-structural elements and also, as it is observed in the Fig. 19, the building suffered the damage of a reinforced concrete wall due to the lateral water pressure. In this building it was also observed that the cover concrete of structural elements of columns was spall-out probably due to a combination of earthquake vibration action and posterior tsunami as can be observed in Fig. 20

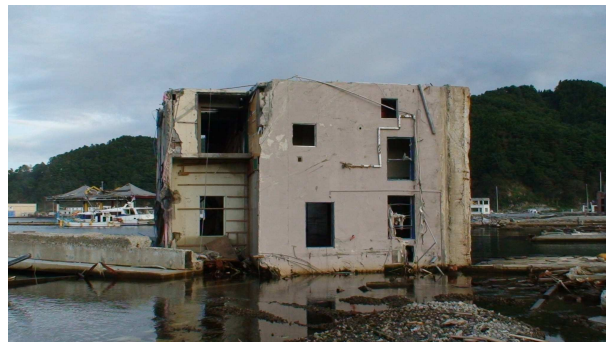
Fig. 21 Overturning of RC building

Fig. 21 shows an overturned 3-story building with a shape of box and few openings. This building was completely covered by the tsunami water and as it is shown in Fig. 22 it has a shallow slab foundation that together with the shape of the building facilitates the action of the floating forces.

If reinforced concrete buildings are intended to be used as refuge, buildings of more than four floors or more than 15 meters are recommend. It is also important to check the condition of the foundation of the structures that are designated as refuge since the failure of the foundation could originate the overturning of the building. Additionally, this selected building must be verified to resist some impact forces or in any case must be located in places where the impact of displaced ships or other building can be avoided.
