The Effects of Roots Action of Tropical Green Roofs—Replication of German FLL in Singapore

Kian. Kai. Tan, Michael. Yit. Lin. Chew, Nyuk. Hien. Wong

Keywords—Building plants, green roof, sustainability, waterproofing membrane

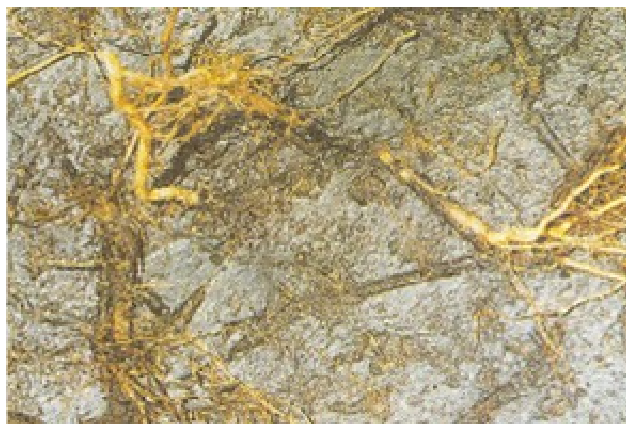
However, due to the nature of the construction industry and the scale of building projects, it is almost impossible for a building to be defect free, including green roofs. Defect on green roof waterproofing membranes are reported in [10], as shown in fig. 1.

Fig. 1 Roots leaving impression on waterproofing membrane, adapted [10]

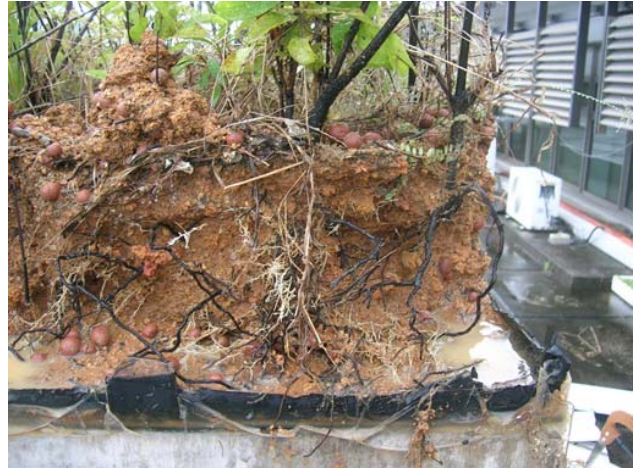
Soil was removed using a water jet. Jet pressure applied was held consistently low to prevent unwanted disturbance to the soil. Soil was removed at a rate of approximately 0.75mm/min for a surface area of 1,000mm×200mm or 150cm³/min. Roots structure exposed after 10mm of soil was removed was vast. This indicates that the duration of this sample was sufficient for roots growth. Exposed roots were approximately 2.5mm thick in diameter, of which covered about 20% of the exposed area (fig. 3).

Fig. 3 Initial exposure of roots

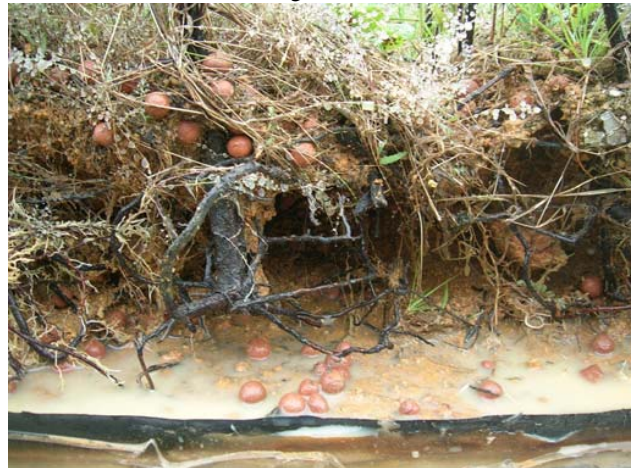
Further erosion revealed the main root of one of the plants of diameter about 12mm. This root terminated 15mm before it reached the membrane. Moreover, the secondary roots, of about 2mm diameter, also turned sideways when they reached the membrane as shown in fig. 4.

Fig. 4 Main root of one of the plants

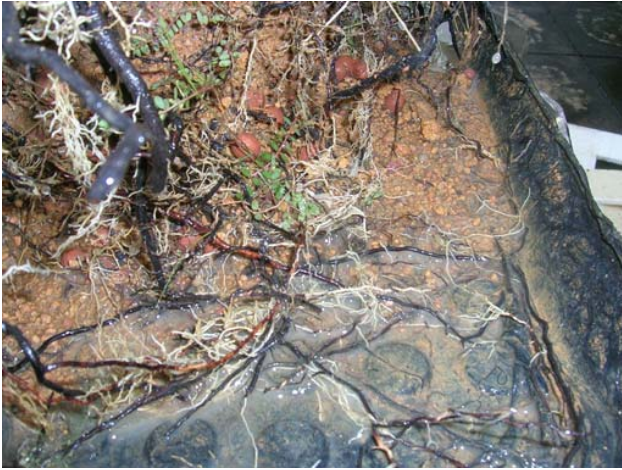
From fig. 5, coverage of secondary roots on the membrane was about 15%. This shows that main roots did not force its way across a membrane; main roots will grow above and do not damage the membrane.

Fig. 5 Secondary roots spreading on membrane surface

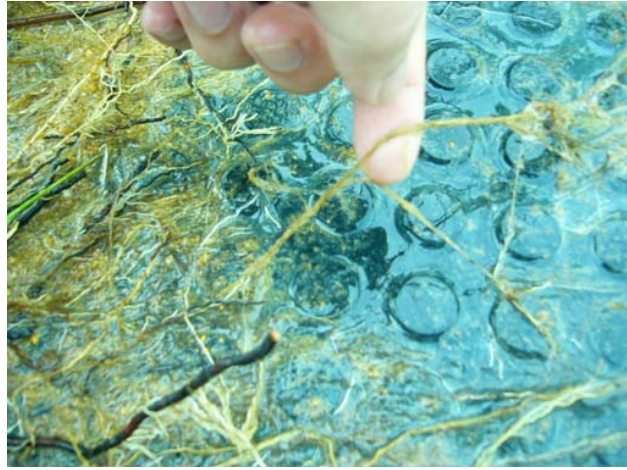
Fig. 7 Roots which seemed to have anchored on the membrane

Further erosion reveals that there were some minor roots which seemed to have grown into the membrane (fig. 7).

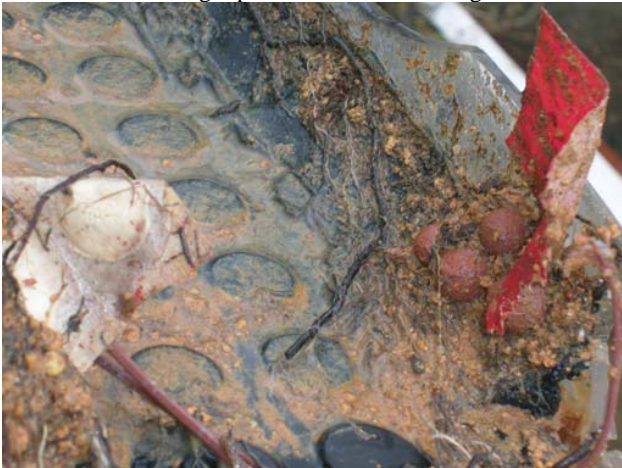
Roots did not grow into the membrane at this area but did seem to grow into the liquid applied waterproofing material used to seal the edges of the sample box. However, there was no evidence of outright penetration as seen in fig. 6.

Fig. 6 Roots seemed to have grown into the liquid applied waterproofing at the edge

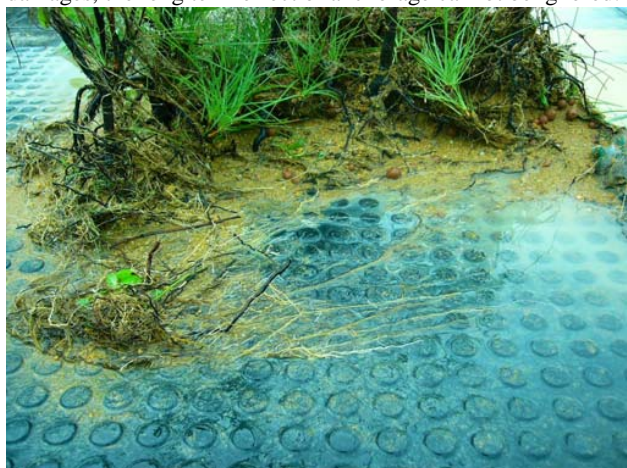
From fig. 8, minor roots which seemed to have anchored on the membrane can be seen. The coverage of these roots was about 40%. Though at closer examination, there was no sign of damages, the long term effect of anchorage cannot be ignored.

Fig. 8 Roots left on the membrane after some erosion; the plants are removed whereas roots which have anchored on the membrane are cut from the plant

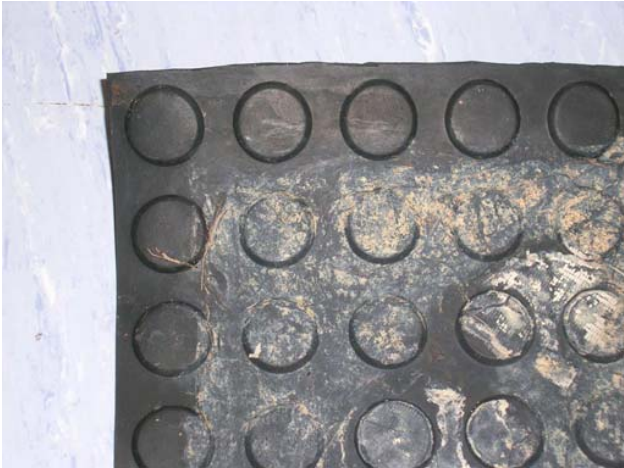
The liquid applied waterproofing was subsequently detached from the sheet membrane and it revealed that no root grew into the joint (fig. 9).

Fig. 9 Clean sheet membrane edges indicate no form of growth between the liquid applied waterproofing and sheet membrane

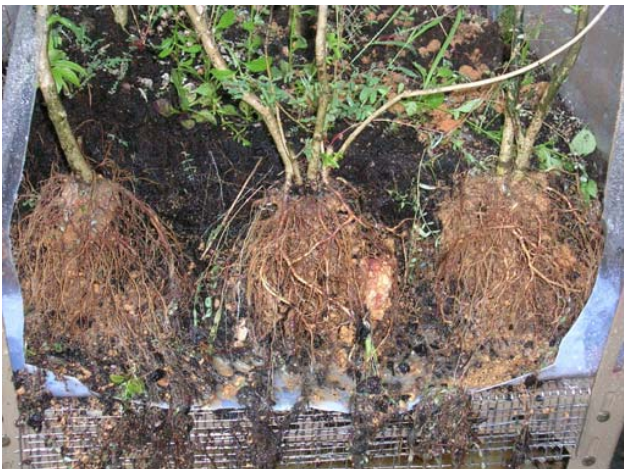
Soil was also removed with a water jet. Upon removal of the first 10mm of soil, substantial root structure was noticed. This again signifies extensive root structure. Further erosion of soil revealed that all the root structures were more well established than those in sample 1, indicating that there was good root growth and the artificial environment created for this sample was conducive for root growth. The root coverage was more than 50% throughout, which was more than sample 1 (15-20%), as seen in fig. 10.

Fig. 10 Vast root structures

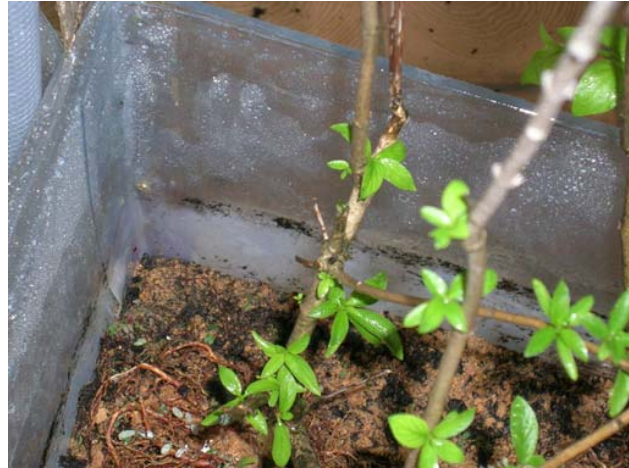
However, the size of roots in this sample was significantly smaller than those in sample 1. This also indicates that though the duration of this sample was sufficient for the root system to grow, the roots might not reach the optimum growth size. From the fig. 11 below, although roots did not anchor in the membrane, it indicates prying action of the roots. This could be due to the improper application of the sealant during the setting-up stage; sealant was not applied to the edge of the joint. The other possibility is simply plant roots poses a challenge to waterproofing systems.

Fig. 11 Growth observed between joints of the membranes

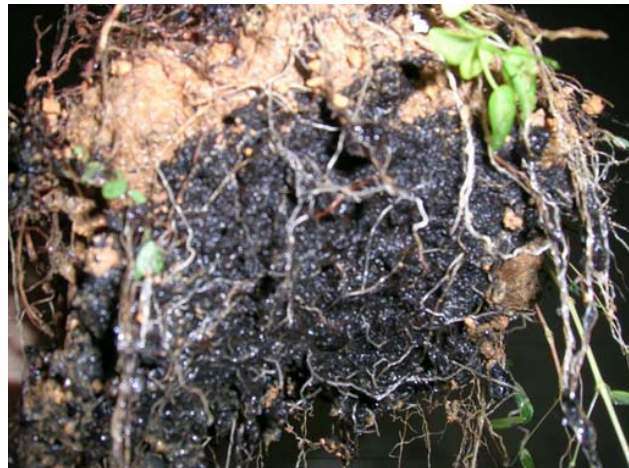
When erosion was sufficient, individual plants, together with some soil, could be lifted. This indicates that was no anchorage of the plants onto the membrane. Furthermore, when observed from the bottom, roots could be seen, implying that roots have grown in and over the fresh plant compound lay below the pre-grown plants (fig. 12). Hence, there is sufficient evidence to indicate that the method of using pre-grown plants to accelerate the sample is viable.

Fig. 12 Roots growing through fresh planting compound

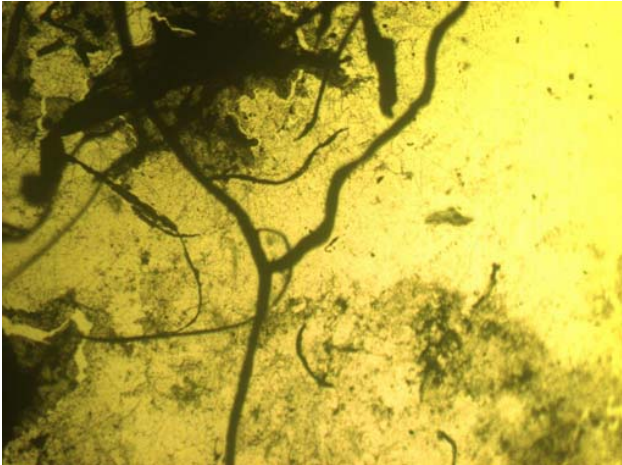
Subsequent erosion of the soil did not reveal other forms of damages inflicted on the membrane by the plant roots. Therefore, the membrane was preserved and studied under a microscope at a later time. Areas where there were significant amount of root growth were studied. These areas were isolated into sections of about 8×8mm. Fig. 13 shows the 2.5× magnification of the area.

Fig. 13 2.5× magnification of typical area (traces of soil seen at top center of fig; algae seen at bottom left of fig)

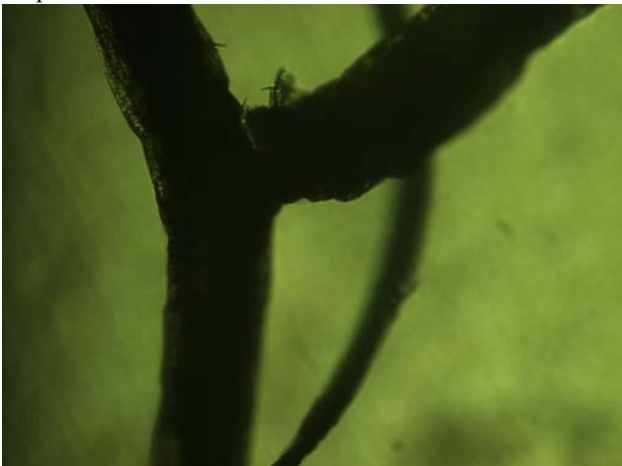
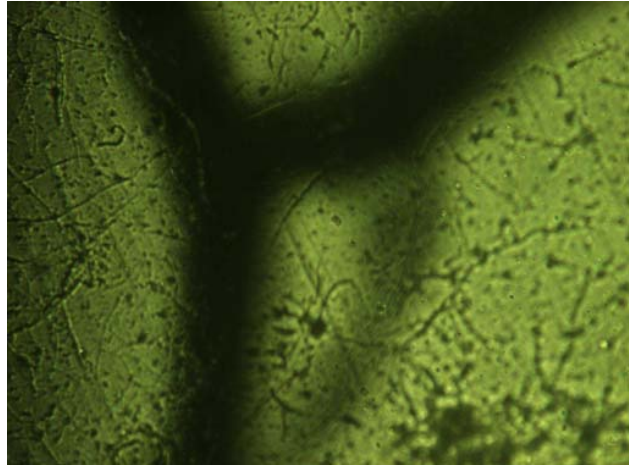
Fig. 15 20× magnification of typical area focusing on the membrane

Fig. 14 shows an area under magnification, focusing at different heights. The top fig. focuses on the root while the bottom fig. focuses on the membrane. This implies that as there was an inability to focus on both the membrane and the root, there was a substantial difference in the level of the root and the membrane. This indicates that the root has not grown deep into the membrane.

Fig. 14 20× magnification of typical area focusing on the root

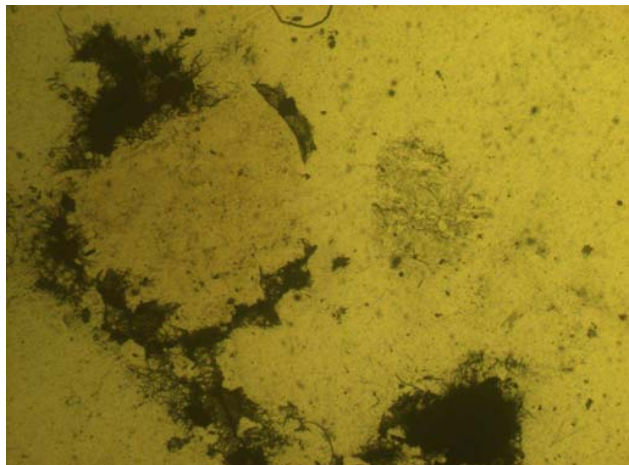
To verify the above inference, the root is removed under a running tap. It was observed that though there was some staining of the membrane under the root growth, there was no root growth mark left on the membrane (fig. 16).

Fig. 16 2.5× magnification of typical area with root cleared
