The Effects of Roots Action of Tropical Green Roofs—Replication of German FLL in Singapore

Kian. Kai. Tan, Michael. Yit. Lin. Chew, Nyuk. Hien. Wong

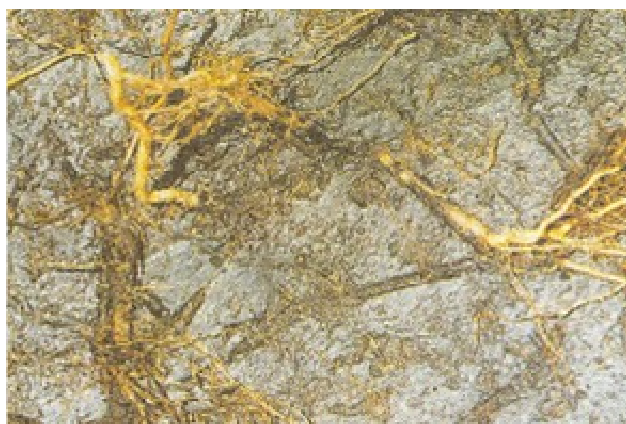
However, due to the nature of the construction industry and the scale of building projects, it is almost impossible for a building to be defect free, including green roofs. Defect on green roof waterproofing membranes are reported in [10], as shown in fig. 1.

Fig. 1 Roots leaving impression on waterproofing membrane, adapted [10]

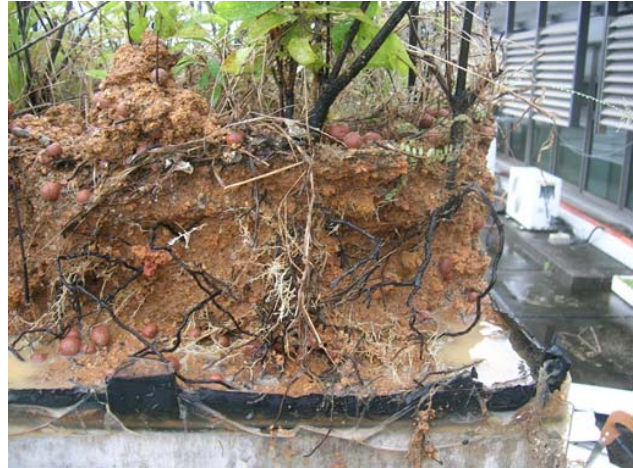
Soil was removed using a water jet. Jet pressure applied was held consistently low to prevent unwanted disturbance to the soil. Soil was removed at a rate of approximately 0.75mm/min for a surface area of 1,000mm×200mm or 150cm³/min. Roots structure exposed after 10mm of soil was removed was vast. This indicates that the duration of this sample was sufficient for roots growth. Exposed roots were approximately 2.5mm thick in diameter, of which covered about 20% of the exposed area (fig. 3).

Fig. 3 Initial exposure of roots

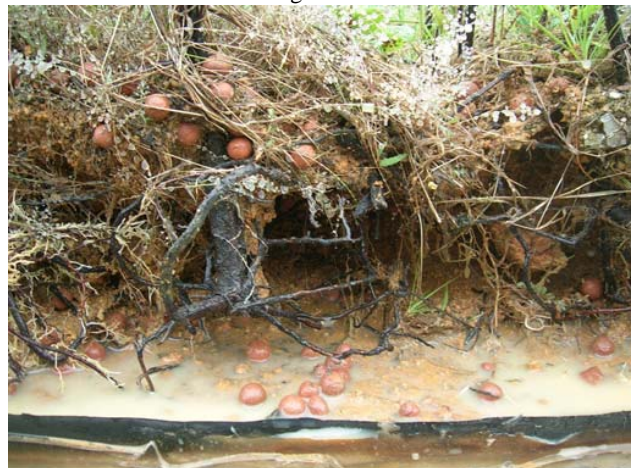
Further erosion revealed the main root of one of the plants of diameter about 12mm. This root terminated 15mm before it reached the membrane. Moreover, the secondary roots, of about 2mm diameter, also turned sideways when they reached the membrane as shown in fig. 4.

Fig. 4 Main root of one of the plants

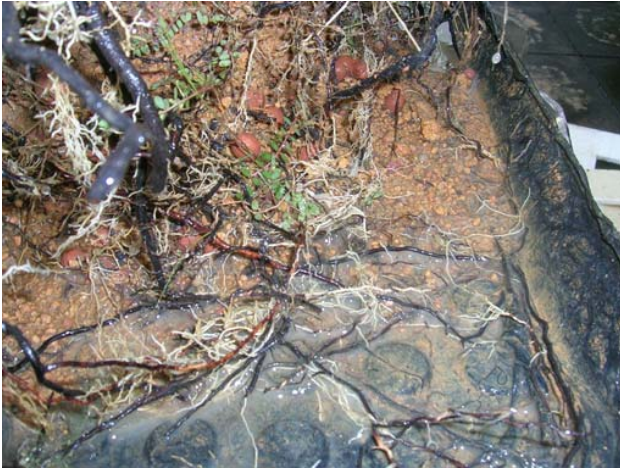
From fig. 5, coverage of secondary roots on the membrane was about 15%. This shows that main roots did not force its way across a membrane; main roots will grow above and do not damage the membrane.

Fig. 5 Secondary roots spreading on membrane surface

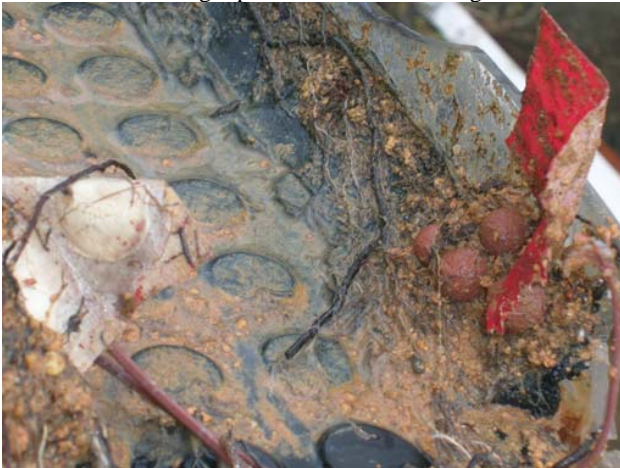
Roots did not grow into the membrane at this area but did seem to grow into the liquid applied waterproofing material used to seal the edges of the sample box. However, there was no evidence of outright penetration as seen in fig. 6.

Fig. 6 Roots seemed to have grown into the liquid applied waterproofing at the edge

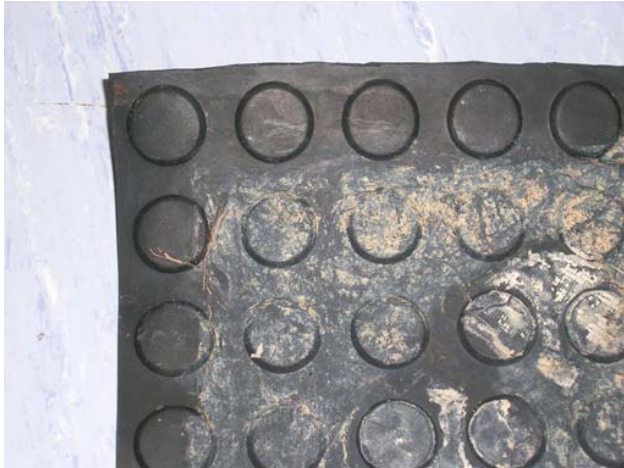
The liquid applied waterproofing was subsequently detached from the sheet membrane and it revealed that no root grew into the joint (fig. 9).

Fig. 9 Clean sheet membrane edges indicate no form of growth between the liquid applied waterproofing and sheet membrane

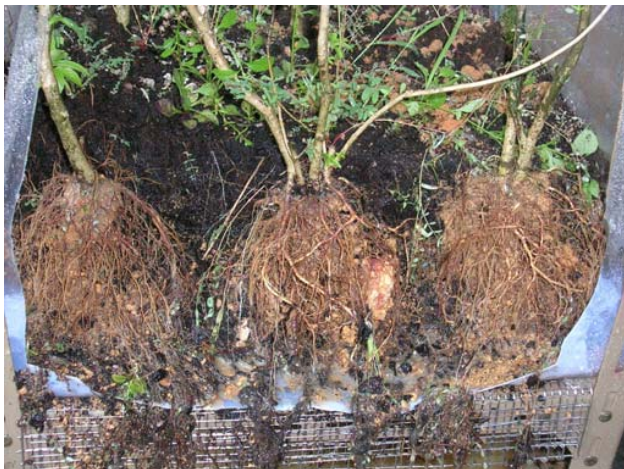
Soil was also removed with a water jet. Upon removal of the first 10mm of soil, substantial root structure was noticed. This again signifies extensive root structure. Further erosion of soil revealed that all the root structures were more well established than those in sample 1, indicating that there was good root growth and the artificial environment created for this sample was conducive for root growth. The root coverage was more than 50% throughout, which was more than sample 1 (15-20%), as seen in fig. 10.

Fig. 10 Vast root structures

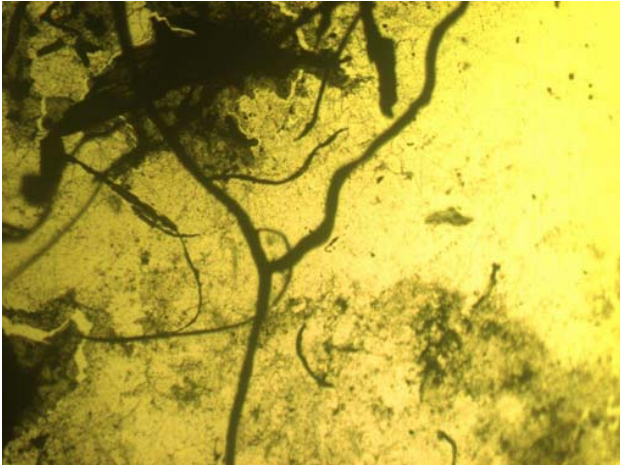
Subsequent erosion of the soil did not reveal other forms of damages inflicted on the membrane by the plant roots. Therefore, the membrane was preserved and studied under a microscope at a later time. Areas where there were significant amount of root growth were studied. These areas were isolated into sections of about 8×8mm. Fig. 13 shows the 2.5× magnification of the area.

Fig. 13 2.5× magnification of typical area (traces of soil seen at top center of fig; algae seen at bottom left of fig)

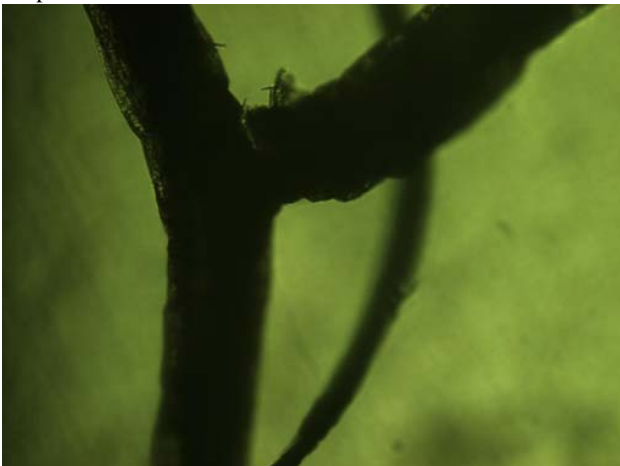
Fig. 14 shows an area under magnification, focusing at different heights. The top fig. focuses on the root while the bottom fig. focuses on the membrane. This implies that as there was an inability to focus on both the membrane and the root, there was a substantial difference in the level of the root and the membrane. This indicates that the root has not grown deep into the membrane.

Fig. 14 20× magnification of typical area focusing on the root

Fig. 15 20× magnification of typical area focusing on the membrane
