Ageing Deterioration of High-Density Polyethylene Cable Spacer under Salt Water Dip Wheel Test

Abstract—This paper presents the experimental results of high-density polyethylene cable spacers for 22 kV distribution systems under salt water dip wheel test based on IEC 62217. The strength of anti-tracking and anti-erosion of cable spacer surface was studied in this study. During the test, dry band arc and corona discharge were observed on cable spacer surface. After 30,000 cycles of salt water dip wheel test, obviously surface erosion and tracking were observed especially on the ground end. Chemical analysis results by fourier transforms infrared spectroscopy showed chemical changed from oxidation and carbonization reaction on tested cable spacer. Increasing of C=O and C=C bonds confirmed occurrence of these reactions.

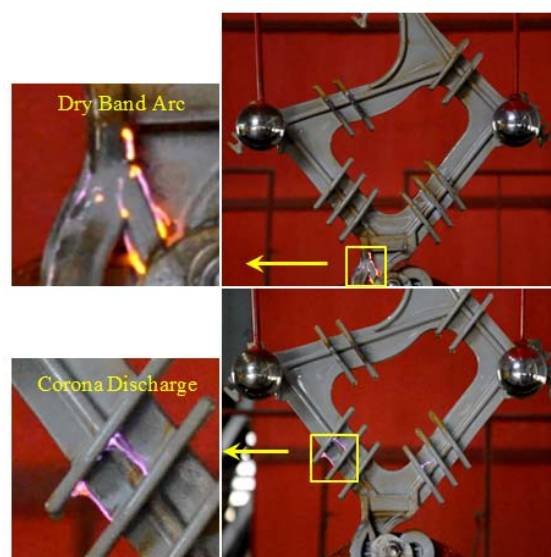
During test, many discharge activities were observed. Dry band arc and corona discharge were often observed on the ground end, trunk and energized end. Especially on the ground end was observed severe arcing. Yellow light paths indicate dry band arcing and purple light indicate corona discharges [12] as show in Fig. 4. This phenomenon caused ageing deterioration on surface of HDPE cable spacer.

Fig. 4 Discharge Activities

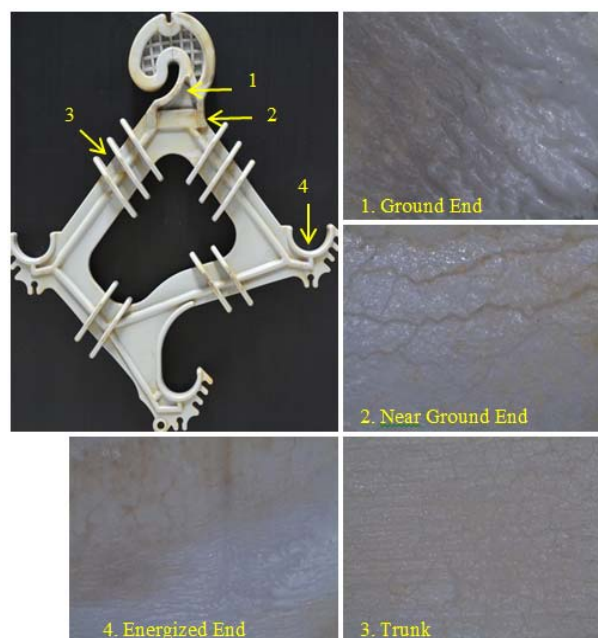
After 30,000 tests cycles, damaged surface of tested cable spacers was observed. Tracking and erosion occurred on tested specimen surface. Severe surface erosion was observed on the ground end portion, near ground end and trunk between sheds near ground end, as illustrated in Fig. 5.

Fig. 5 Tracking and Erosion After Tested [Specimen 4]

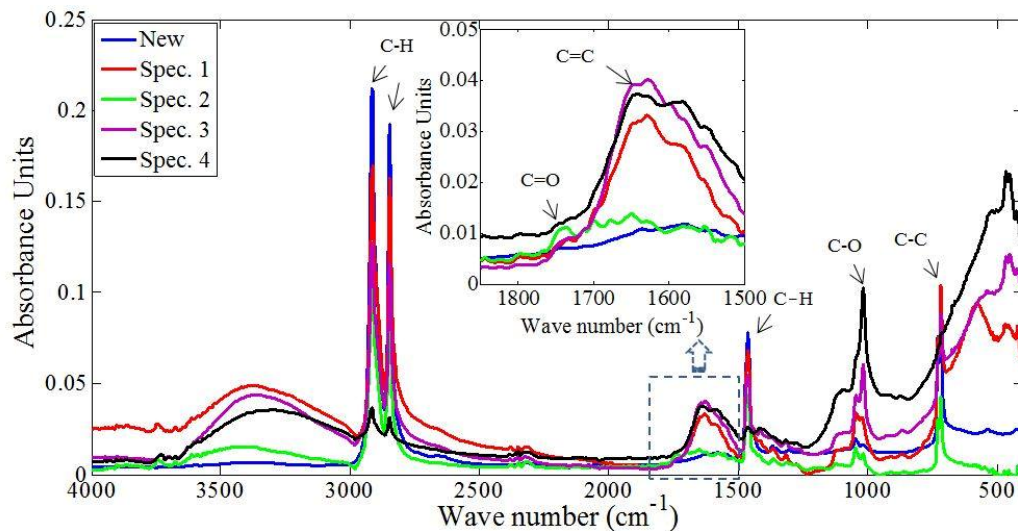
Appearance of C=O bond at wave number 1,745 cm^{-1} and C=C bond at wave number 1,630 cm^{-1} indicates the occurrence of Oxidation and Carbonization, respectively. As illustrated in Fig. 7, reduction in C-H bond and C-C bond were observed on all tested specimens when comparing with new specimen. In contrast, increasing in C=O bond and C=C bond were observed on all tested specimens. Ratio of C=O bond and C-C bond is illustrated in Fig. 8. And ratio of C=C bond and C-C bond is illustrated in Fig. 9

Fig. 7 ATR-FTIR analysis result [Position 1]

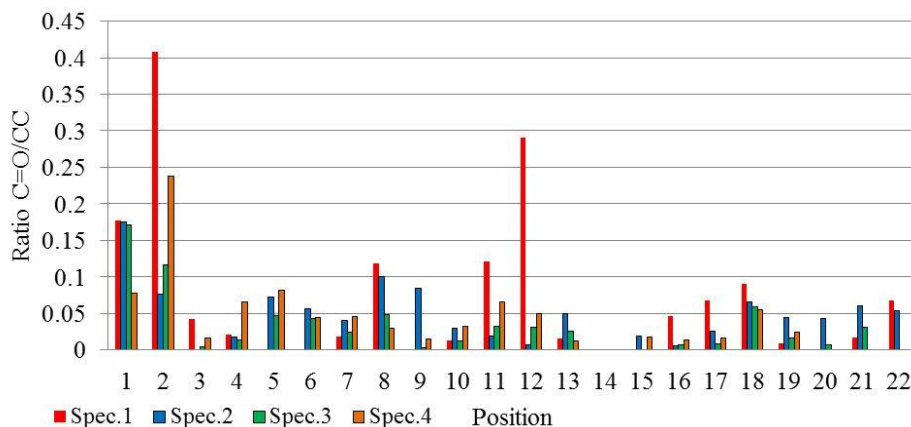
Fig. 8 Ratio of C=O/C-C

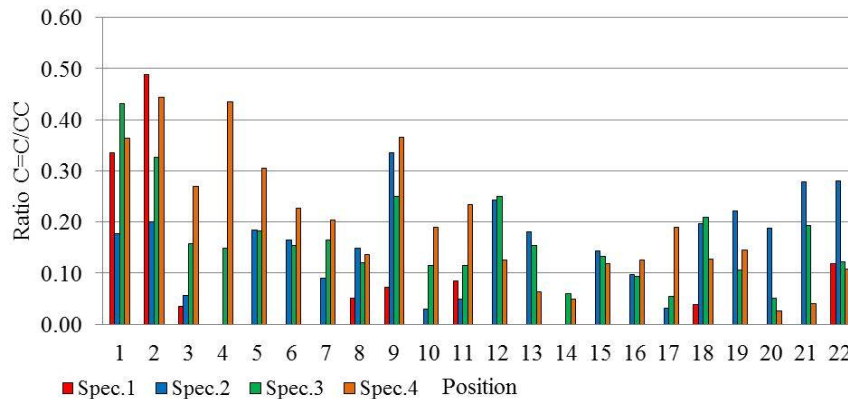
Fig. 9 Ratio of C=C/CC
