Stress Corrosion Crack Identification with Direct Assessment Method in Pipeline Downstream from a Compressor Station

H. Gholami, M. Jalali Azizpour

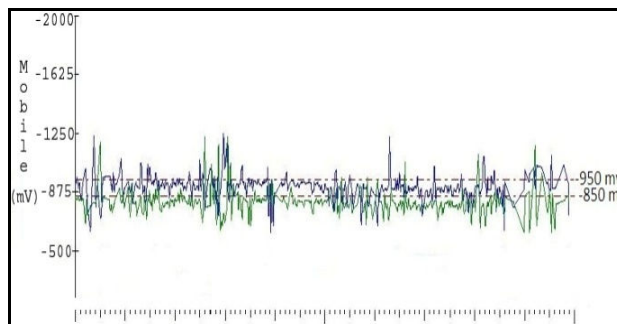
Fig. 1 CIPS results

Inadequate cathodic protection level was detected in through of the pipeline according to the (-850mV) instant-off potential criterion, generally (Graph 1). This graph is a sample of CIPS results in this pipeline.

All the factors discussed in NACE standard are met in this pipe line. In addition, SCC is typically found in locations where CP is shielded from the pipe surface or is inadequate. CIPS results showed that potential is under-protection according to (-850 m.v "off"). So, results of CIPS show that this pipeline is susceptible to SCC.

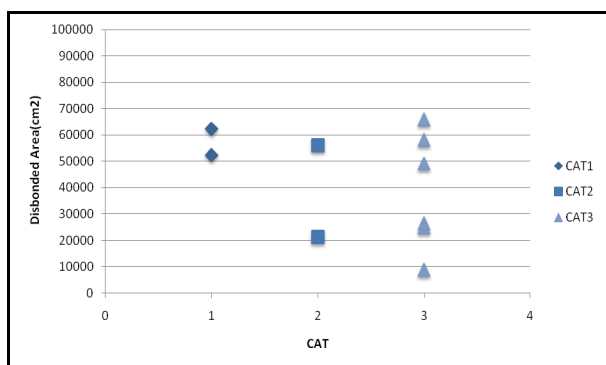
Fig. 2 The extent of disbondment in compare with the coating defect category

Fig. 2 illustrates disbondment area close to coating defects for a pipeline with PVC cold wrap coating and after 38 years from construction year. Extent of disbondment area next to the DCVG category 1 is approximately same in compare with category 3.

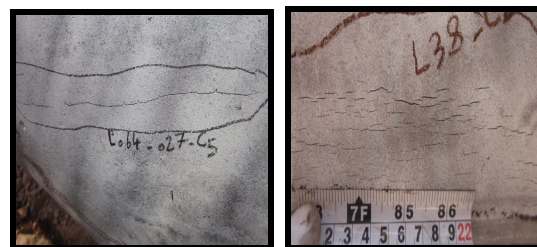
(a) (b)

Fig. 3 (a), (b), (c), (d) and (e) Samples of SCC shapes, found place and orientation for E- Branch pipeline

SCC occurred in places with corrosion metal loss. The SCC was typically within areas of general corrosion and/or pitting (Fig. 3 (b)). SCC can occur in individual or colony form. Colonies typically contain from a few to thousands of individual cracks (Figs. 3 (c) & (d)). Cracks are essentially parallel to one-another and oriented perpendicular to the local direction of maximum stress on the pipe. Typically cracks are axially-oriented where the operation hoop stress is the dominant stress. Where external bending loads act on the pipe or where local stress raisers (i.e. dents) are present, the dominant stress directions can shift to the circumferential-oriented or some intermediate angle (Figs. 3 (a) & (e)).

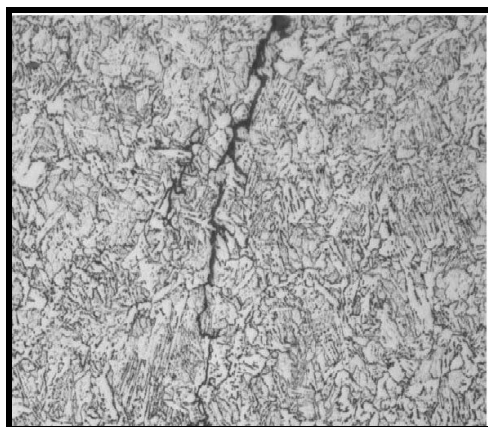
standard metallographic techniques and examined using an optical microscopic. Fig. 4 shows these results. Intergranular phenomenon was detected in SCC sample. This type of SCC morphology considered in high-pH SCC. But, there is potential for neutral pH SCC in this pipeline, too.

(b) Intergranular phenomenon

Fig. 4 Morphology of SCC in E-Branch pipeline
