The High Temperature Damage of DV – 2 Turbine Blade Made from Ni – Base Superalloy

Abstract—High pressure turbine (HPT) blades of DV – 2 jet engines are made from Ni – based superalloy. This alloy was originally manufactured in the Soviet Union and referred as ŽS6K. For improving alloy's high temperature resistance are blades coated with Al – Si diffusion layer. A regular operation temperature of HPT blades vary from 705°C to 750°C depending on jet engine regime. An overcrossing working temperature range causes degradation of the protective coating as well as base material which microstructure is formed by the gamma matrix and strengthening phase gamma prime (forming small particles in the microstructure). Diffusion processes inside the material during exposition of the material to high temperatures causes mainly coarsening of the gamma prime particles, thus decreasing its strengthening effect. Degradation of the Al – Si coating caused its thickness growth. All the microstructure changes and coating layer thickness growth results in decreasing of the turbine blade operation lifetime.

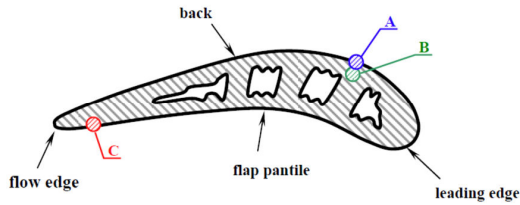
Fig. 3 The cross section of blade and description zones of interests
 A – checking of the uniformity and homogeneity of alitize layer from 1/4 of blade back B – evaluation of morphology and amount of γ' - phase and grain boundary right under alitize layer C – checking of alitize layer degradation or presence of Cr rich carbides needles.

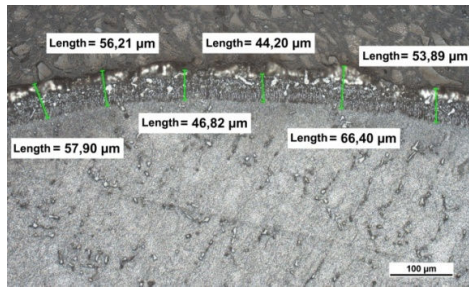
Fig. 4 Al – Si protective layer thickness measurement, non-etched specimen: (a) leading edge with average coating thickness of 50 μm , (b) turbine blade back with average coating thickness of 36 μm , (c) flow edge with average coating thickness of 45 μm

The Al – Si layer on the surface of blade is significantly coarsened and lost its homogeneity due to high temperature degradation and abrasive wearing. Degradation as itself shows in layer thickness increasing. Al – Si layer thickness h depending from spraying thickness at its application and can be easily determined from dependence $h = 0.7\delta$, where δ is for spraying thickness. Then for starting stage Al – Si layer thickness is around $h = 24.5 \mu\text{m}$ (an optimum spraying thickness for annealing at 950°C is up-to $\delta = 35 \mu\text{m}$). The thickness of Al – Si layer is higher in all observed areas what indicates higher temperature of loading than reported 751°C. The highest degree of degradation was observed at three areas from all four observed, namely leading edge with average thickness 50 μm , Fig. 4 (a); turbine blade back with average thickness 36 μm , Fig. 4 (b); and flow edge (in some parts of flow edge was not Al – Si layer identified at all, a huge degradation due to abrasive wearing at high temperatures) with average thickness of 45 μm , Fig. 4 (c).

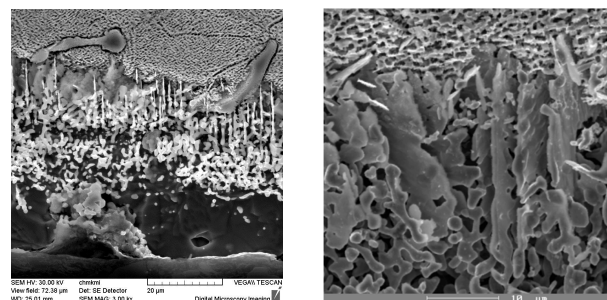
The next problem with Al – Si layer degradation is forming a needle like Cr rich carbides and blocky form of primary Ti rich carbides in layer – base material zone. Fig. 5 reports such carbide formation confirmed also by chemical SEM mapping.

Fig. 5 Chemical analyses of layer – base material zone with Cr and Ti rich carbide formation: (a) overall view, (b) detail of Cr rich carbides, (c)-(d) SEM mapping, etc. MARBLE, SEM microprobe Bruker

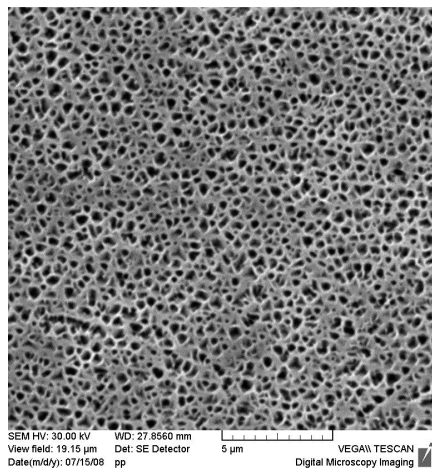
Fig. 6 Degradation of γ' precipitate at high temperature ($751^\circ\text{C}/2\text{s}$) loading compared to starting stage microstructure: (a) γ' - phase morphology, initial stage, (b) after $751^\circ\text{C}/2\text{s}$ for 600 hours of loading, etch. Marble, SEM
