# Directing the Forensic Investigation of a Catastrophic Structure Collapse: The Jacksonville Parking Garage Collapse

W. C. Bracken

**Keywords**—Catastrophic structure collapse, collapse investigation, Jacksonville parking garage collapse, forensic investigation.

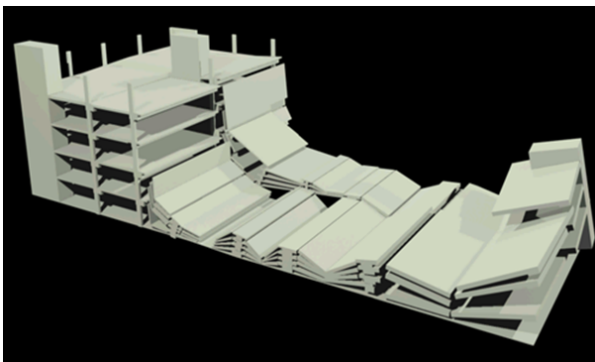
Fig. 3 Collapse Configuration

When the structure collapsed, more than 60% (the entire Northern portion) collapsed straight down in what rescue engineers described as a "pancake collapse". The portion left standing at the South end was badly damaged and ultimately required that it be razed. The disposition of the structure in its collapsed state is depicted in Fig. 3.

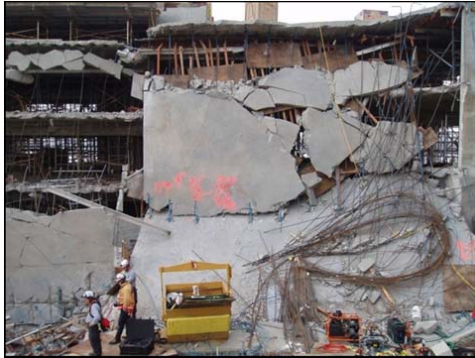
Fig. 4 Hanging Slabs

After a major structural collapse safety is the obvious primary concern. As seen in Fig. 4, a photo of the collapse immediately prior to the commencement of the investigation, the precarious nature of the debris was compounded by the number of potential secondary collapse hazards. Safety is accomplished through control of the scene. Control is accomplished by not just installing fences, guards and cameras but also through well-developed protocols that are published to all parties.
