Condition Monitoring for Controlling the Stability of the Rotating Machinery

Abstract—In this paper, the experimental study for the instability of a separator rotor is presented, under dynamic loading response in the harmonic analysis condition. The global measurement and analysis of vibration on the cement separator RC500 is carried, the points of measurement used are radial dots, vertical, horizontal and oblique. The measures of trends and spectral analysis for reconnaissance of the main anomalies, the main defects in the separator and manifestation, the results prove that the defects effect has a negative effect on the stability of the rotor. Experimentally the study of the rotor in transient system allowed to determine the vibratory responses due to the unbalances and various excitations.

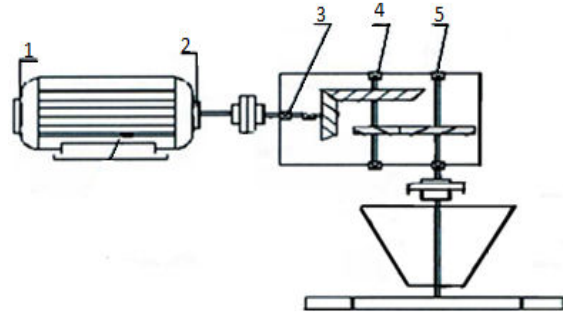
Fig. 3 Measuring points

We noticed that the vibration level by speed measurement in the bearings 02 and No. 03, in the alarm condition, requiring the intervention and the bearings 01 and No. 04 and 05 in alarm status but are acceptable and after the separator Z2 repair we noticed a reduction in the levels velocity and stabilization (correct state) in all bearings the trend curve and the spectrum defined defects in each measuring point.

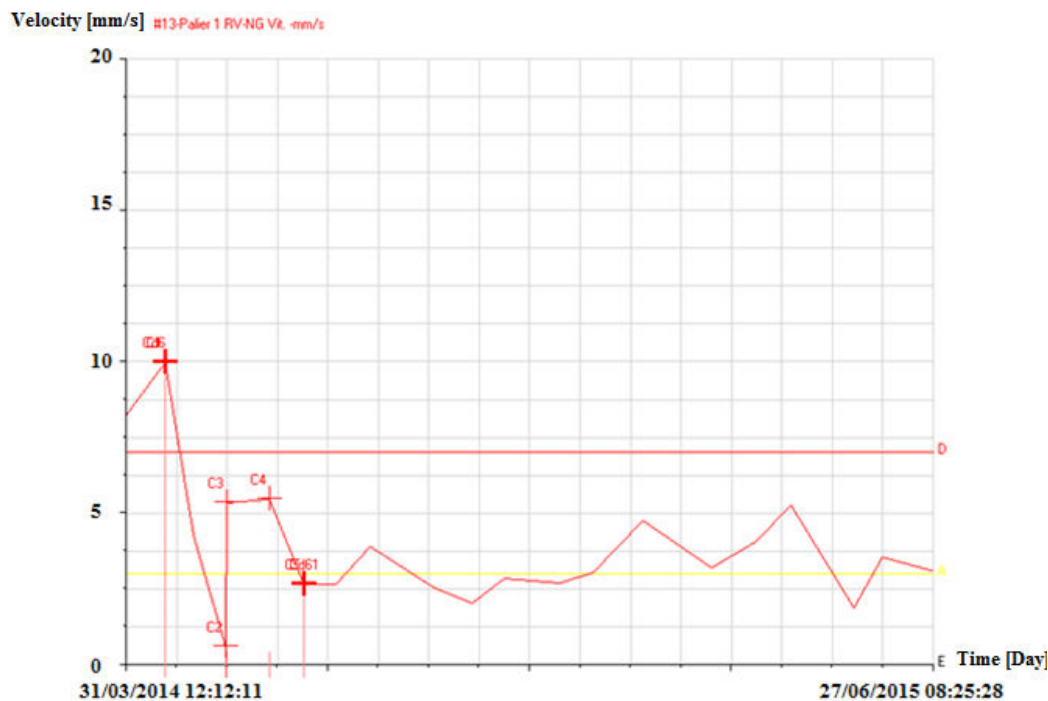
Fig. 4 Trend curve of bearing (01) RV-NG

The trend curve for the bearing N°01 (mm / s) is presented. There was an increase vibratory velocity level which exceeds the alarm threshold in point C4 (5.49 mm / s) which shows the presence of an anomaly, but we do not know their origin, after repair a speed decrease is observed with a reduction in (2.84 mm / s), for diagnosing the origin of the excess passes to spectral analysis.

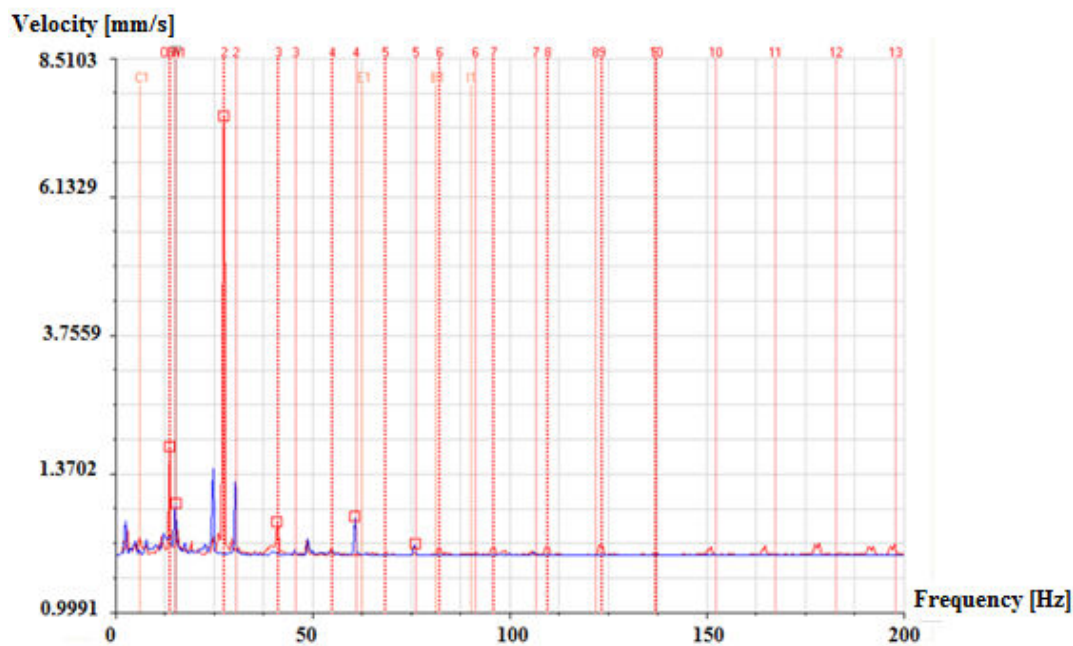
Fig. 6 Spectral Image superimposed on bearing N°02 RH

Concerning the Bearing N°02, through the Trend curve we noticed a speed level of increase that exceeds the danger threshold Cd1 points (9.25 mm / s), indicating the presence of an anomaly but does not know their origin, this anomaly is more danger. According repair a speed decrease is observed with a reduction in (6.27 mm / s), for diagnosing the cause of the excess passes to spectral analysis. The spectrum N°02 (mm/s) is given in Fig. 6.

The spectral signature (red spectrum) represents a net increase in amplitude equal (7.51 mm / s) in the low frequency

range corresponding to a frequency value equal to 27.41 Hz, this value corresponds to the 2nd harmonic of the rotation frequency of the motor shaft, which is a misalignment between the motor and reducer. The recommendation is the lineage of the line engine transmission – gearbox and the coupling change.

After the repair carried out (the coupling change) we notice (blue spectrum) a net decrease in the speed level (the fault disappears), which confirms the accuracy of diagnosis. The spectrum N°03 (mm/s) is given in Fig. 7.

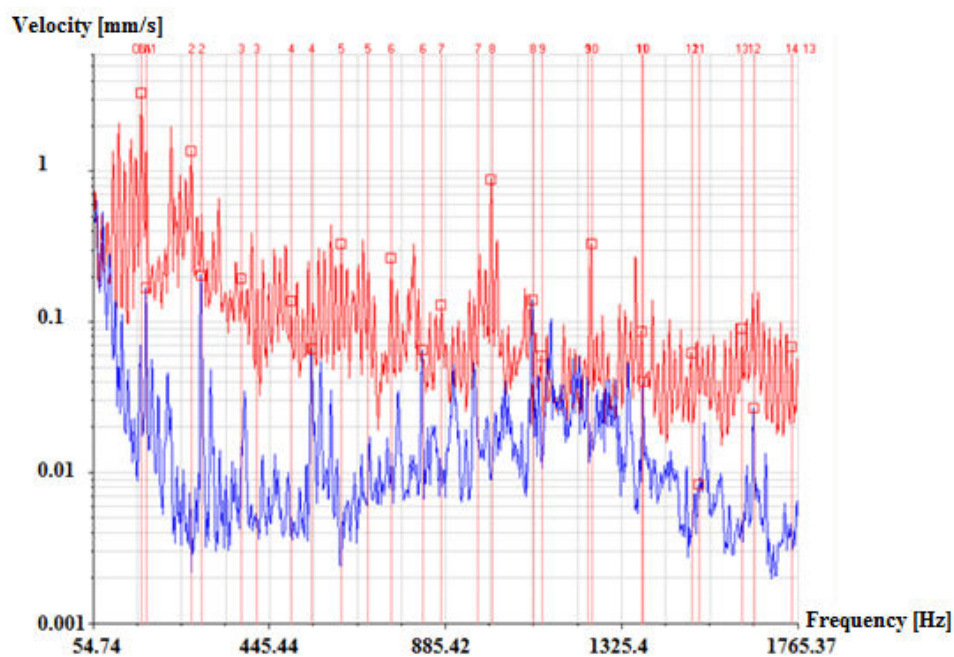
Fig. 7 Spectral Image superimposed on the logarithmic scale on bearing N°03 RO

The spectral signature (red spectrum) represents a net increase of amplitude in the medium frequency domain corresponds to a second frequency value that equals 250 Hz, this value corresponds to one of the first train of the gear meshing defect (pinion). The recommendation is changing the gearbox.

After the repair carried out (the gear change) we notice (blue spectrum) a net decrease in the speed level (the fault disappears), which confirms the accuracy of diagnosis.

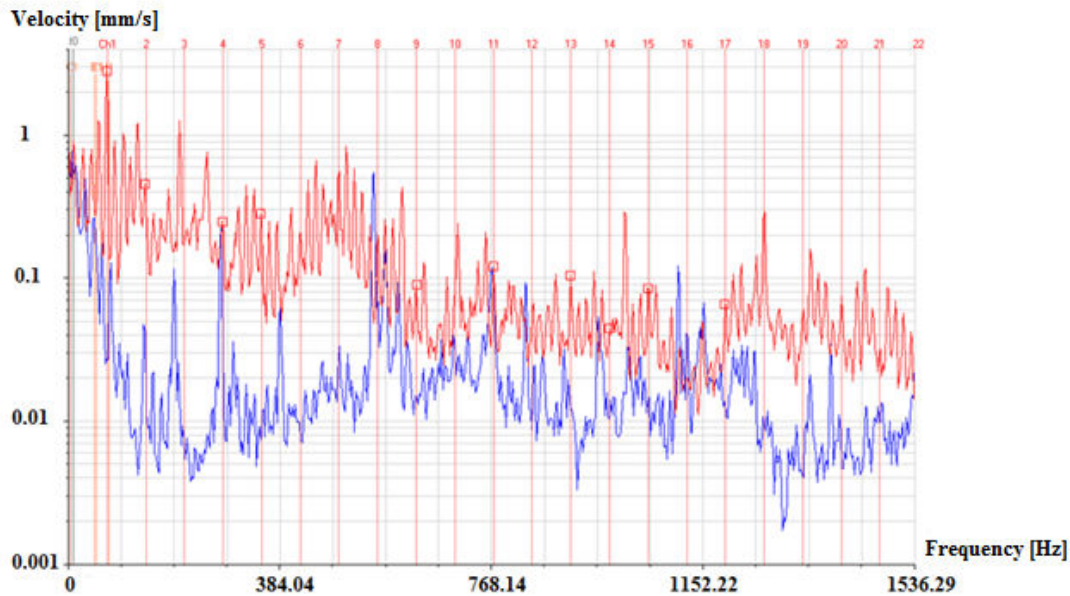
Fig. 8 Spectral Image logarithmic scale superimposed on bearing N°04 RO.

For the bearing N°04, According to the trend line oblique radial extent in remarks at point C2 (4.80 mm / s) an alarm threshold is exceeded, after repairing a decrease until Cd11 (1.86 mm/s), to diagnose original passes to frequency analysis.

The spectrum N°04 (mm/s) is given in Fig. 8. The spectral signature (red spectrum) represents a net increase of amplitude in the medium frequency domain corresponds to a frequency value equal to $Ch1 = 70.15$ Hz, this value corresponds to a discharge failure of the internal bearing ring.

The recommendations are changing the rolling bearing No 04. After the repair carried out (the gear change) we notice (blue spectrum) a net decrease in the speed level (the fault disappears), which confirms the accuracy of diagnosis.

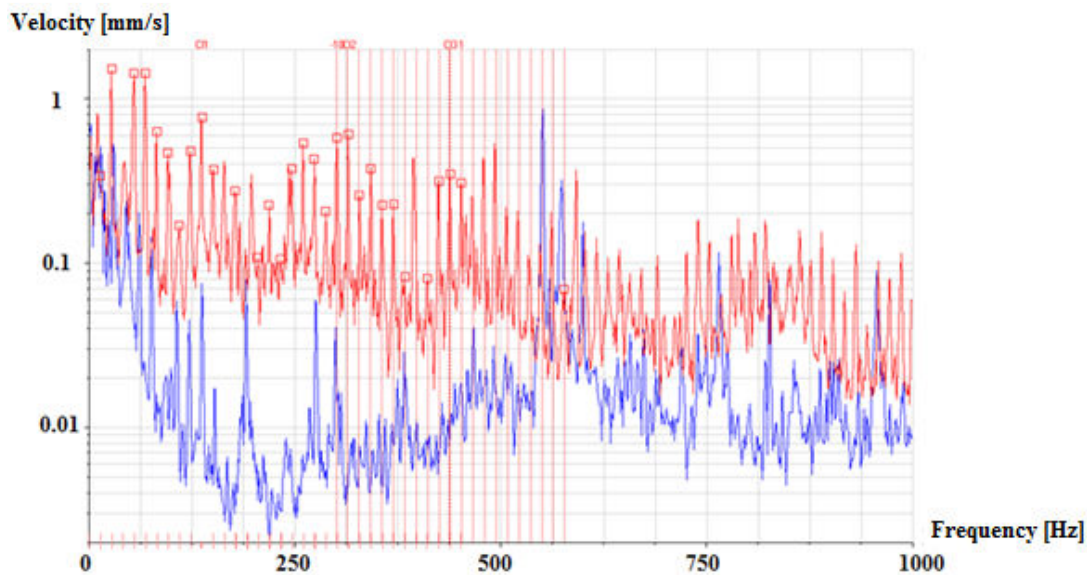
Fig. 9 Spectral Image superimposed on a logarithmic scale on bearing N°05 RO.

For the bearing N°05, According to the oblique radial extent of the bearing 05, we note that the point C2 (4.08 mm / s) an alarm threshold is exceeded, after repair decreased to C3 (1.86 mm / s) is observed. The spectrum of bearing N°05 (mm/s) is given in Fig. 9.

The spectral signature (red spectrum) represents a net increase of the average amplitude in frequency domain corresponding to a shock to the frequency of rotation of the motor on the bearing supporting the shaft of the separator.

The recommendation is changing the rolling bearing No 05. After the repair performed (the change bearing and gearbox) we notice (blue spectrum) a net decrease in the speed level (the fault disappears), which confirms the accuracy of diagnosis.
