Rock Slope Stabilization and Protection for Roads and Multi-Storey Structures in Jabal Omar, Saudi Arabia

Ibrahim Abdel Gadir Malik, Dafalla Siddig Dafalla, Abdelazim Ibrahim

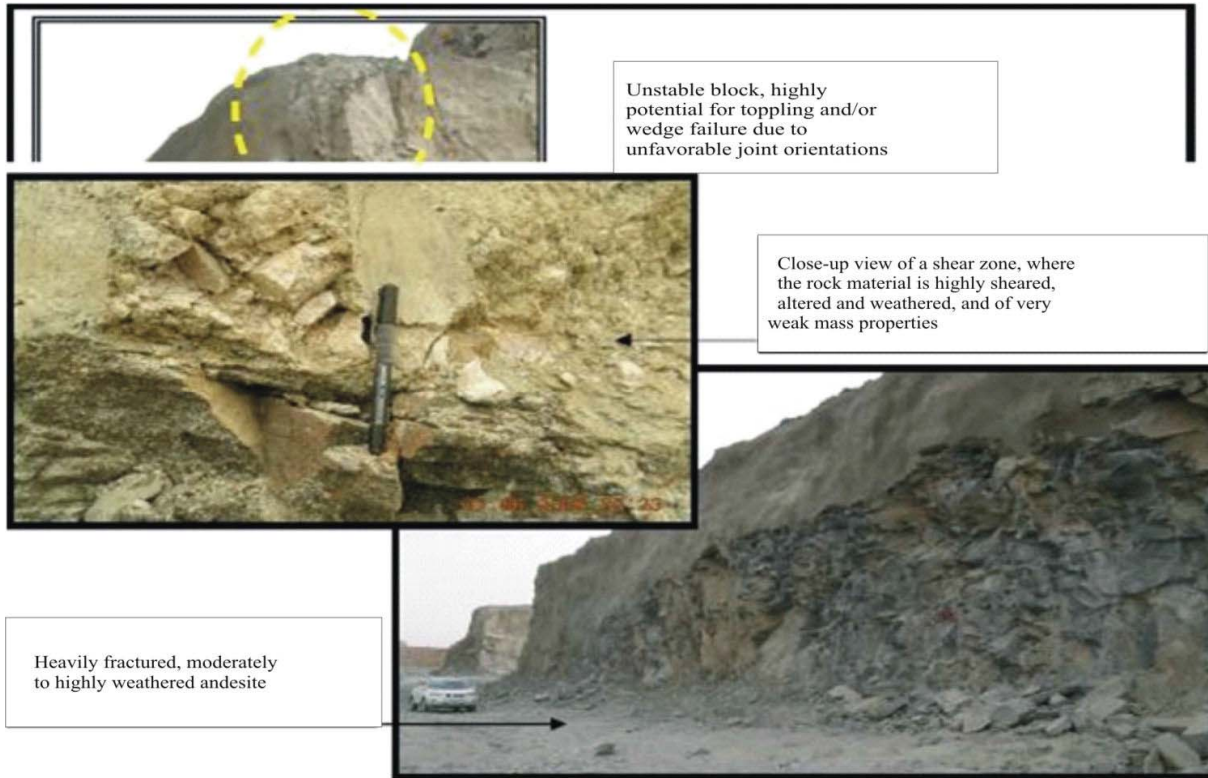
In general, the rocks are heavily jointed, faulted and sheared due to tectonic deformation [7]. Along the shear and fault zones, the rocks are commonly highly fractured and sheared with some degree of alteration and are highly weathered.

Fig. 1 Some of the common geological features of the rock mass along the Site

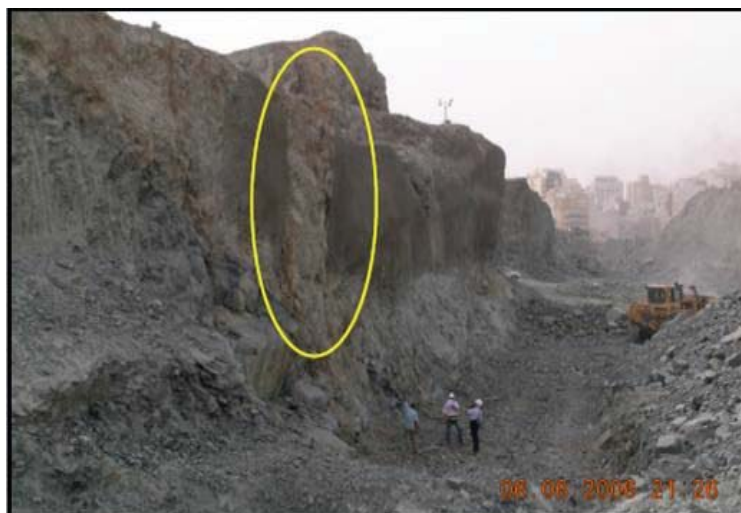
The site was selected as a critical area since the exposed bedrocks by recent rock cutting are generally in very poor condition, heavily jointed and sheared. Based on information from the Resident Engineer on site, rock slope failures occurred recently at the upper portion of the cut slopes which covered by "concrete spray" (Fig. 2).

Fig. 2 View of the site condition of the site, the yellow circle indication the failure section
