Rock Slope Stabilization and Protection for Roads and Multi-Storey Structures in Jabal Omar, Saudi Arabia

Ibrahim Abdel Gadir Malik, Dafalla Siddig Dafalla, Abdelazim Ibrahim

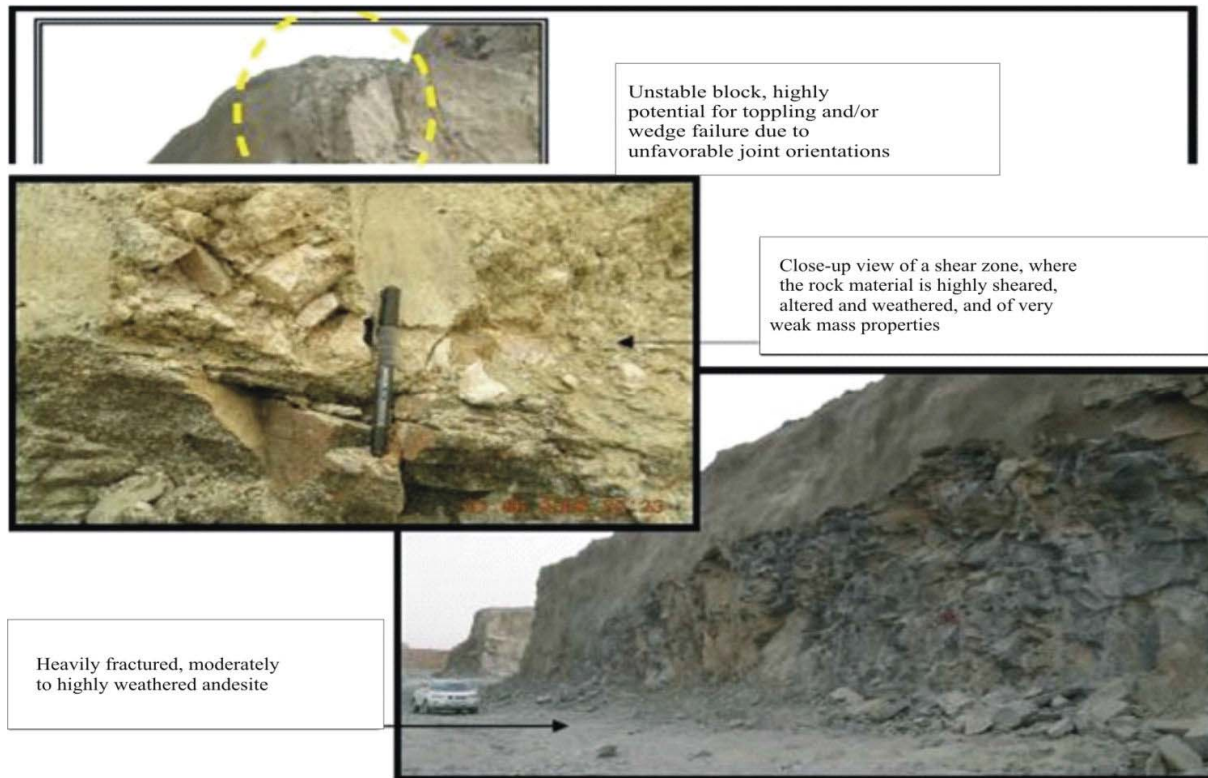
In general, the rocks are heavily jointed, faulted and sheared due to tectonic deformation [7]. Along the shear and fault zones, the rocks are commonly highly fractured and sheared with some degree of alteration and are highly weathered.

Fig. 1 Some of the common geological features of the rock mass along the Site

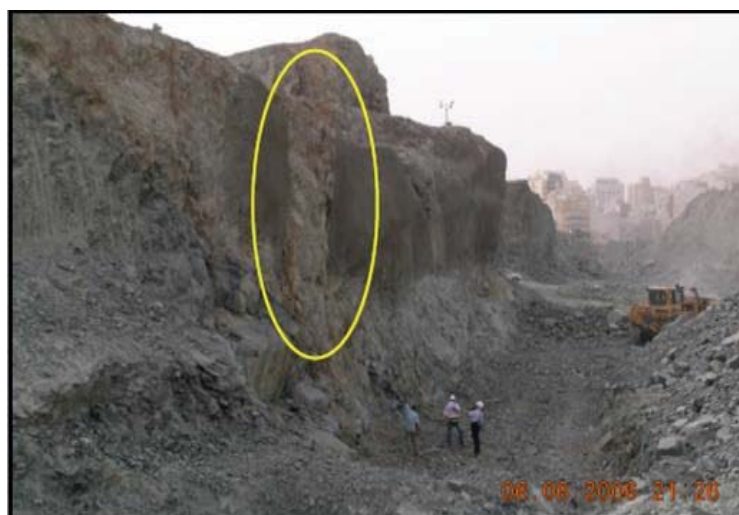
The site was selected as a critical area since the exposed bedrocks by recent rock cutting are generally in very poor condition, heavily jointed and sheared. Based on information from the Resident Engineer on site, rock slope failures occurred recently at the upper portion of the cut slopes which covered by "concrete spray" (Fig. 2).

Fig. 2 View of the site condition of the site, the yellow circle indication the failure section

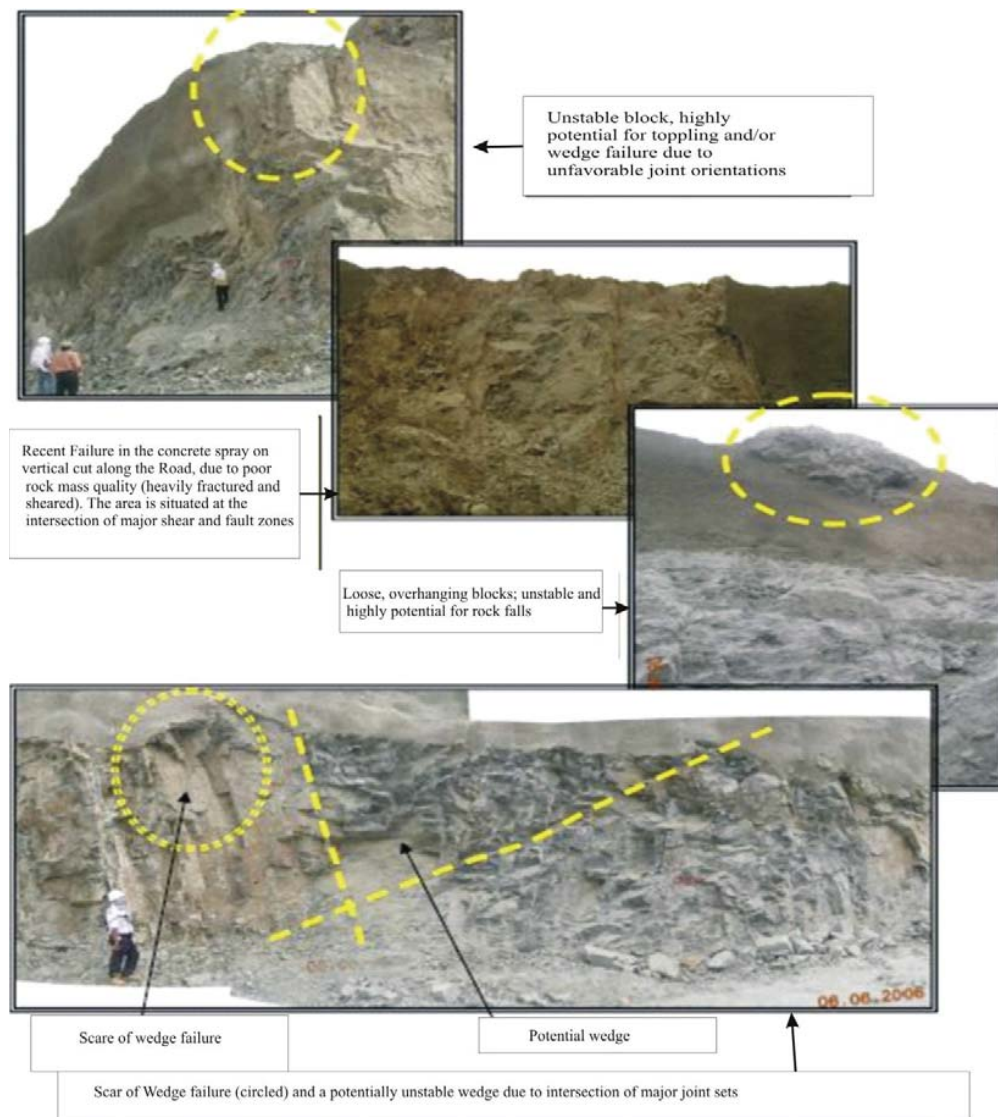
inhibits the creation of open, smooth vertical rock cuts [3]-[5]. This is evident in the field where in many places, fallen wedges and blocks can be found along the foot slope and their scars can be clearly observed in the slope faces.

unsuccessful. Wedge failures, rock falls, and tension cracks had since developed, suggesting that the "concrete spray" was inadequate and could not support the vertical cut in poor rock mass and thus some other slope protection measures have to be adopted. From a brief survey, it was also found that the cut slopes along the site Mare potentially unstable and are very likely to fail either in the form of wedge, toppling and/or rock falls. Some of the identified critical spots are shown in Fig. 3.

Fig. 3 Examples of some of the identified geotechnical problems associated with vertical cut in poor rock mass along the site

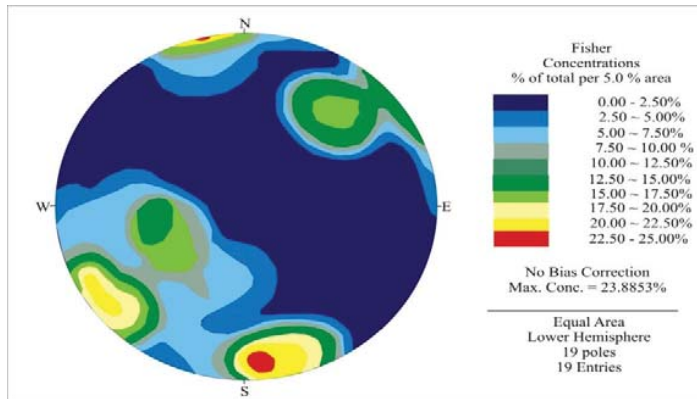
Geological mapping works was carried out in the vicinity of the unstable slope shown in Fig. 3 (a) in order to assess and to verify its stability. The discontinuity data orientation was plotted into lower hemisphere stereographic projections and analyzed (Fig. 4). The results of the analysis (Fig. 5) confirmed the presence of unstable blocks, which is defined by the intersection of three (3) major sets of joints (H: 340/35; J2: 322/90, and B: 256/78). The toppling failure is made possible by the intersection of the steeply dipping J2 with plane H acting as the basal sliding plane. The failure may also take place in the form of wedge due to the intersection of J3 and J1 [6] and [9].

Fig. 4 Stereographic plot the discontinuities of the failed slope

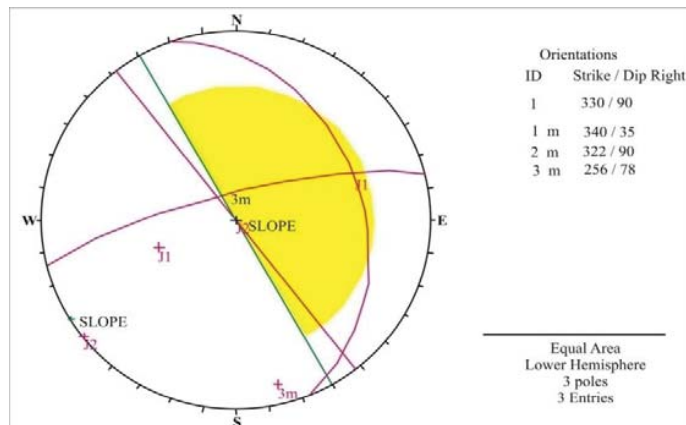
Fig. 5 Kinematic stability analysis of the rock slope at the site, Sta. 0+160

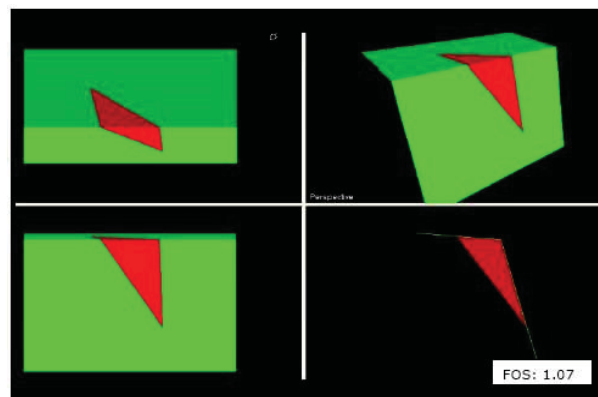
The wedge failure identified from the kinematics stability analysis (Fig. 5) was further modeled by using SWEDGE v4 of Rocscience in order to determine its factor of safety during the failure. In this back analysis, it is assumed that the friction angle along the discontinuity plane is 36° and the failure took place in dry condition. Results of the analysis (Fig. 6) suggested that the factor of safety was 1.07.

Fig. 6 Back analysis modeling of the unstable wedge, by using SWEDGE v4 program
