Investigation of Failures in Wadi-Crossing Pipe Culverts, Sennar State, Sudan

Magdi M. E. Zumrawi

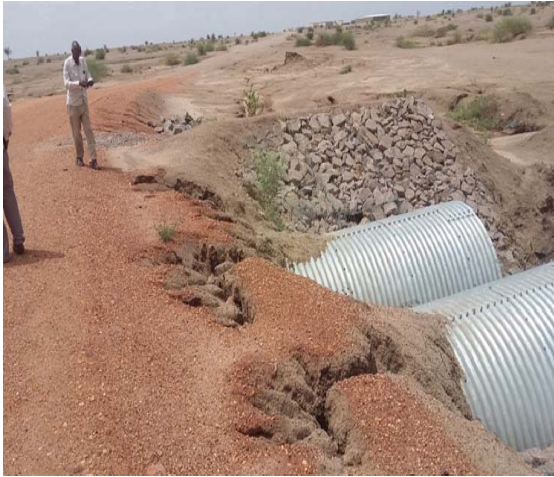
Severe cracks and potholes were clearly seen on top embankment especially at the edges nearby the pipes inlets and outlets. Also the head walls of the pipes showed severed failures and collapse of the gabion mesh used to protect the embankment around the pipes as shown in Fig. 6. The gabion mesh was placed between the pipes only without any link between them. The gabion mesh was fall down when the embankment failure occurred due to water erosion.

Fig. 6 Severe cracks and potholes on embankment edges due to water erosion

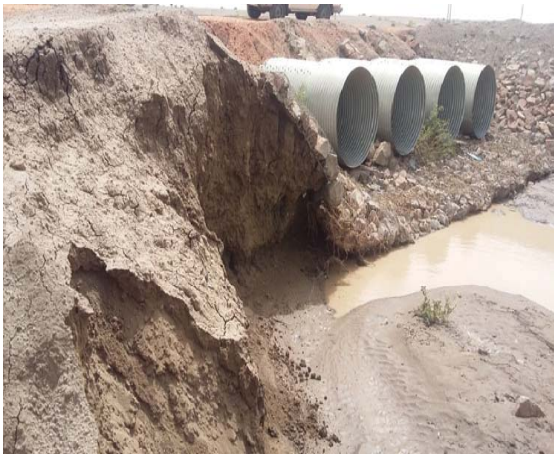
Fig. 7 Collapse and failure of wing walls embankment due to water scouring

It was observed also partial breaching and weakening of the wing wall embankments at inlets and outlets of culverts which may result in complete collapse. This embankment weakening was happening mainly due to scouring effect of the incoming wadi which flows adjacent to the embankment section parallel to the crossing axis. This scouring has caused the embankment slope to get steeper and has increased the wadi depth which has increased the embankment height that can lead to failure. During the rainy season, this steeper section was falling into the wadi where it got saturated and washed downstream. In

some crossings, the embankment has changed its original section, dimension and shape throughout the entire length of the crossing where the top embankment is narrowed and the side edges with severe cracks and potholes and the slopes at inlets are flattened in some sections and steeped at others (see Fig. 7).

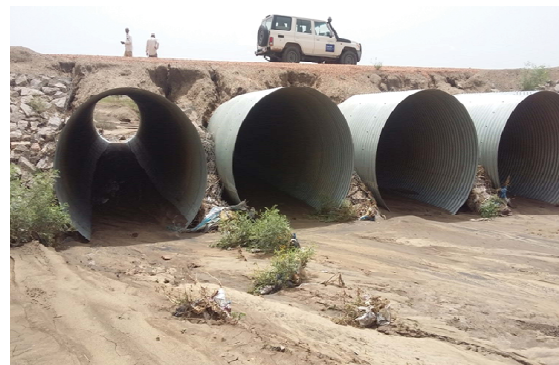
In addition to breaching and weakening of the embankment, the other concern observed in the crossings is sediment deposition and vegetation in the apron area of outlets. The sediment deposition has reduced the storage capacity of the pipes by significant volume. This is mainly due to huge sediment load from the catchment area which leads to reduction in pipes capacity (see Fig. 8).

Fig. 8 Sediment deposition and vegetation in the apron area

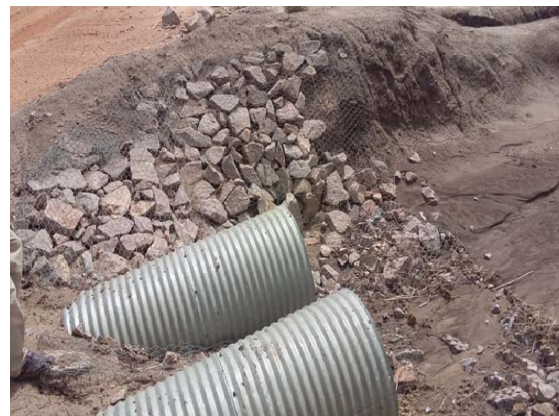
In most crossings, it was observed that the wing walls of the inlets and outlets which are protected by gabion mesh showed better performance than the head walls as shown in Fig. 9. While in very few crossings, the mesh of the gabion missed or opened and some of the stones were thrown away from the walls. This problem may adversely affect the stability of embankment slope.

Fig. 9 The gabion mesh used for lining of wing walls

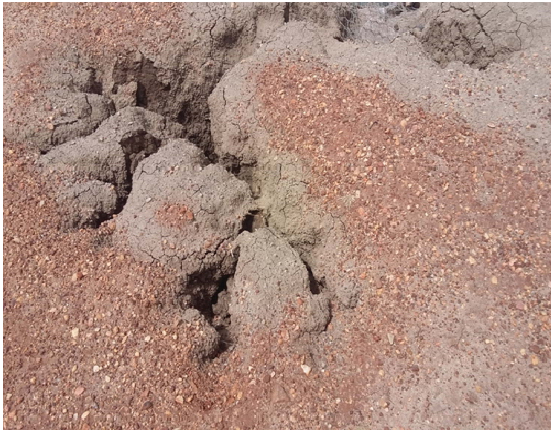
It is clearly observed from Fig. 10 that the subbase layer laid on the embankment is becoming very thin (i.e. thickness less than 20 cm) to support the traffic loading and partially accumulated at the sides. As a result, the underneath

embankment of clayey soil suffered from severe cracking and potholes occurred at edges above the pipes inlets and outlets.

Fig. 10 Sever cracks and potholes on Subbase and embankment layers

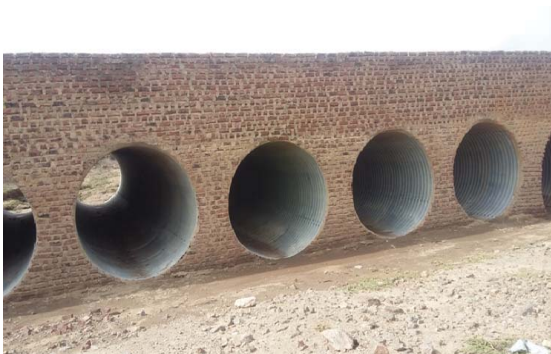
It was noticed that the Fresh crossing in west Aldindir was properly design and constructed. The pipes are protected with a head wall build of brickworks and the side wing walls are lined with stone pitching as shown in Fig. 11. It is clearly observed that the crossing is in a good condition particularly in the inlets and outlets of the pipes.

Fig. 11 Head and wing walls of the Fresh crossing are in good condition
