Investigation on the Physical Conditions of Façade Systems of Campus Buildings by Infrared Thermography Tests

N. Türkmenoğlu Bayraktar, E. Kishali

In the context of the study Kocaeli University, Anıtpark campus located in the central part of Kocaeli, Turkey is investigated. There are four buildings, one of which belongs to the "*Faculty of Architecture and Design*". The main building focused in the context of the research is an existing building built in 1980s. Until today, it had faced different kinds of interventions on building envelope. Exterior and interior physical climatic factors influencing thermal conditions, the deteriorations on building envelope caused by physical environmental factors; temperature distribution, heat losses from opaque and transparent facade elements by thermography as a non-destructive test method in order to improve strategies for the retrofitting process for the building envelope is presented.

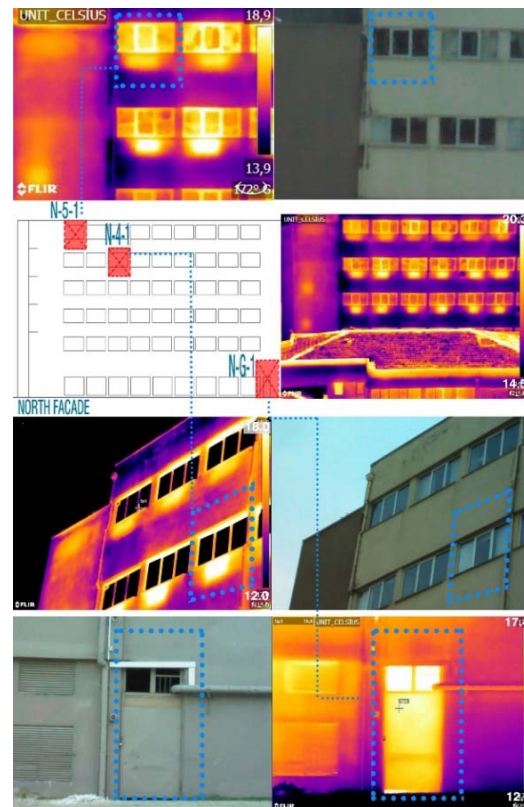
Fig. 7 IRT captures on North Elevation of Faculty of Architecture and Design

Moisture induced anomalies were also observed via IRT technique. Infiltration from the roof where staircase and the building connected in the north-east part building was observed. The insufficient downspout and rain drain influence hygrothermal conditions of the offices located at the top floor oriented to the North; efflorescence and biological growth were observed on the interior surface of the most North-east office of the building even by direct investigation (N-5-1 in Fig. 7). Outside surface temperature was logged between 4.5°C and 7°C on the outside surface; the highest value obtained on the envelope where radiator heats the zone, whereas interior air temperature was logged as 18°C. It is deduced that heat loss phenomenon occur with higher amount compared to other offices. The northern parapet of the roof display lower outside surface temperature with respect to other parts of the elevation; especially, the top level of the north-east area of the elevation is highly exposed to direct and wind-driven rain phenomenon. Contrarily, capillary rise based degradations were not detected on both elevations by IRT technique (N-G-1 in Fig. 7; S-G-1 and S-G-2 in Fig. 8).

Closed openings and relatively new materials in the north elevation was noticed via IRT. Lack of insulation on both

façade and higher heat losses enable to map these areas easily (N-4-1 in Fig. 7). It was also determined on the northern envelope that interventions on the openings of toilets were executed.

In consideration of the obtained data, refurbishment strategies towards increasing energy efficiency of building envelope are necessary. The insulation is required to prevent heat losses from the north façade. More detailed assessment need to be conveyed at the roof level. Rain drain and

infiltration issue should be blocked since relative humidity level and mold growth influences the health of users. It is recommended that the vinyl coat and windows framing be changed in order to prevent heat losses. The enhancement of energy efficiency by adding insulation to the architectural composition would provide benefit to the building and the economy.

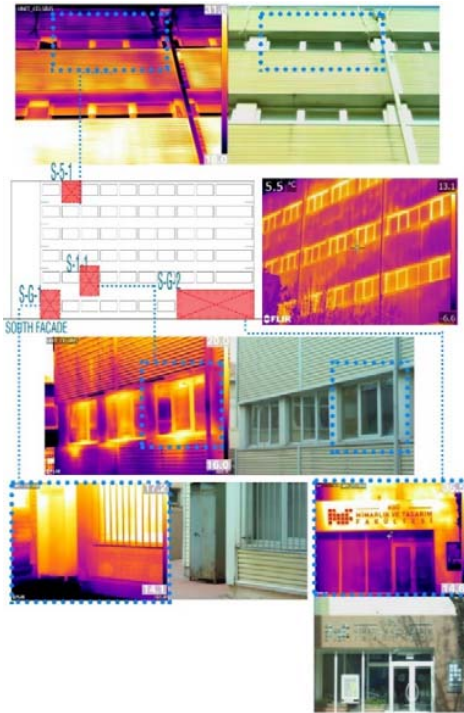
Fig. 8 IRT captures on South Elevation of Faculty of Architecture and Design

On the other hand, South façade with vinyl finishing displayed better thermal performances compared to the North façade (Figs. 7 and 8). Active heating with heat losses were easily observed when the façade was examined via IRT captures. Outside surface temperature of south envelope for the S-5-1 was measured between 5.5°C and 6.5°C; concurrently interior ambient temperature was logged as 22°C. In spite of the better performance of the South façade, the patchy view and non-homogeneous surface temperature distribution was obtained. Additionally, close-up captures indicate that heat losses from window framings occurred in the South of building. It is proved that heat losses occur there as well (S-5-1 and S-1-1 in Fig. 8).
