Structural Analysis and Strengthening of the National Youth Foundation Building in Igoumenitsa, Greece

Chrysanthos Maraveas, Argriris Plesias, Garyfalia G. Triantafyllou, Konstantinos Petronikolos

Keywords—Earthquake resistance, pushover analysis, reinforced concrete, retrofit, strengthening.

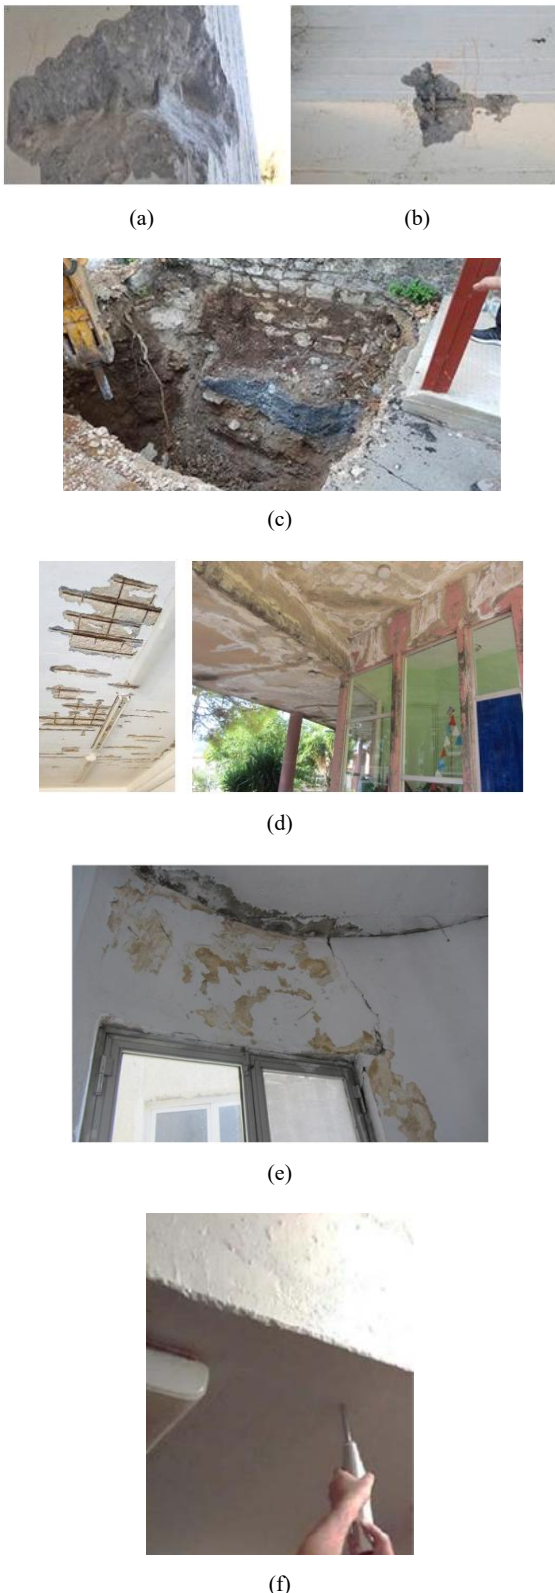
The main objectives of this study were to evaluate the structural adequacy and plan a retrofit of Buildings II and IV, as well as to perform a seismic assessment according to KAN.EPE [1]. In-situ, non-destructive and destructive tests were conducted to further assess the structural condition and details. The cover was removed in order to assess the reinforcement at selected column and beam locations. Locations from the initial construction phase and from the concrete jacketing intervention were accessed in order to verify reinforcement details, as shown in Figs. 3 (a) and (b). A sample excavation was performed to reveal the foundations in a column of Building IV, as presented in Fig. 3 (c). Areas with localized damage were also inspected, as shown in Figs. 3 (d) and (e).

Fig. 3 Disclosure of steel reinforcement materials (a,b), disclosure of the foundation in a column (c), localized damage (d,e), and a non-destructive test (f)

The configuration of the reinforcement materials was captured via local disclosure of steel rebar. Ribbed steel rebar of quality StIII with an average tensile strength $f_{ym} = 460$ MPa was identified in the main steel reinforcement. Smooth steel rebar of quality St I with an average tensile strength $f_{ym} = 260$ MPa was identified for the stirrups. Typically, the steel rebar in the supports for the Building IV slab (edge of beam) presented surface corrosion. In addition, significant moisture was noted on the surface of the concrete in the same positions. Corrosion activity was tested by measuring the half-cell potential of the steel reinforcement. The experimental results indicated that the probability of corrosion was over 90% for 54% of the surface of the soffit floor of Building I. The probabilities of corrosion were lower in the soffit slabs of Buildings II and III. Higher concrete carbonation depths were observed in the unprotected parts of the slab near the supports. The long period of abandonment and low-intensity use of the building complex had significant effects on its durability in the face of environmental factors. Despite the successful crack repairs, the ensuing lack of maintenance led to development of moisture, gradual corrosion of some elements, and detachment of the concrete cover. The corrosion half-cell potential measurements indicated further evolution of corrosion, leading to progressive degradation of the load-bearing capacity of the structure.

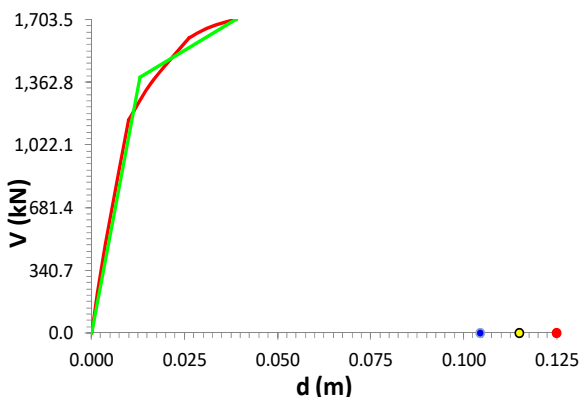
For Building II, the results from the preliminary elastic static analysis adequacy indicated significant exceedance, expressed as the percentage by which the deficiency factor limits ($\lambda>2.5$). The results indicate that 42% of the main structural elements (columns, concrete walls, and beams) failed. Specifically, 61% of the vertical elements and 33% of the beams failed. Furthermore, tests of the differences between the masses and stiffnesses of various levels in the building, the

average relative displacement between the nodes of the floor, the average relative displacement at x floors, the average relative displacement at z floors and the morphological regularity of the building were not satisfied. However, the criterion that references the upper limits of the building eigenperiods was satisfied. Based on these results, the only feasible method of further evaluation was the inelastic static method (pushover). Pushover analysis confirmed the results of the preliminary test with regard to the inability of the building to withstand seismic deformation at the selected performance level (B1). For at least one load combination, the building was unable to reach the design displacement limit and collapsed as mechanism. This case concerns triangular load distribution of the seismic combination $F_x+0.3F_z$. As can be seen in Fig. 6, the building is unable to reach the target displacement.

Fig. 6 Force–displacement curve of Building II for a triangular load distribution of the seismic combination $F_x+0.3F_z$

The main direction of the earthquake changes the requirements for retrofitting and strengthening of the vertical elements significantly. It is obvious that the overall stiffness in the transverse x direction (East–West) is reduced due to the formation of the structure (thin, elongated North–South concrete walls). In summary, Building II required structural strengthening measures in each case, as the structure could not carry the seismic load and meet the minimum requirements for performance level B1.

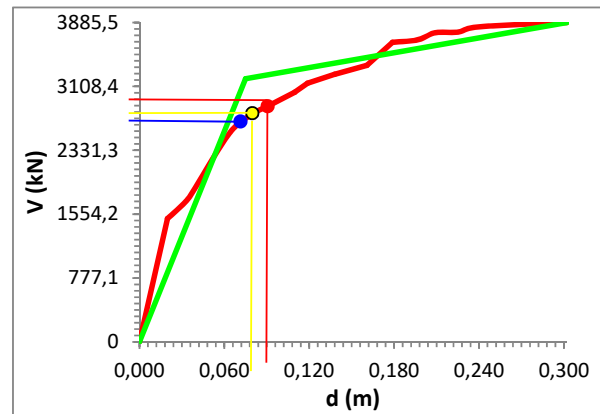
For Building IV, the results from the preliminary elastic static analysis check indicated significant exceedance, expressed as the percentage by which the deficiency factor limits ($\lambda > 2.5$) are exceeded. The results indicate that 44% of the main structural elements (columns, concrete walls, and beams) failed. Specifically, 77% of the vertical elements and 23% of the beams failed. Furthermore, tests of the differences between the masses and stiffnesses of the various levels in the building, the average relative displacement at x floors, the average relative displacement at z floors and the morphological regularity of the building were not satisfied. However, the average relative displacement between the nodes of the floor and the criterion that references the upper limits of the building eigenperiods were satisfied. Based on these results, the only feasible method of further evaluation was the inelastic static method (pushover). Pushover analysis

confirmed the significant number of plastic hinge positions and hence the retrofit requirement identified by the preliminary analysis. The results indicate that the direction of the earthquake does not affect the retrofits that are required. In conclusion, Building IV exhibited damage to several structural elements. Retrofitting and strengthening are thus required. The locations where strengthening is required include existing strengthened elements, including beams. This introduces additional difficulties. The force-displacement curve of Building IV for a triangular load distribution of the seismic combination $F_x+0.3F_z$ is illustrated in Fig. 7.

Fig. 7 Force-displacement curve of Building IV for a triangular load distribution of the seismic combination $F_x+0.3F_z$

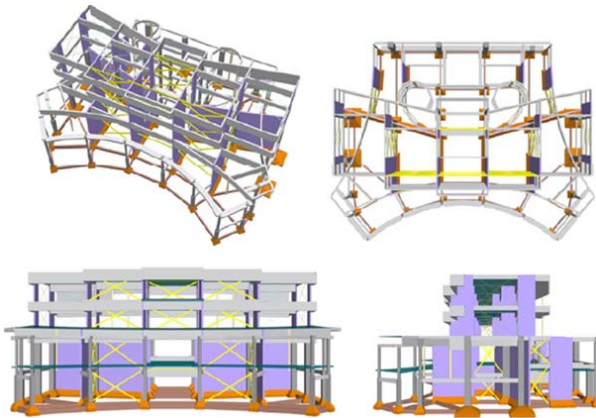
Fig. 8 Building II strengthening proposal with type X steel braces for modeling purposes. The type Λ steel braces allow the access under them

The analytical results indicate that solution c) is the most efficient, as it lets the building achieve the design displacement for each load combination, the global response is improved, and point interventions are reduced. The retrofitting scenario proposed for Building II is shown in Fig. 8.

For Building II, the plan is to strengthen the slabs with shotcrete concrete with embedded steel reinforcement and to strengthen beams and ground floor concrete walls via concrete jacketing. The reinforcement design also calls for construction of an entrance ramp and demolition of the canopy roof and stairs. Furthermore, the corroded concrete surfaces are to be repaired by applying anti-corrosion measures. The structural interventions for the construction of the new frame elements to be inserted between the RC elements include type Λ or K steel braces that consist of horizontal and vertical elements, as well as diagonal configuration links of the desired morphology. The total cost of restoring and strengthening Building II is thus estimated to be approximately 450.000€.

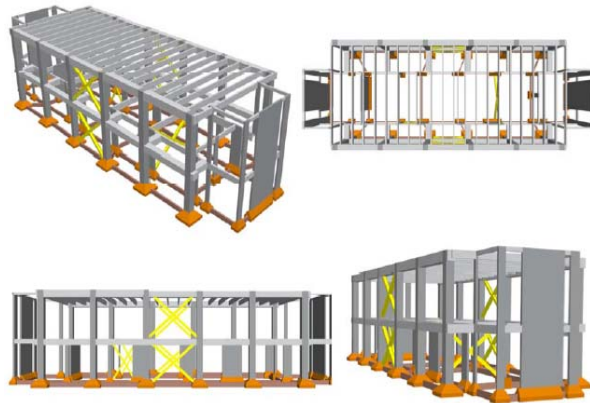
Fig. 9 Building IV strengthening proposal with type X steel braces for modeling purposes

The analytical results indicate that solution c) is the most efficient, as it provides better building performance. The number of point interventions is reduced and most importantly, retrofitting of members that were previously strengthened via concrete jacketing is avoided. A presentation

The retrofit plan for Building IV includes strengthening the slabs with shotcrete concrete, demolishing concrete surfaces, and repairing corroded concrete surfaces by applying anti-corrosion measures. Two scenarios are proposed for strengthening of the beams and concrete walls. The first includes construction of concrete jacketing for both beams and concrete walls, while the second includes concrete jacketing for beams and construction of new metal frames and concrete elements. The total cost of restoring and strengthening Building IV following the first scenario is estimated to be approximately 200.000€, whereas the cost of the second scenario is estimated to be approximately 210.000€.
